**PHASE I ENVIRONMENTAL
SITE ASSESSMENT**

Subject Property:
Sherburne School
35 Sherburne Street
Portsmouth, New Hampshire

Prepared By:
Todd Scheffer, P.G.
SRW Environmental Consulting, LLC
143 Rochester Hill Road
Rochester, NH 03867
(603)330-3537

January 4, 2023

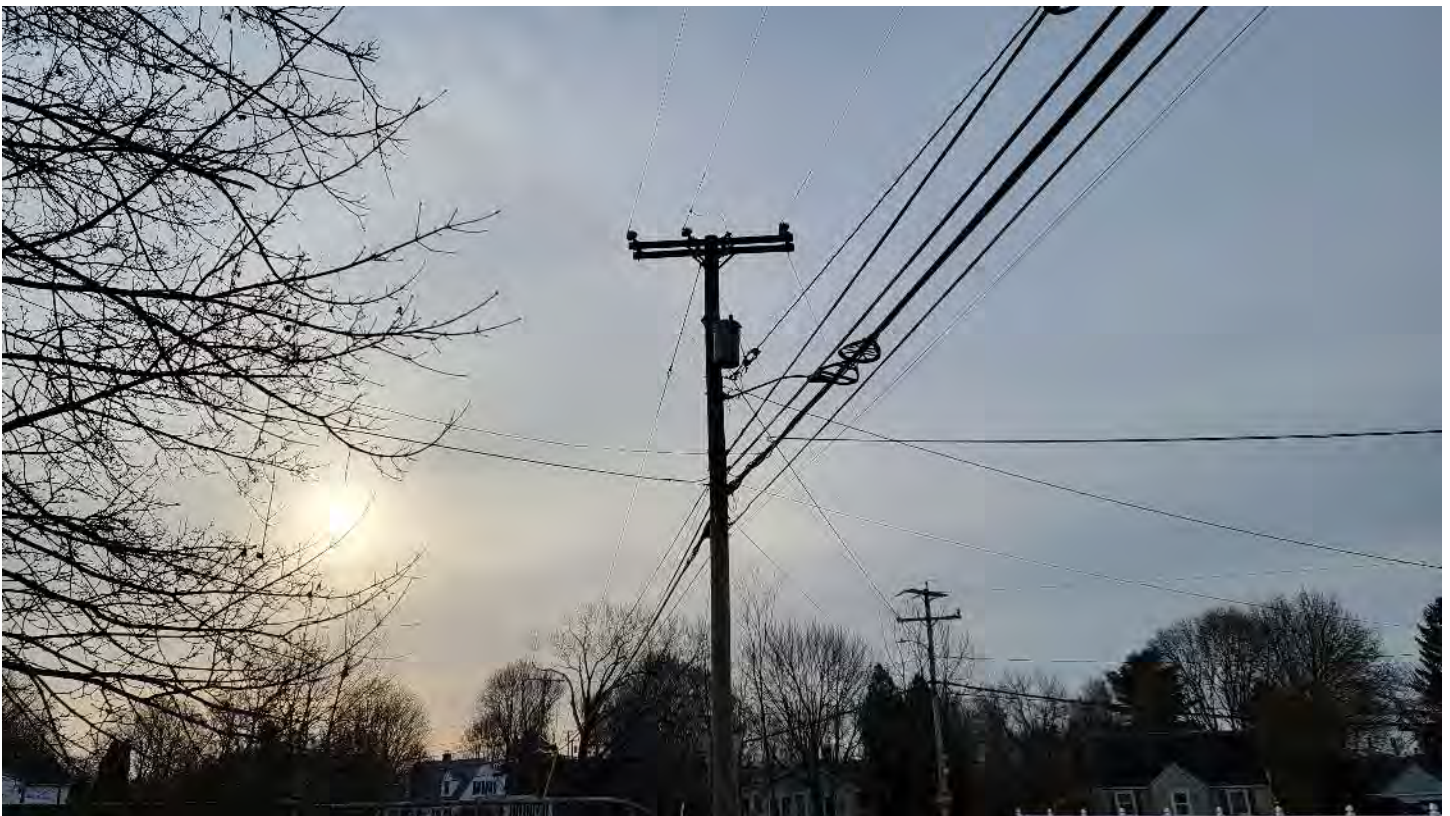
Pole-mounted electrical transformer.

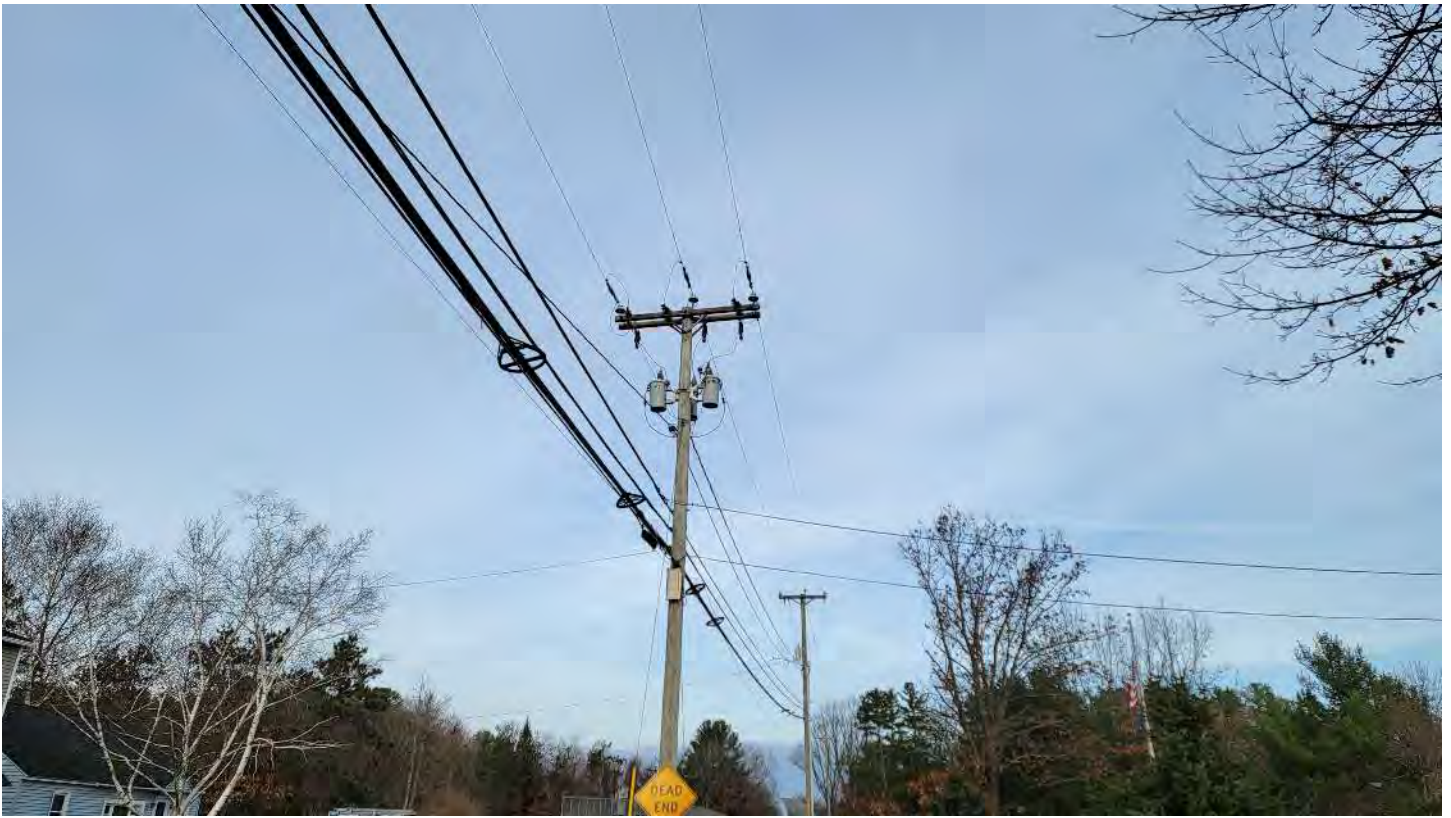
Bank of 3 pole-mounted electrical transformers.

- *Electrical transformers:* All transformers appeared to be in good condition, and no evidence of a past or ongoing release, or conditions which suggest that a release may be imminent was observed.

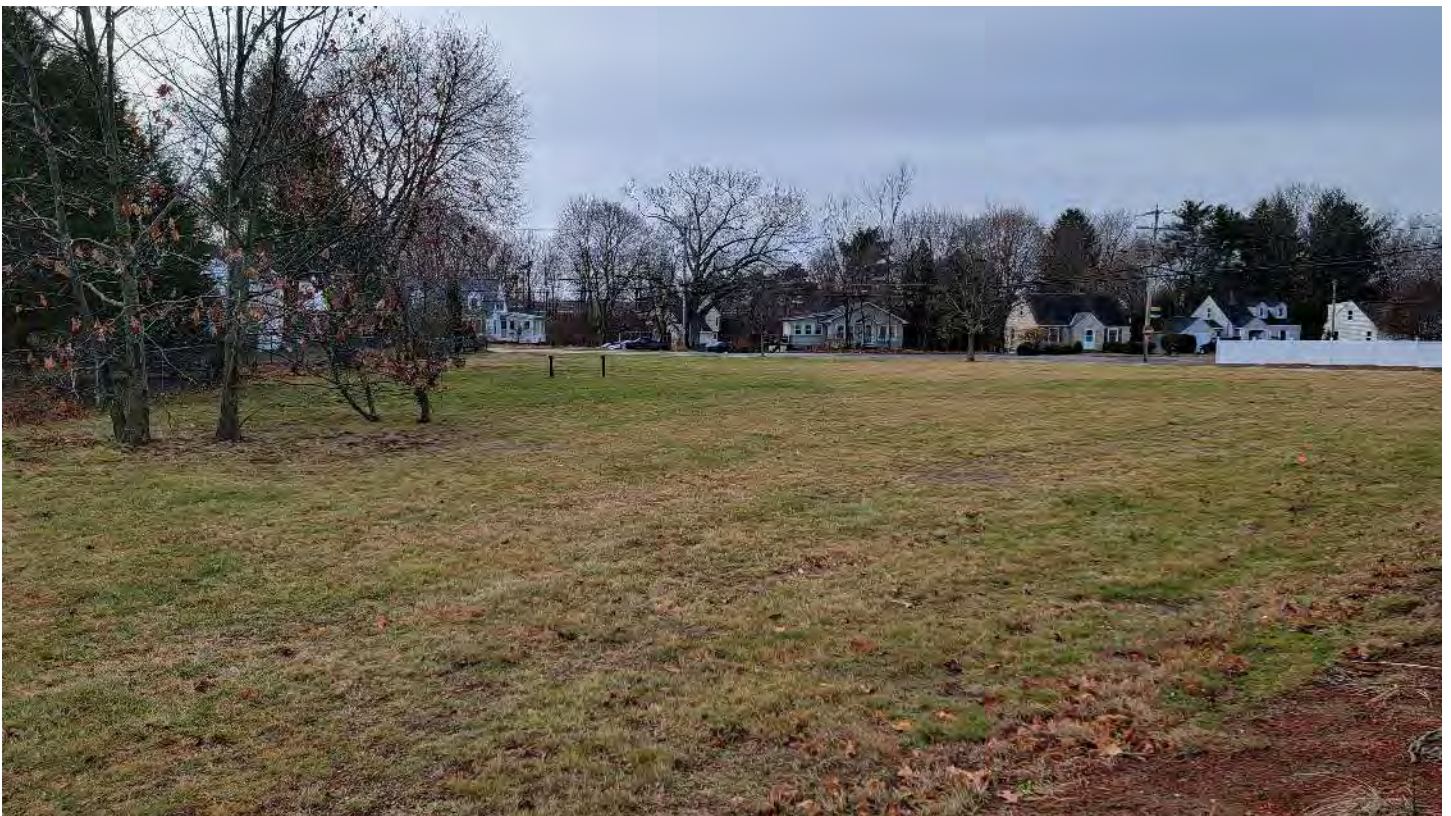
Vacant field on the southern side of the property, with newly installed monitoring wells.

SRW does not recommend any additional assessment at this time, except for providing continued access to the site's monitoring wells so that corrective actions at the Pease Air Force Base property can include monitoring groundwater conditions at the subject property.

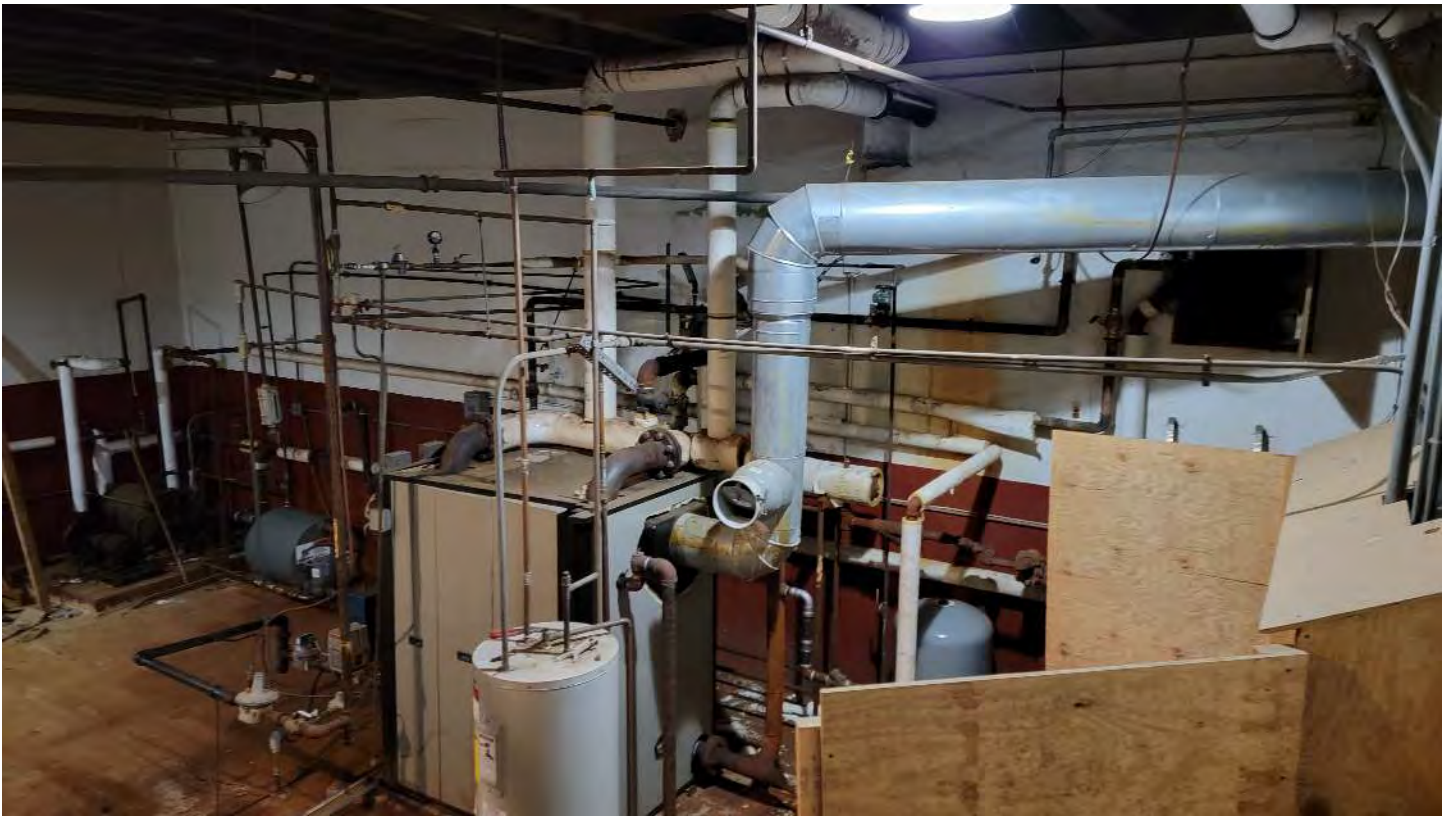
Inside of the boiler room.

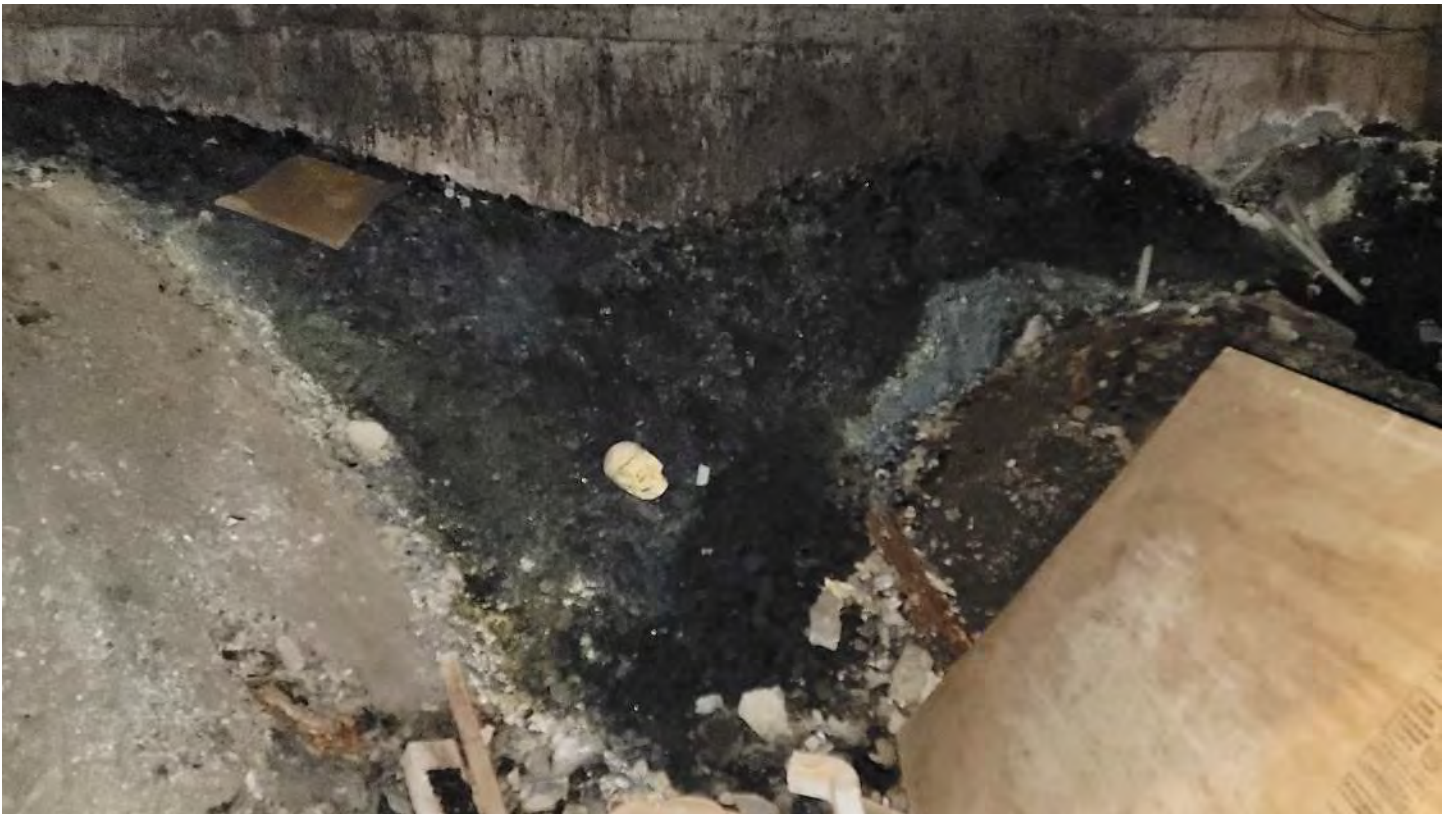
Remnants of historic coal storage.

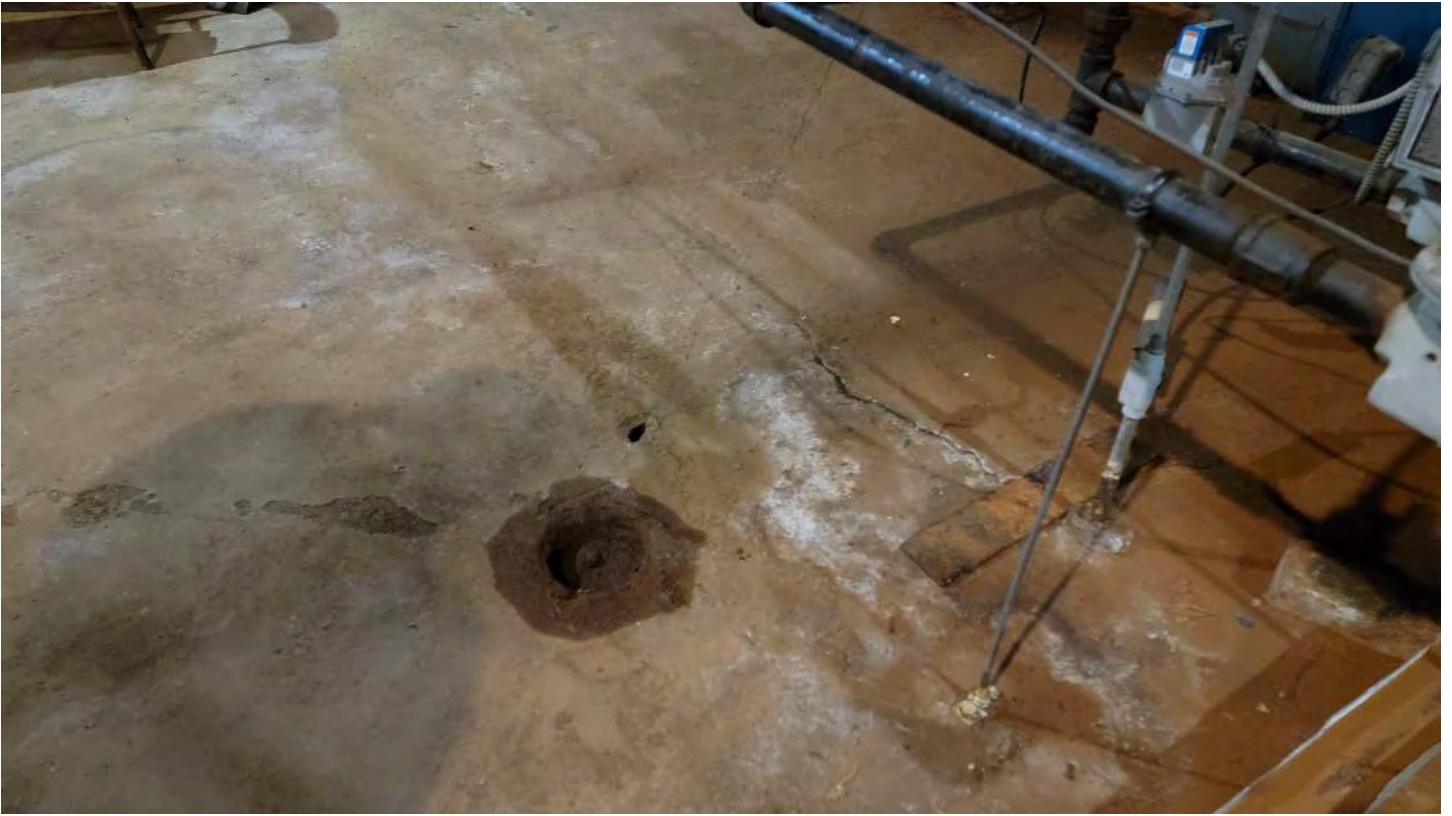
building. No evidence of staining, which could indicate improper disposal of regulated substances was observed near the floor drain. Another floor penetration in the basement is a sump pit. The pit is equipped with a sump pump that appears to discharge to the municipal sewer system.

Floor drain in the boiler room.

- *Basement floor penetrations:* The floor drain is connected to the municipal sewer system. The sump pump also appears to discharge to the municipal sewer system. No evidence of staining, which could indicate improper discharge of regulated substances, was observed near the sump pump pit or floor drain. The floor drain and sump pump are not considered to be RECs.

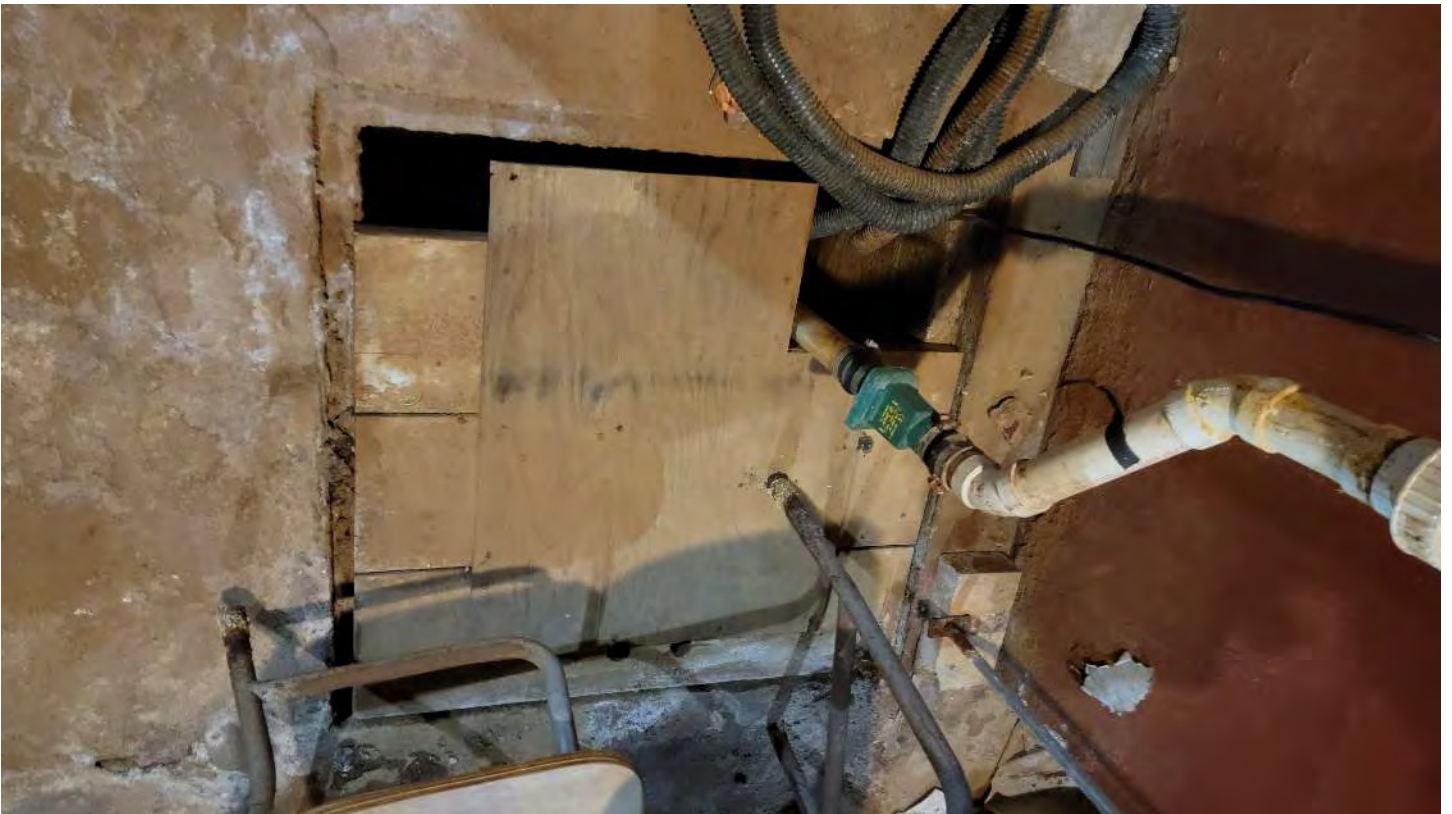
Sump pit.

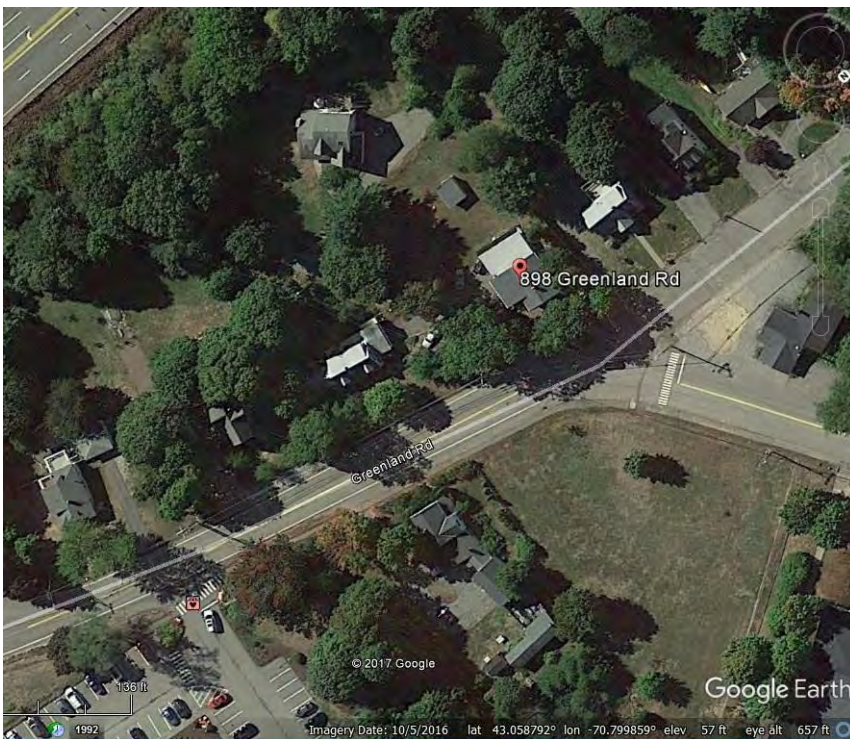
The NH Department of Environmental Services (NHDES) received a complaint referral from City of Portsmouth (City) and local residents concerning K & M Carpet Cleaning (K&M) and the dumping of carpet cleaning wastewater onto the ground in a residential area (Picture #1). There had been

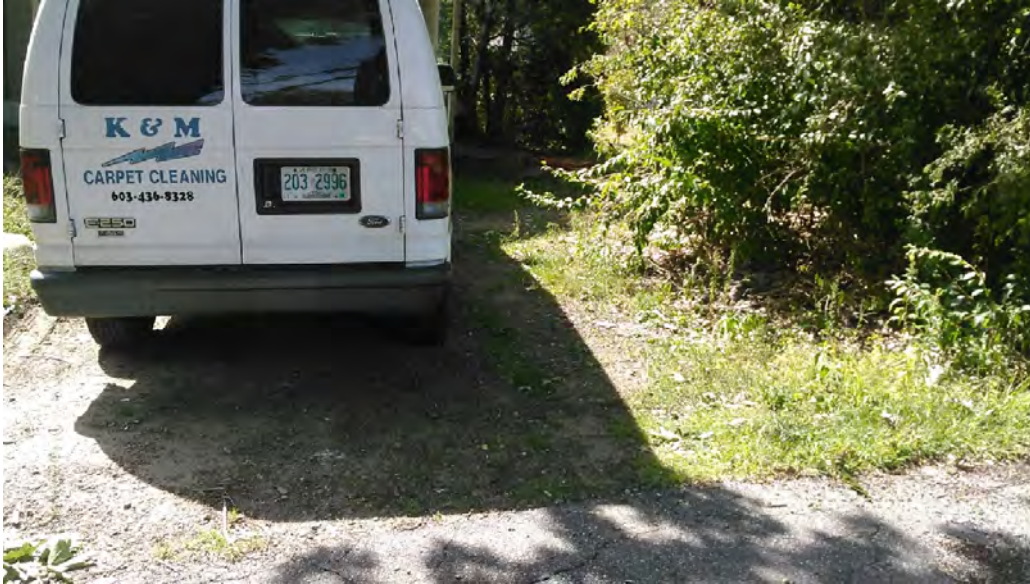
Picture #2

NHDES walked around the front of the property between the house and road (van parking area - Picture 2) and saw some ground discoloration and several piles of solids, debris, hair and fiber. Any release may have infiltrated on-site. NHDES did not see any obvious indication of runoff of wastewater to the road or adjacent storm water catch basins.

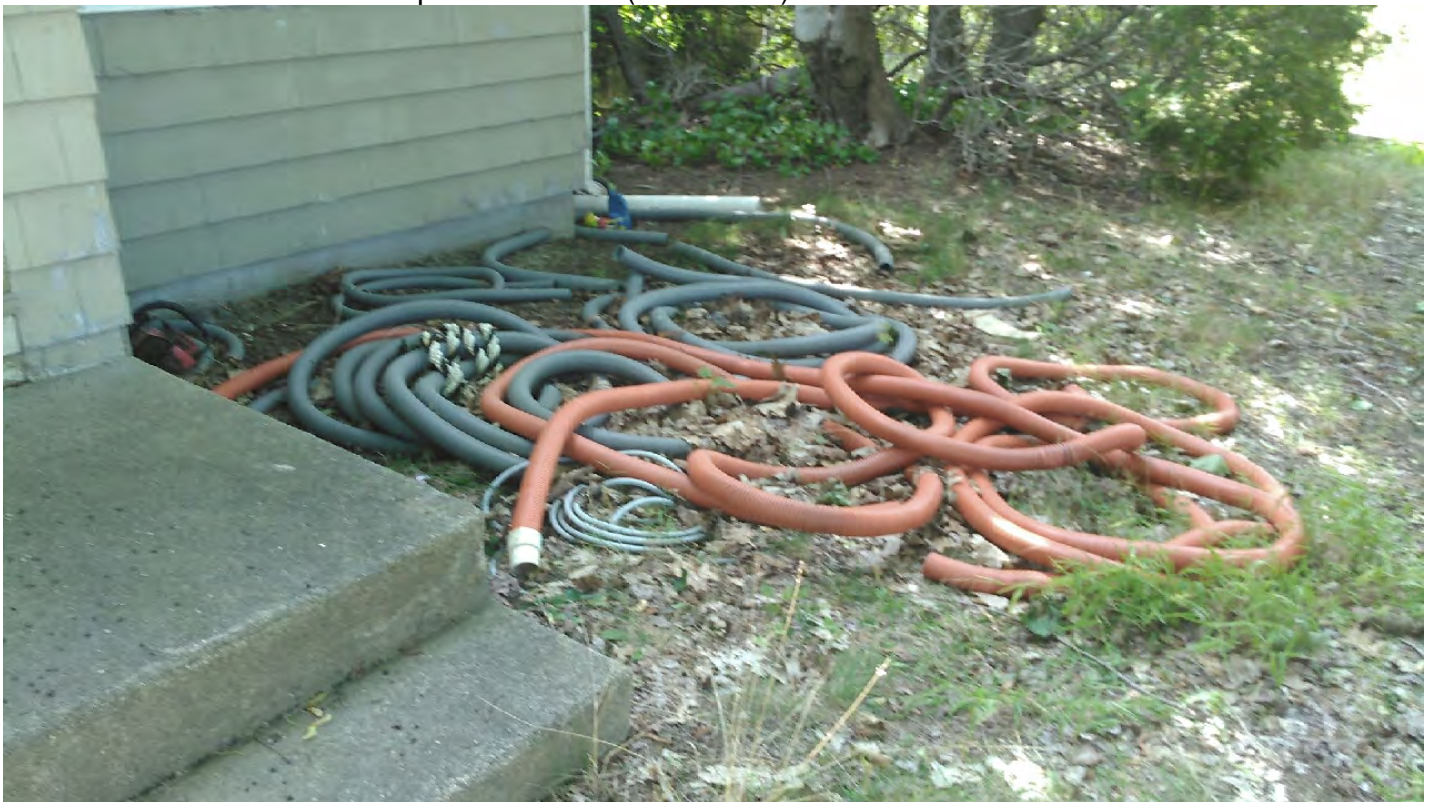
The front of the house had a pile of hoses –(Picture #3).

On September 5, 2017 at 1:56 pm, Mr. Maddock called NHDES. In this follow-up conversation, he stated that no wastewater is discharged on-site onto or into the ground. He also stated that he connects the disposal hose to the house's basement sewer line connection and pumps the carpet cleaning wastewater into the municipal sewer. He explained that the piles of solids in the yard were from a filter trap he has emptied out. He also noted that the piles of debris would be cleaned up and put in the garbage.
