Preservation Plan

African Burying Ground at Langdon Farm Portsmouth, NH

PRESERVATION
COMPANY

June 2024

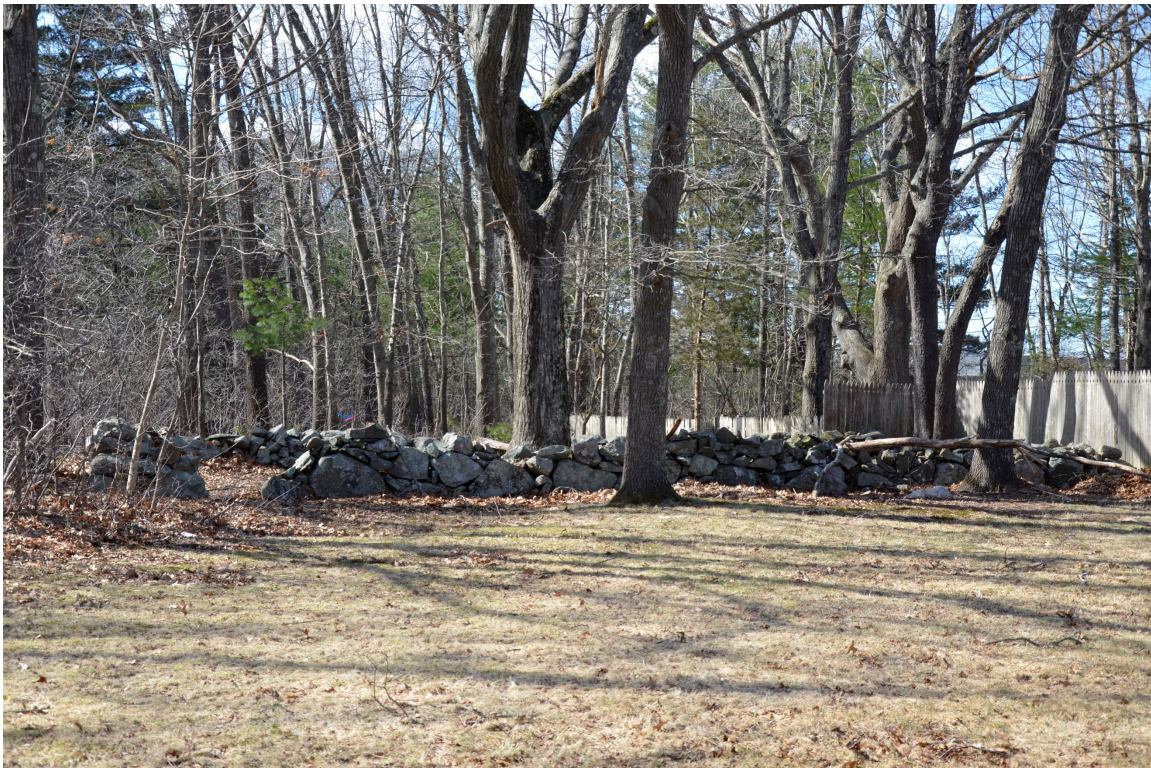
Photo 1: The small burying ground located south of the Christ Church entrance driveway (view facing south)

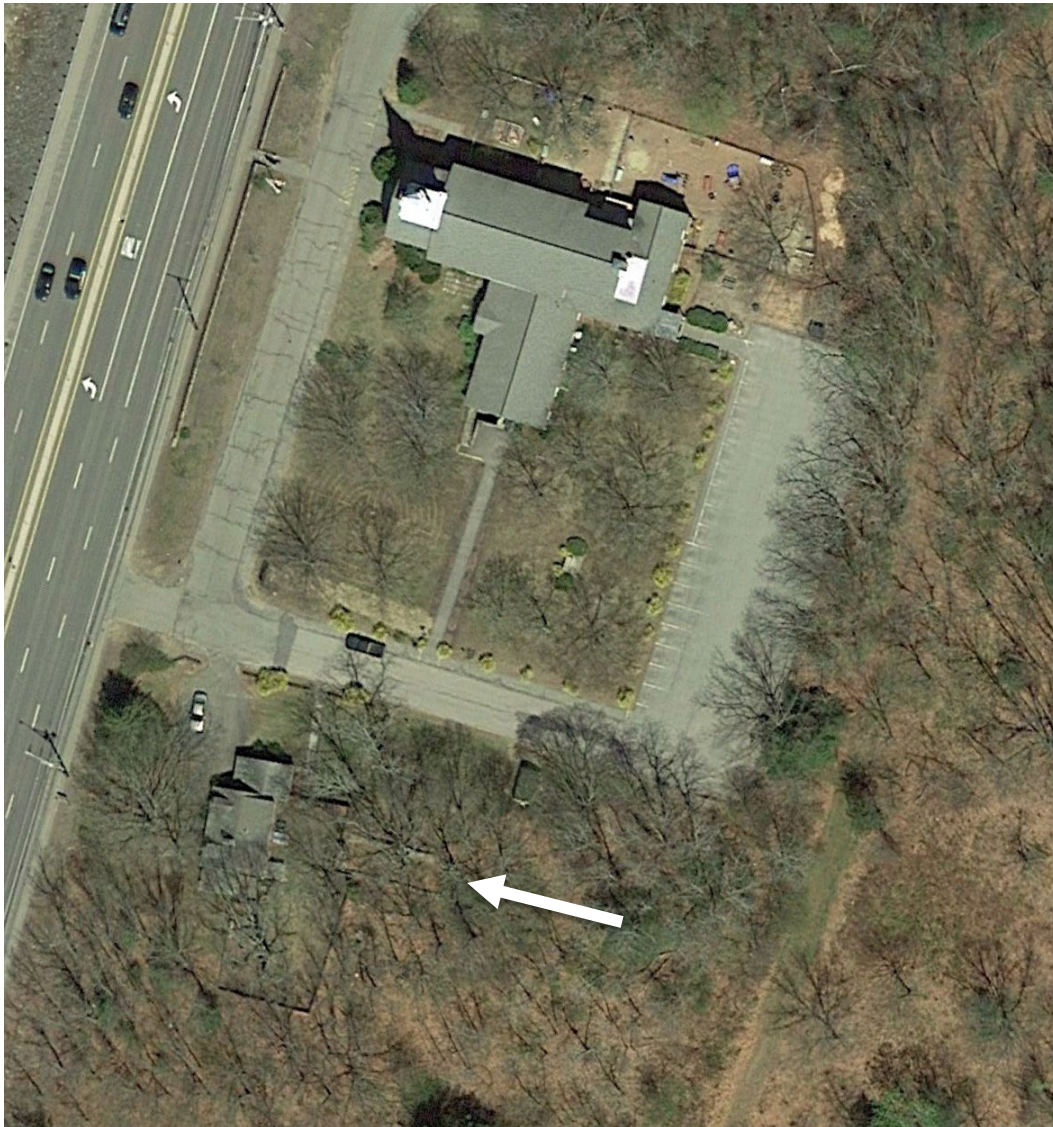
Figure 3: Google Earth 2018 shows cemetery walls, rectory, church and parking lot

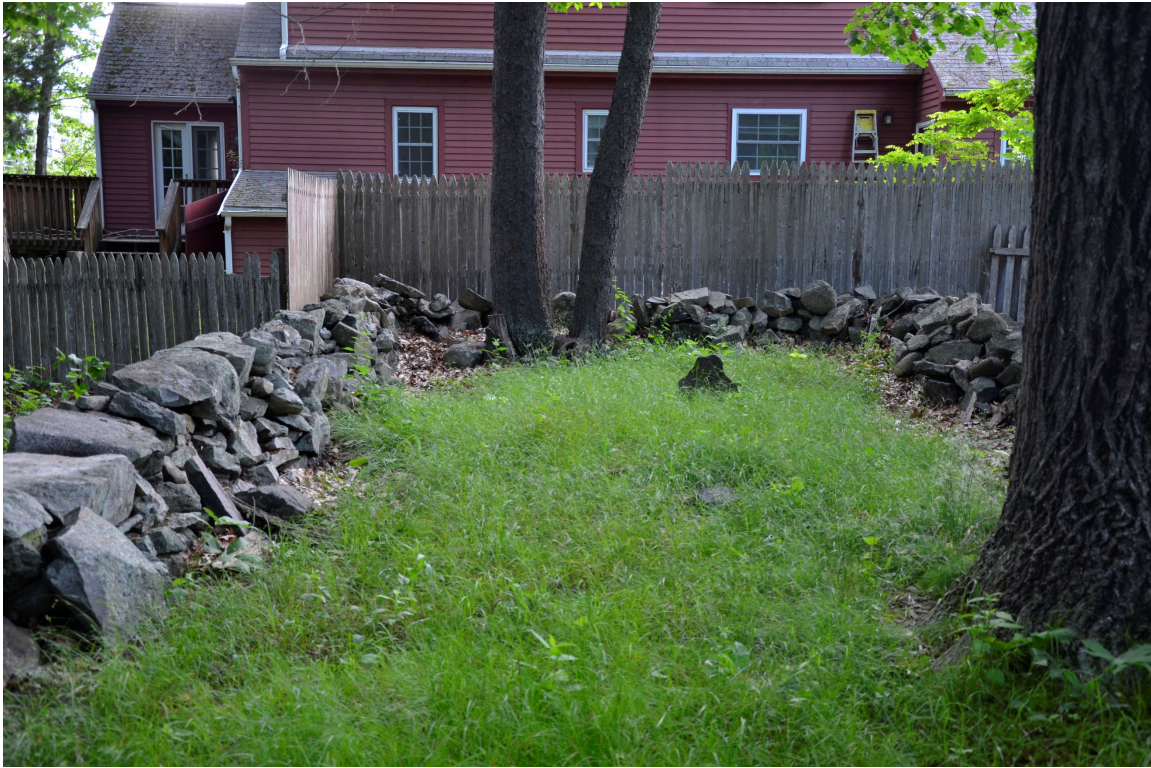
Photo 3: The rear of the rectory and its fencing abuts the burying ground (view facing west)

The site is relatively undisturbed within the walled area and in the rectory yard nearby. The rectangular stone-walled enclosure is approximately 44' x 14', oriented east-west. The date of the wall has not been identified. It predates the 1960s when the parcel was transferred. The wall is fieldstone. There is an irregular opening in the northeast corner. The markers are small, un-inscribed, locally available stones. There are nine stones visible. They roughly mark the graves located by remote sensing. An open grassy area is maintained. A large tree grows in the middle of one side. The walled enclosure abuts the wooden fence of the rectory yard.

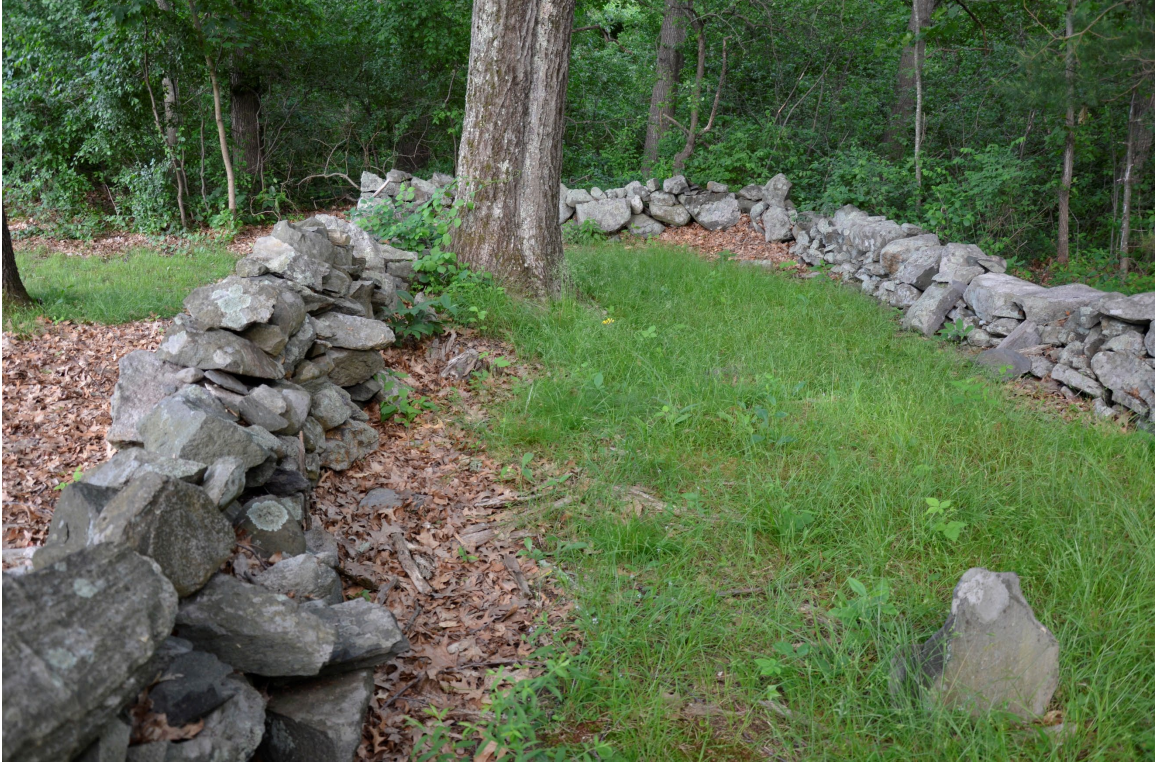
Photo 4: The largest stone is an upright slab (view facing southeast)

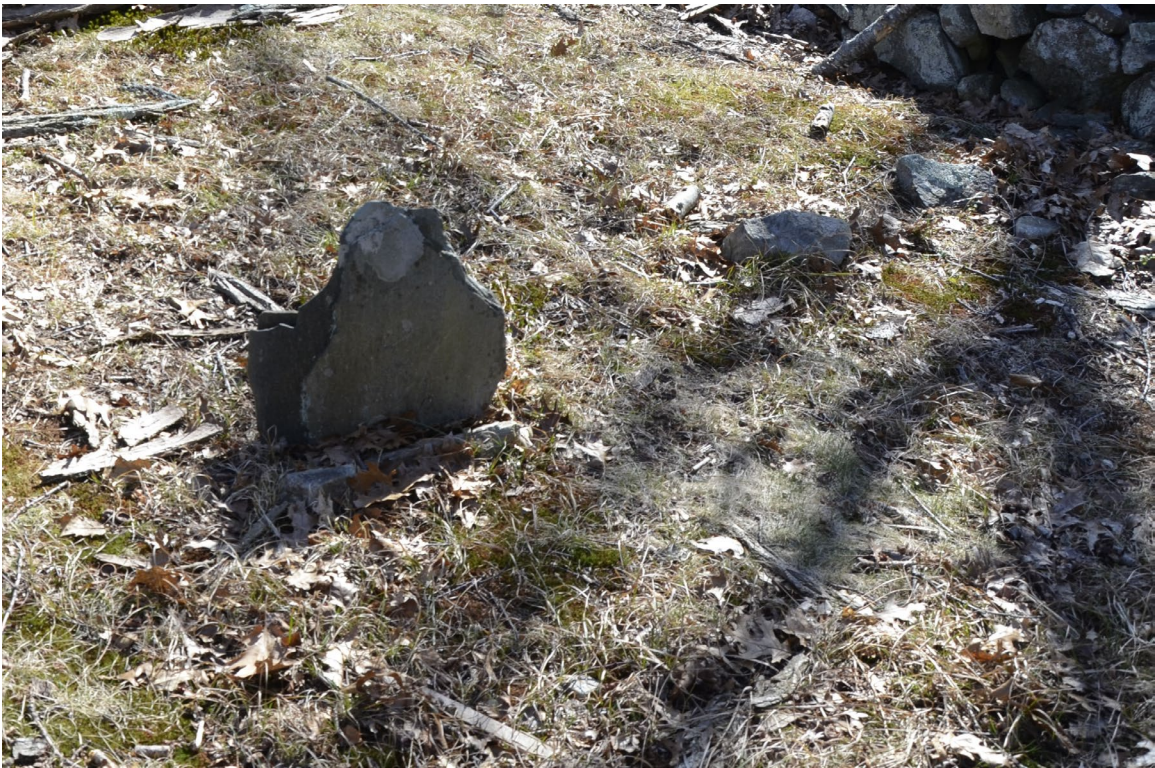
Photo 5: Detail of stones with low foliage season (view facing southeast)

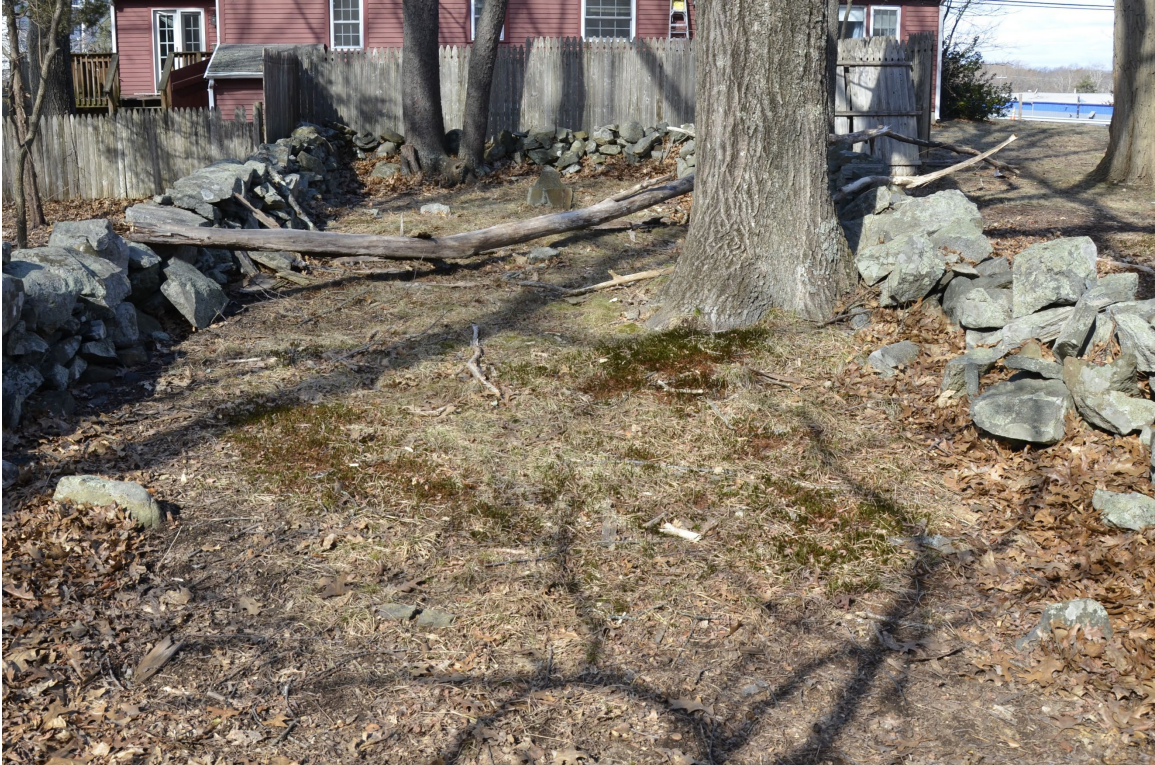
Photo 6: Detail showing fieldstone markers in the eastern end (view facing west)

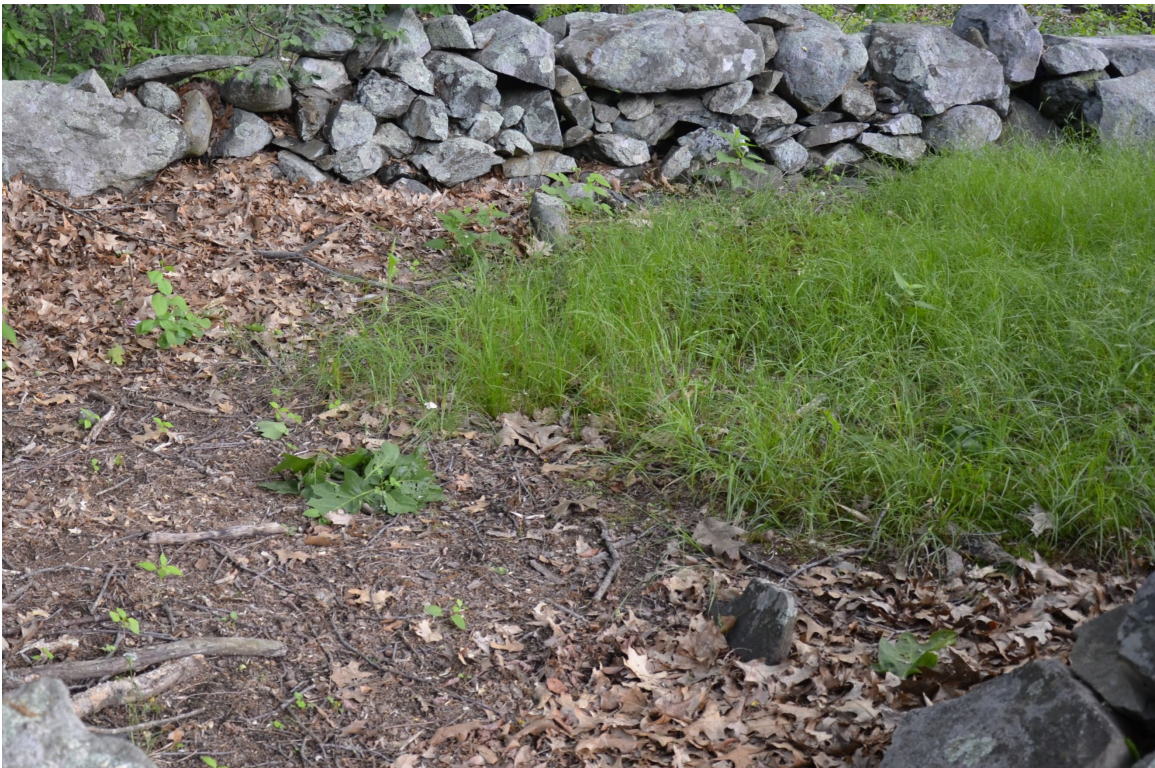
Photo 7: Detail of stone markers (view facing southwest)

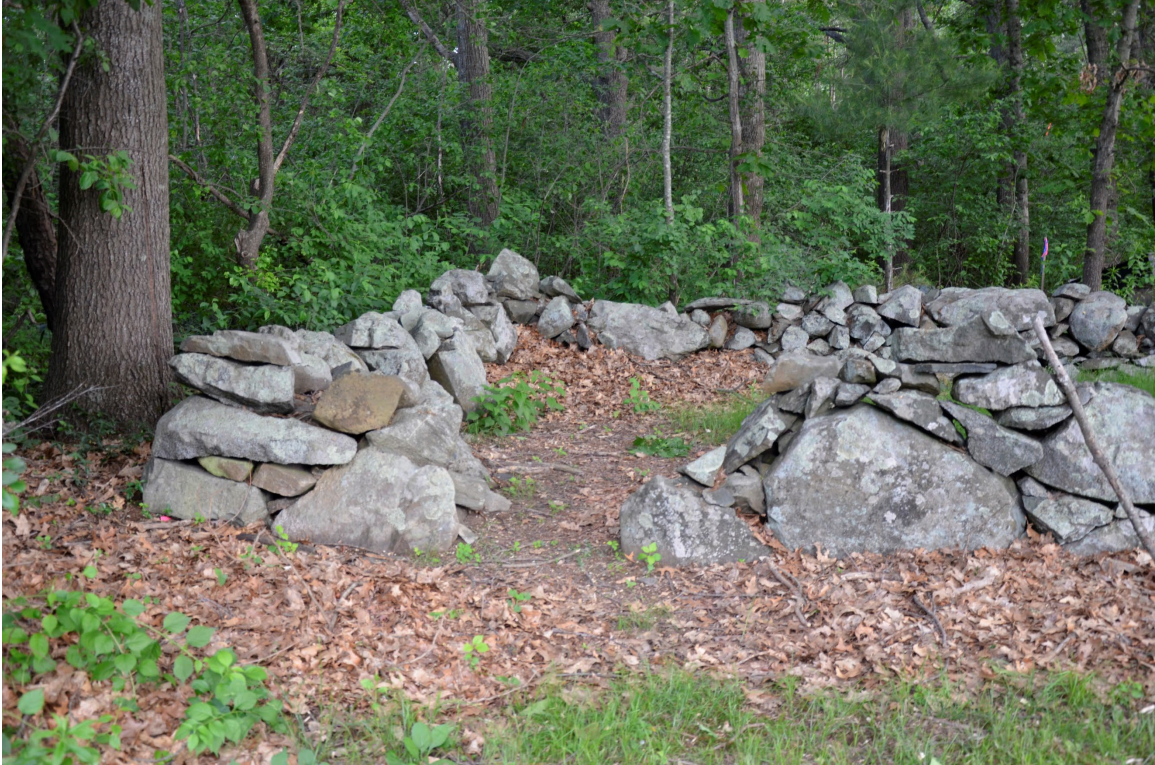
Photo 8: Wall opening is in the northeast corner (view facing south)

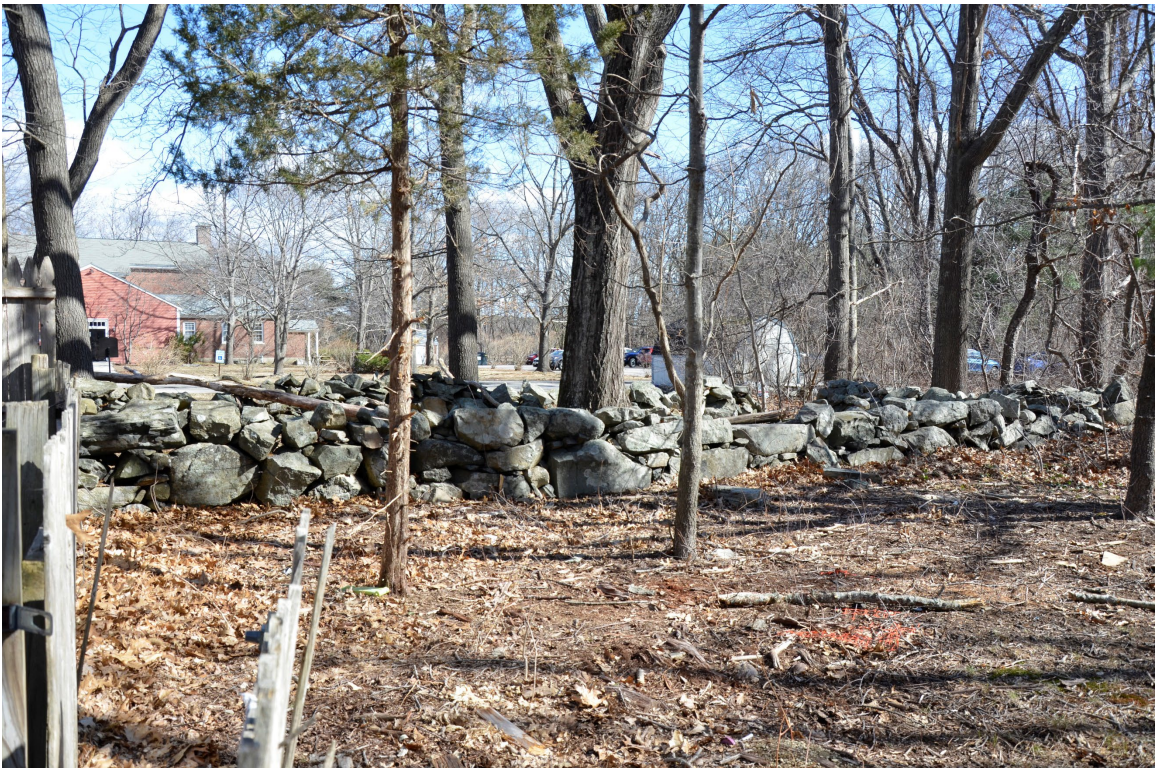
Photo 9: South side of walled area (view facing north)

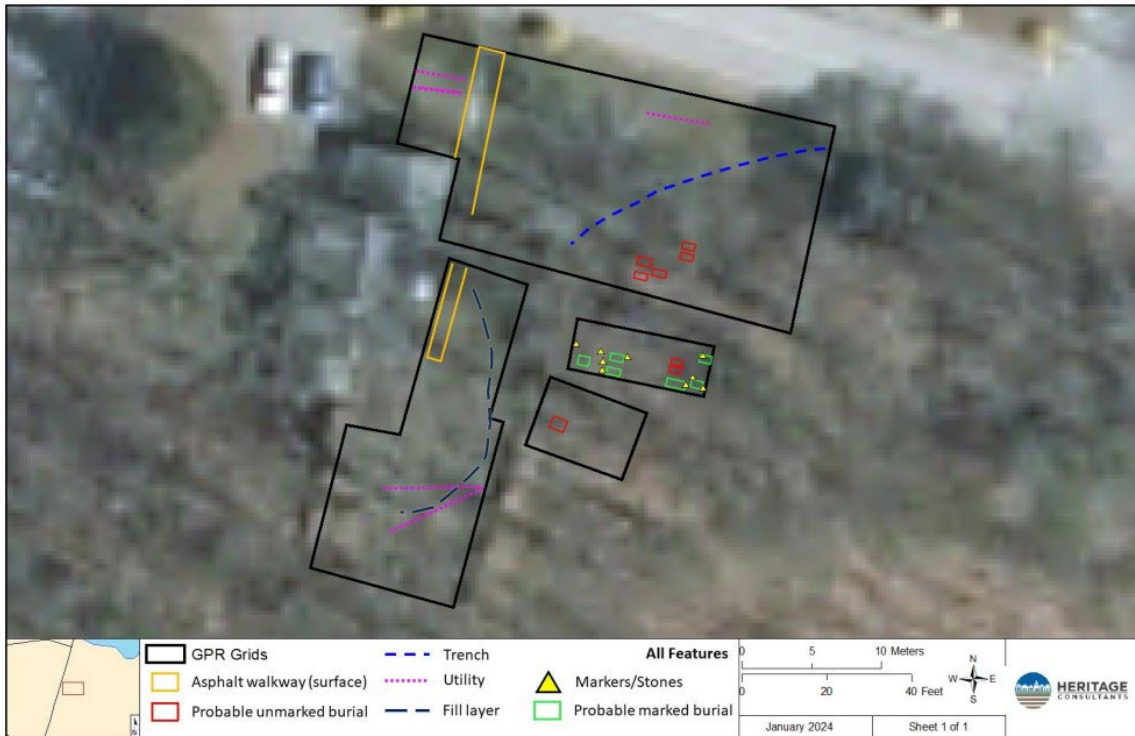
Recent remote sensing archaeology indicates the burying ground retains marked and unmarked graves. Heritage Consultants completed a ground penetrating radar (GPR) prospection survey of the Langdon Slave Burial Ground for the Portsmouth Housing Authority in February 2024 (see supplemental report). The survey covered approximately 0.22 acres. Four grids were laid out within a 50' buffer around the stone walled area. Remote sensing located six probable marked burials and two unmarked graves within the wall and five possible unmarked burials in the yard to the north and one south (Heritage Consultants 2024).

Figure 52: Annotated aerial image of all features identified in Survey Grids 1 – 4.

Figure 11: Heritage Consultants 2024 GPR results with locations of stones (yellow), probable marked burials (green) within the walled area, and probable burials unmarked (red).

Numerous features were identified within the four gridded surveys conducted via GPR. Several of these features are modern and do not relate to the Langdon Slave Burial Ground, but instead represent later, intrusive effects to the property. These features include five separate utility lines, an asphalt pathway, a large trench, and an area of homogenous fill soils. In addition to these modern features, nine individual grave markers were identified within the stone walled bounds of the cemetery (Grid 1), associated with six marked probable graves identified through GPR work, as well as two unmarked probable graves within the cemetery. In addition to the eight identified graves within the cemetery, six additional probable unmarked graves were identified outside the bounds of the cemetery, including five within Grid 2 and one within Grid 4. A total of 14 graves were therefore identified via geophysical survey methods. All features identified in Survey Grids 1 through 4 can be seen over aerial imagery in Figure 52.

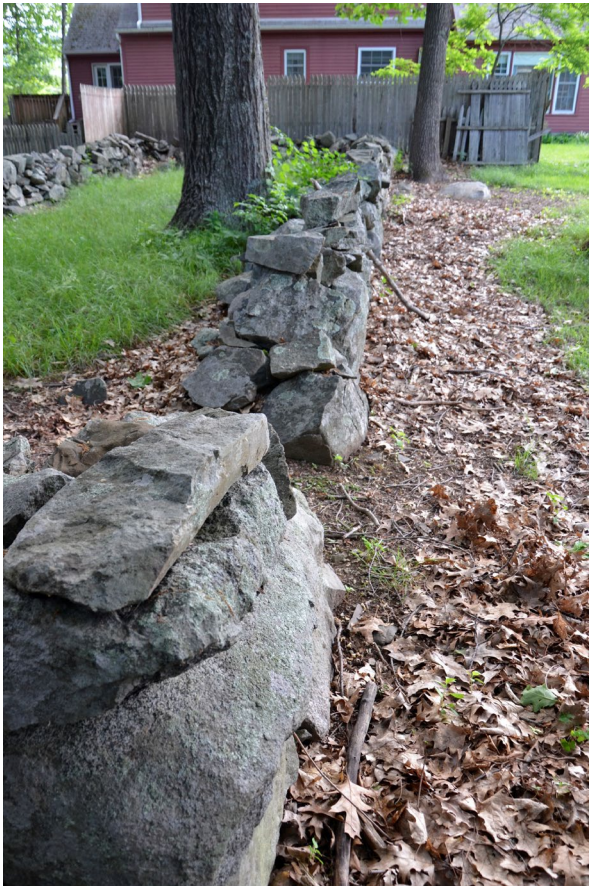
Photo 10 (left): The north wall, as well as the south, still retains a straight exterior face.

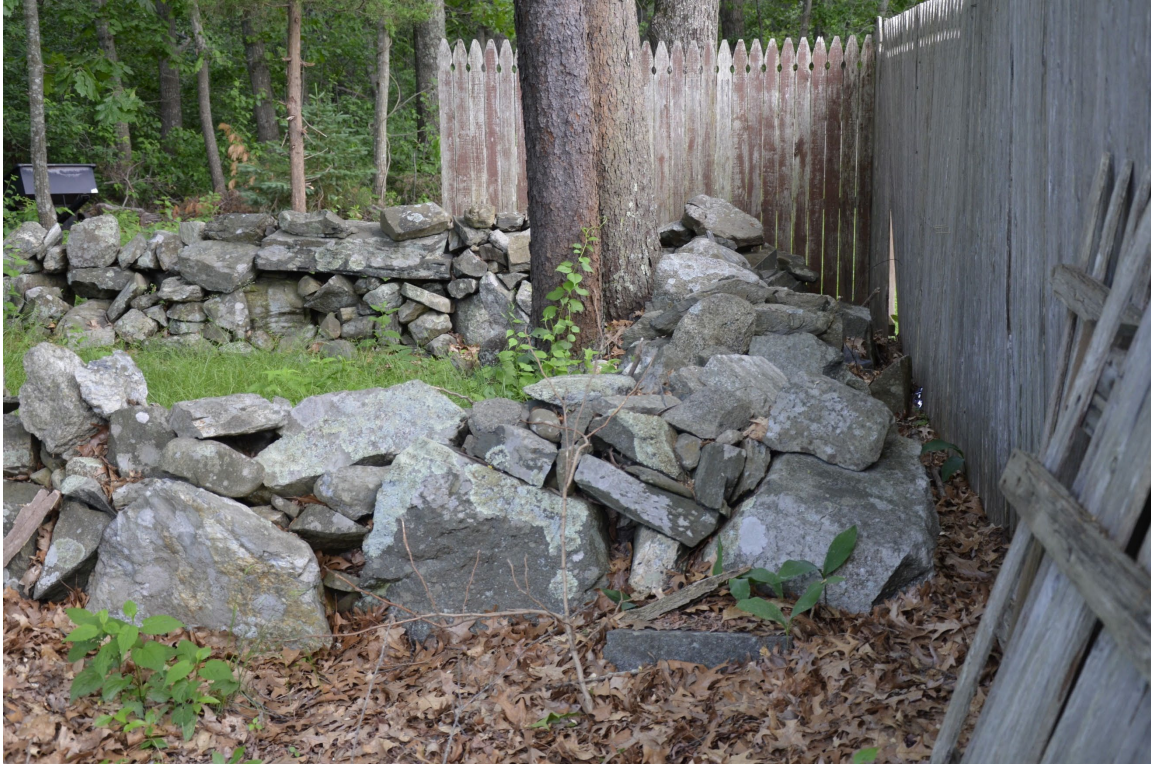
The cedar stockade-style fence for the rectory was constructed immediately abutting the west wall. The fence is likely 20-30 years old and is beginning to show structural instability. Broken sections of the fence have been removed and set aside.

Photo 12: The wood fence bordering the back yard of the rectory, built directly against the stone wall, is in poor condition and is reaching the end of its useful life.

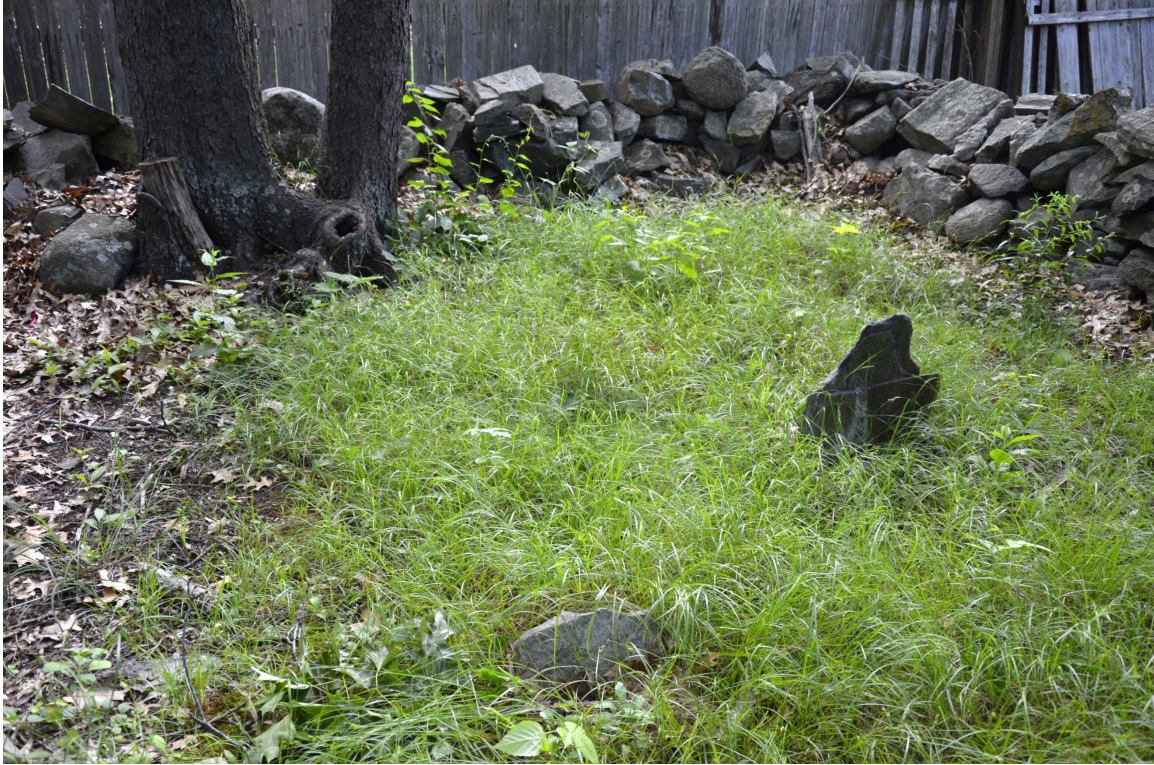
Approximately five stone markers are still visible inside the stone walls, though they are in poor condition. Most are small, broken pieces of slate with no visible markings, though some are half-buried and obscured by earth and grass or leaves. The GPR identified more stone markers than are readily visible at the surface.

Photo 13: Stone markers are obscured by vegetation; two trees in the southwest corner have caused some stone displacement.

- Clear and maintain the vegetation: Though disruptive to the burial site and the stone walls, the trees should not be removed due to the potential harm that the ground disturbance would cause. Leaves and other ground debris should be removed from the entire site (both inside and outside the walled area), and invasive plants should be pruned back at ground level, not pulled or dug. Historically planted materials such as vinca and daffodils should be maintained.

- Inspect the stone markers: The stone markers should be inspected for any cracks or weaknesses. Cleaning treatments are likely not necessary for the stones, but if desired, they should be done in a non-abrasive method and using non-toxic cleaning solutions (refer to Preservation Brief 48: Preserving Grave Markers in Historic Cemeteries).

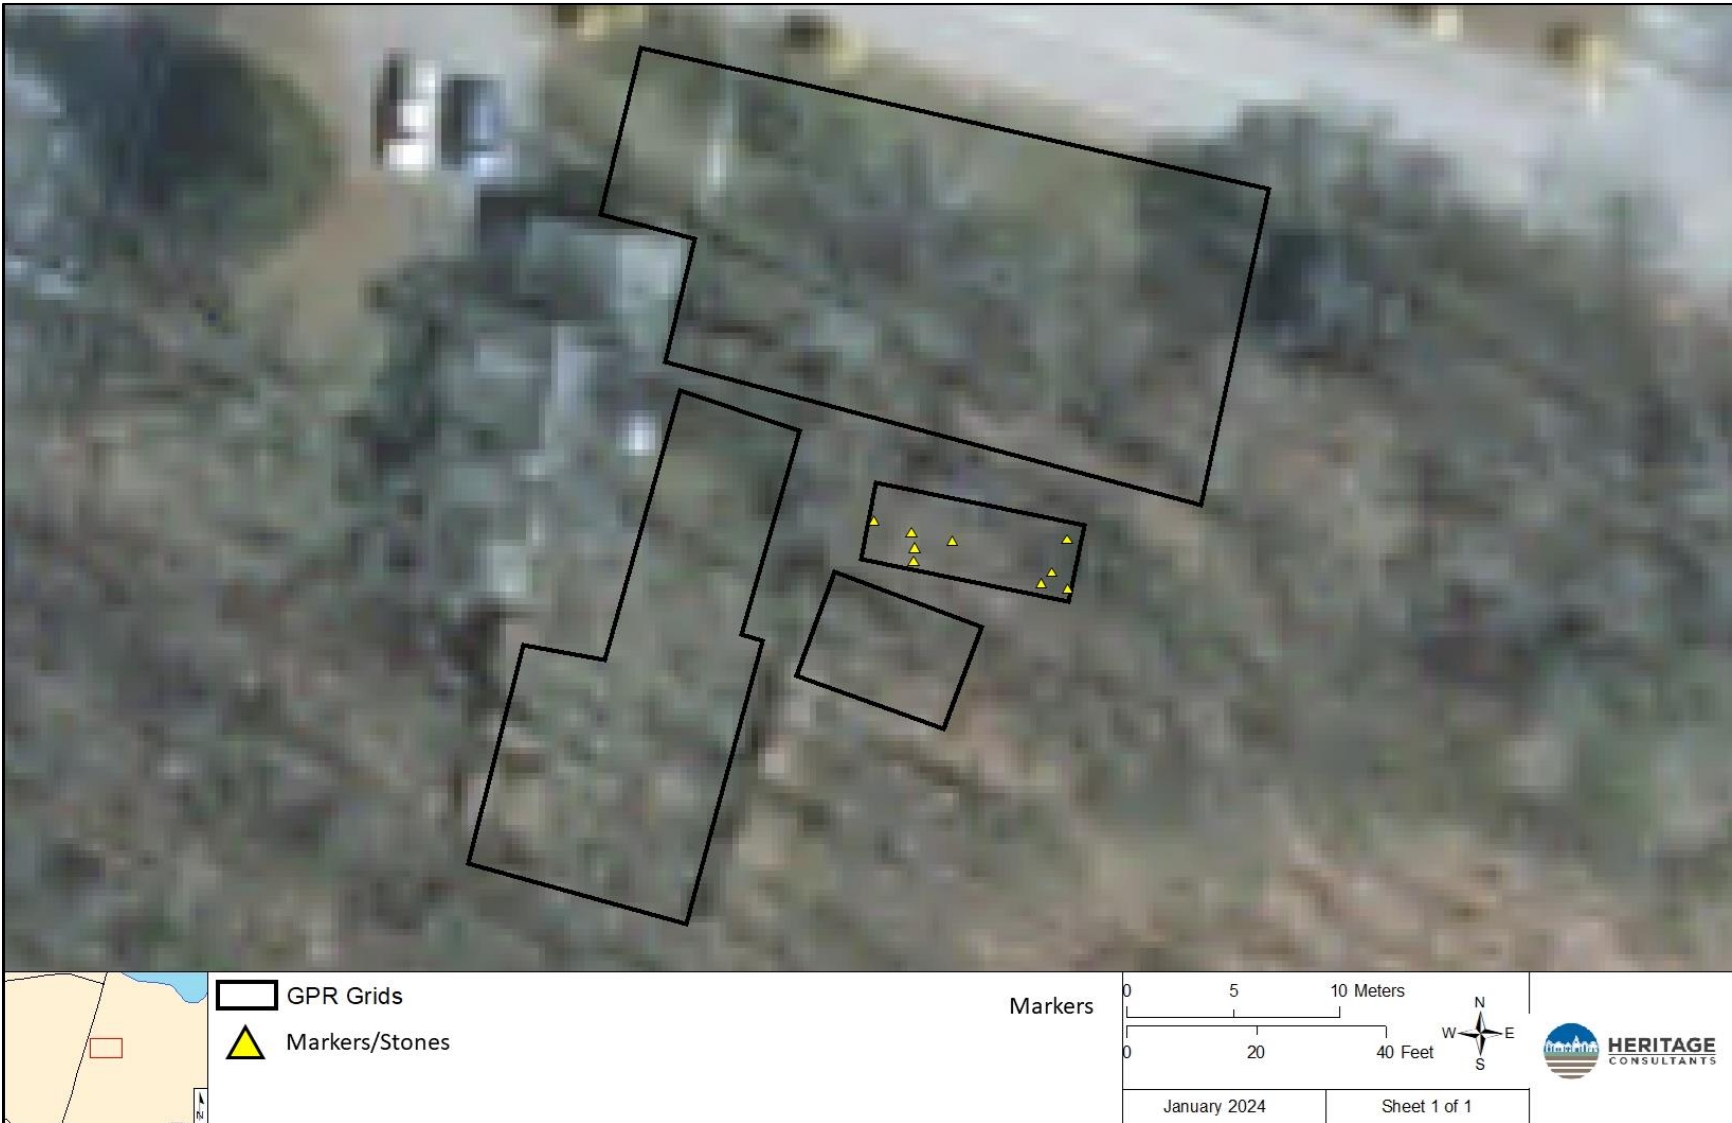
walled cemetery and the location of the grave markers are displayed in Figure 9. It should be noted that the parameters for quantifying a headstone were very broad in this context because the stones within the cemetery are mostly large, unaltered fieldstones (Photo 2). It is possible that some of these stones may be footstones or may not be grave markers at all. There is no way to distinguish headstones from footstones in this context due to the absence of inscriptions and a clear cemetery layout, except through the geophysical analyses presented below. Alternatively, it is also possible that there were more grave markers within the burial ground that were removed or used to make the stone wall surrounding the cemetery.

Figure 9: Location of potential grave markers within the stone-walled cemetery at the Langdon Burial Ground.

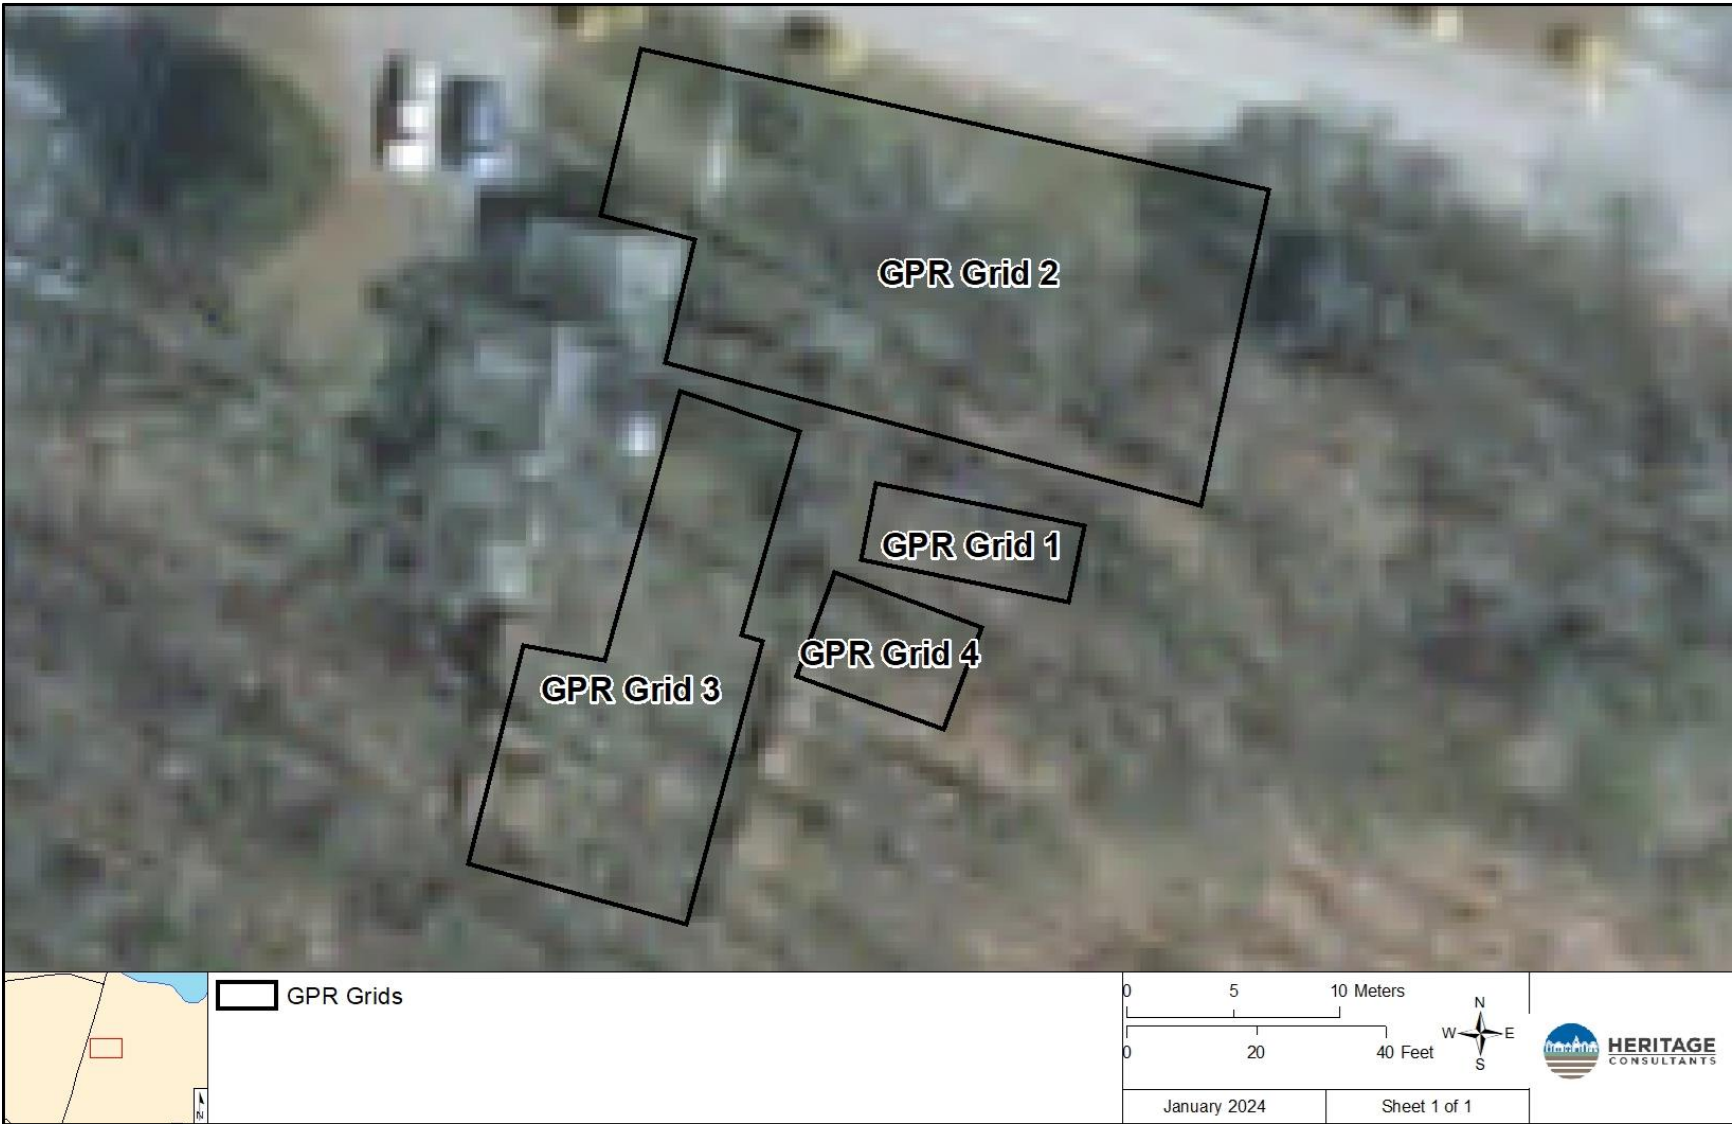
A total of four grids were collected during the fieldwork effort (Figure 10). These grids were laid out to maximize the surveyable area within and immediately around the stone-walled cemetery.

Figure 10: Location of GPR Survey Grids, displayed on satellite imagery background.

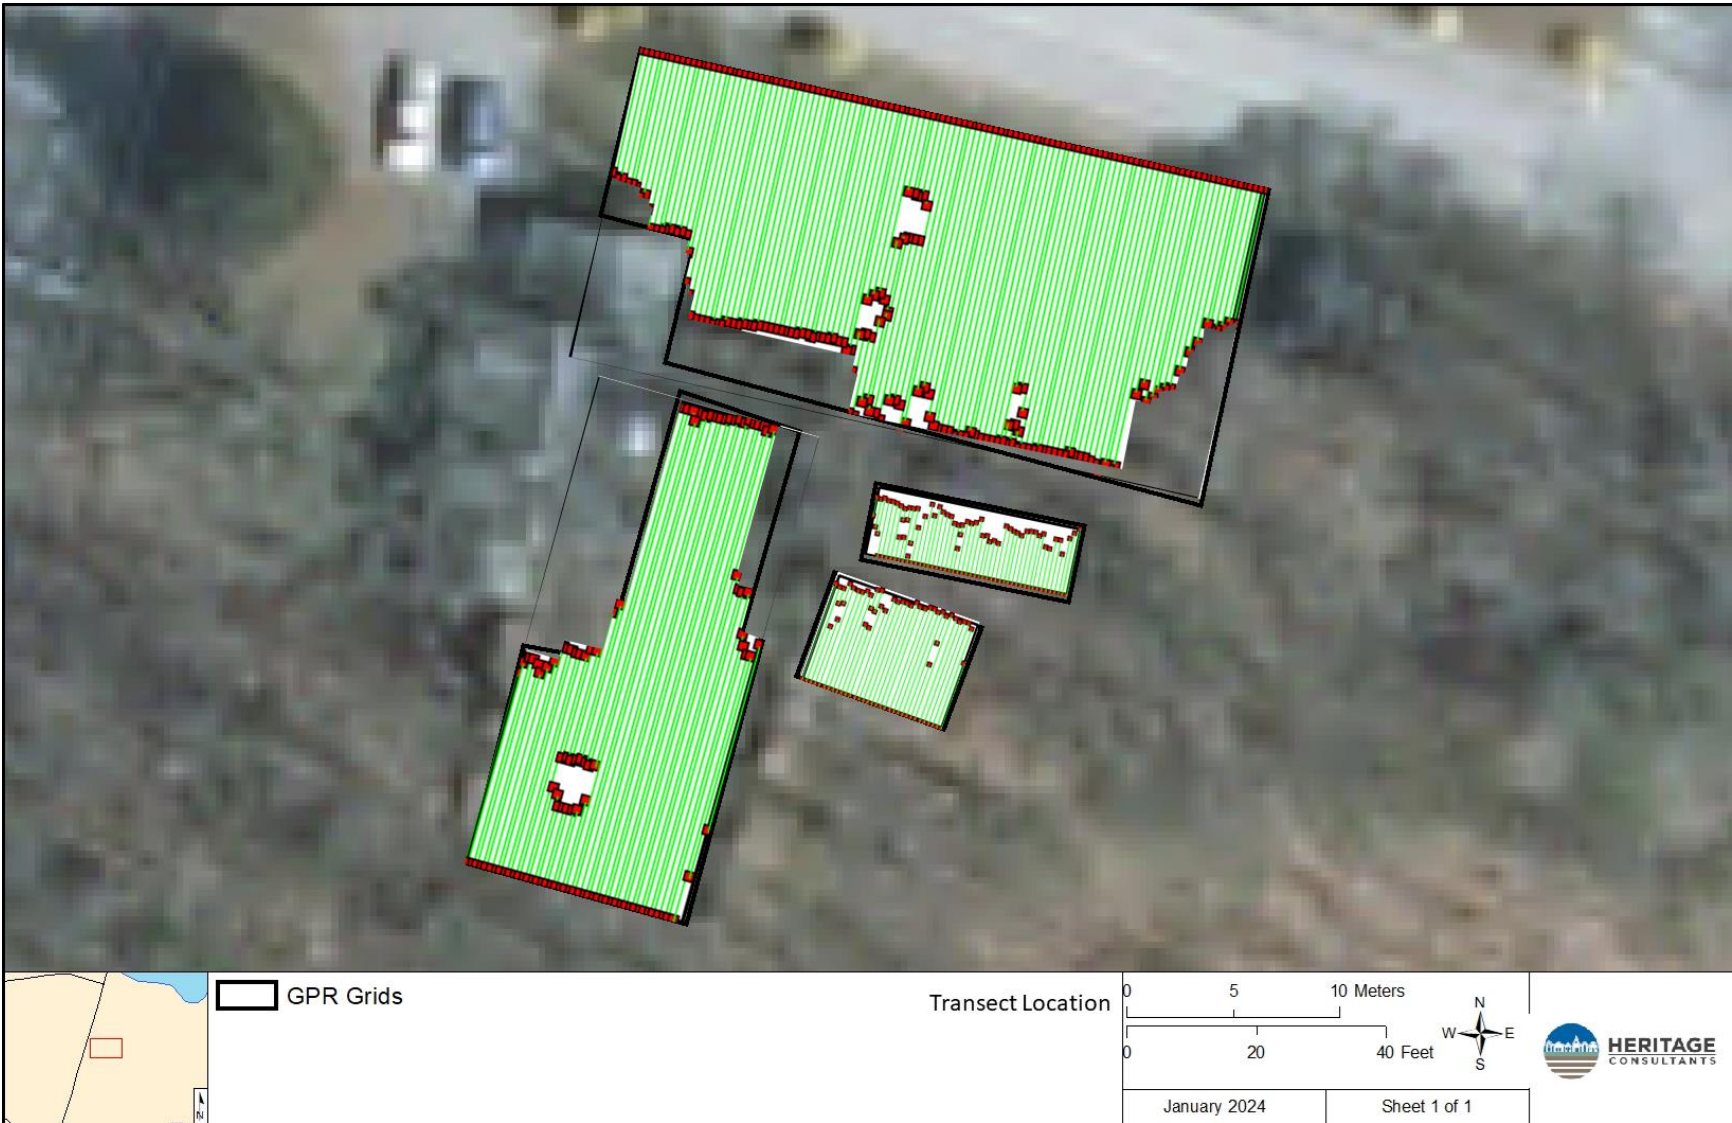
As described in Chapter IV, a total of four grids were collected during the fieldwork effort. These grids were laid out within the 50-foot buffer around the Langdon Slave Burial Ground. A total of 250 individual transects were collected and analyzed during this survey. Figure 11 shows the location of each individual transect in green.

Figure 11: Location of GPR survey transects, displayed on satellite imagery background.

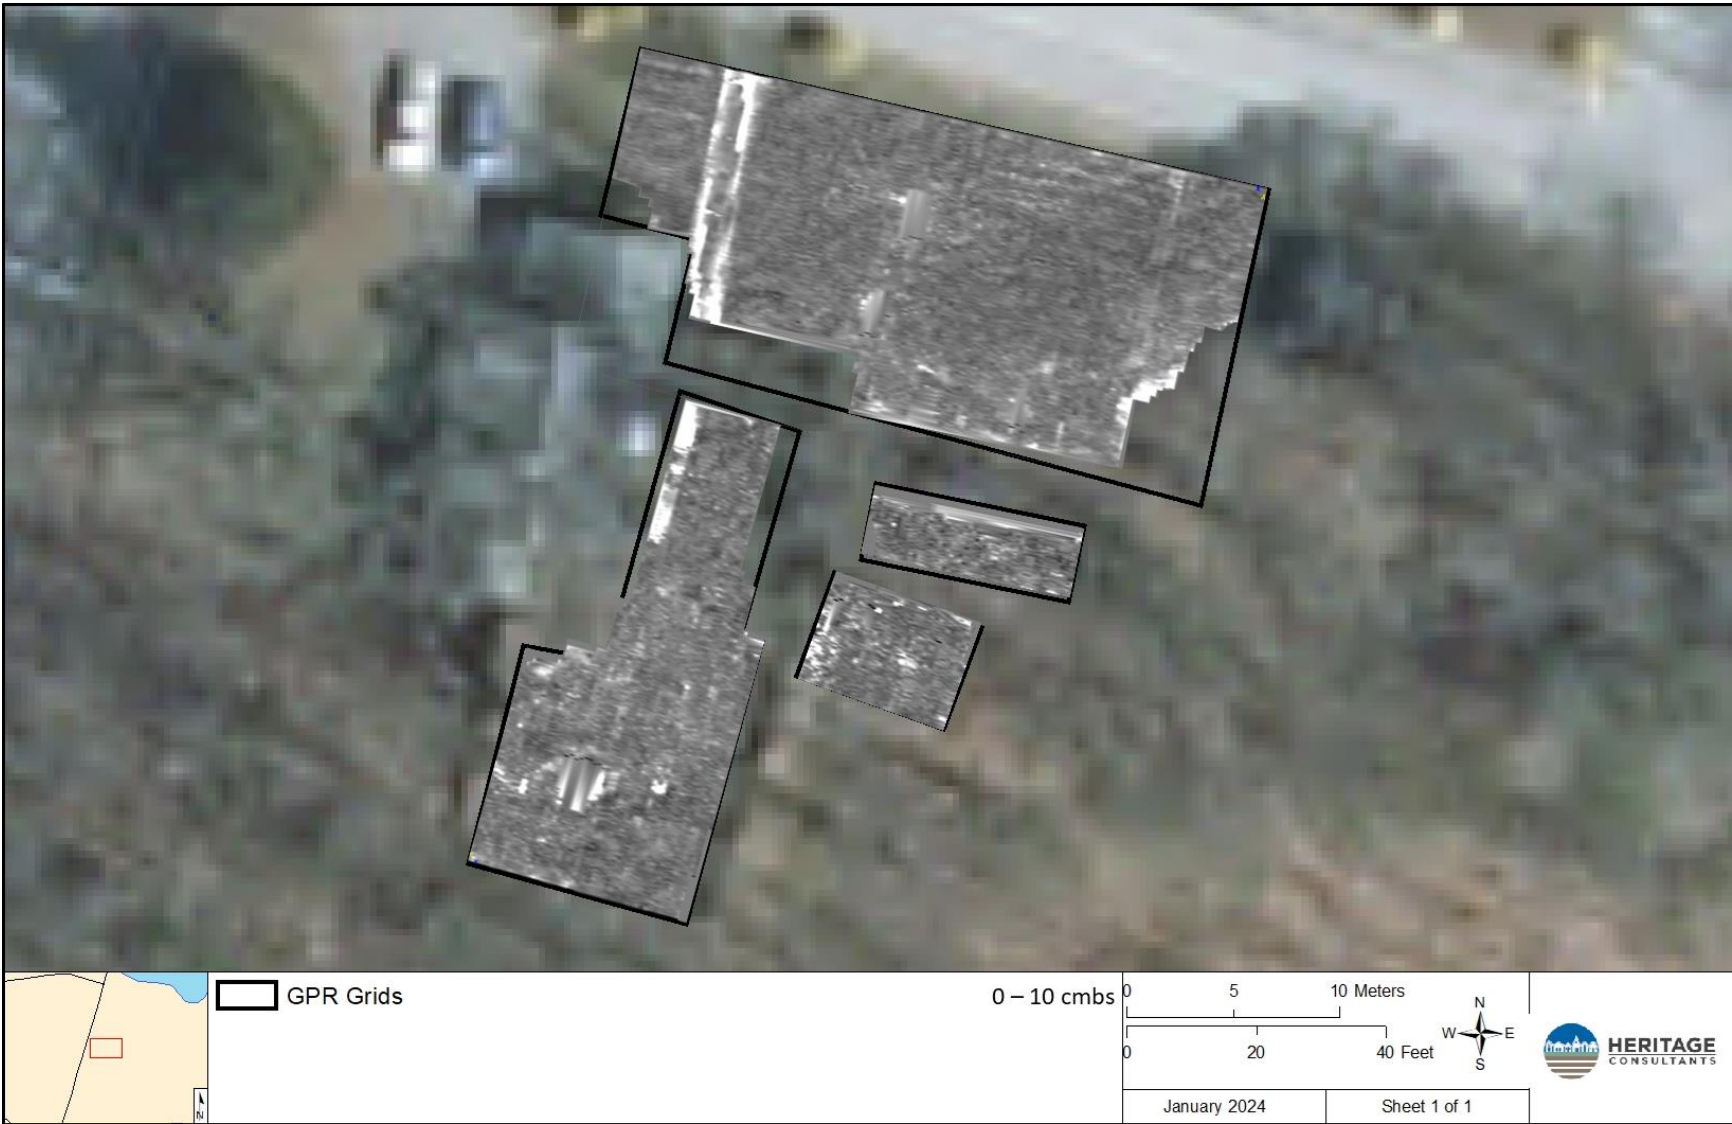
Figure 12: GPR amplitude map of Survey Grids 1-4, with approximate depth indicated.
