Preservation Plan

African Burying Ground at Langdon Farm Portsmouth, NH

PRESERVATION
COMPANY

June 2024

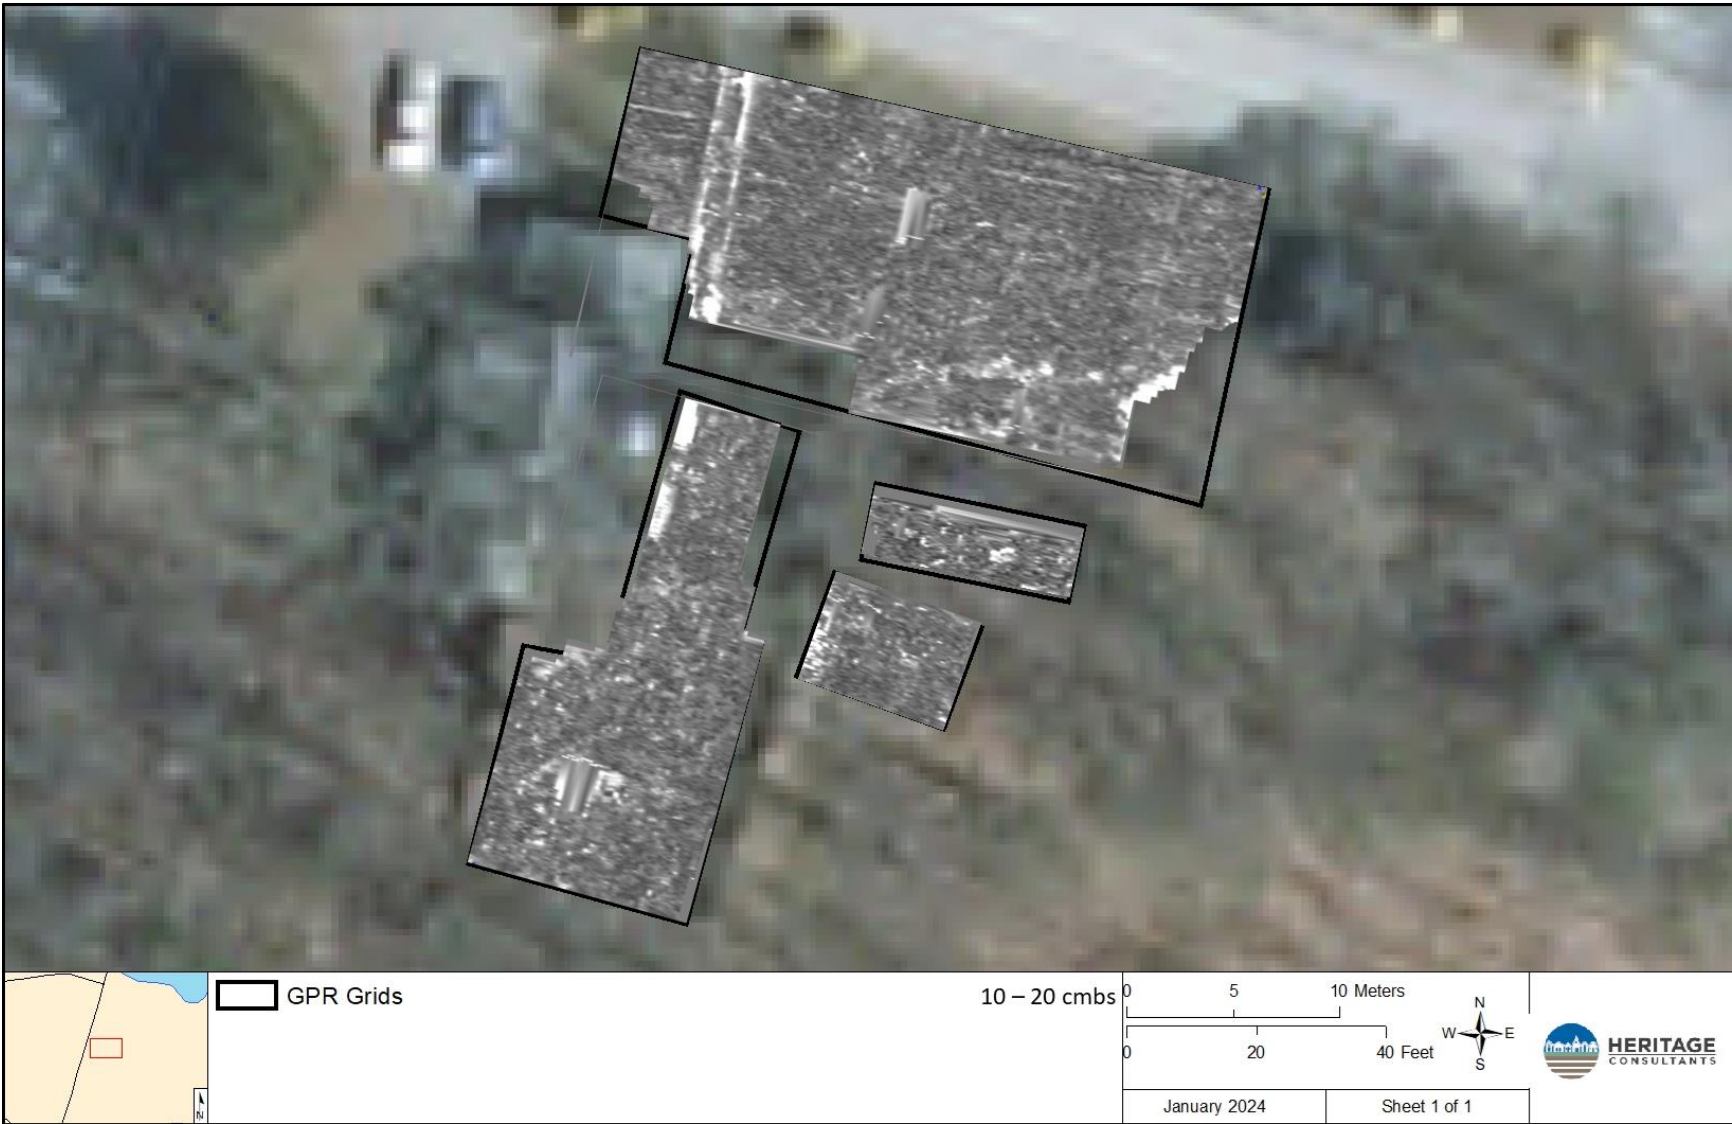
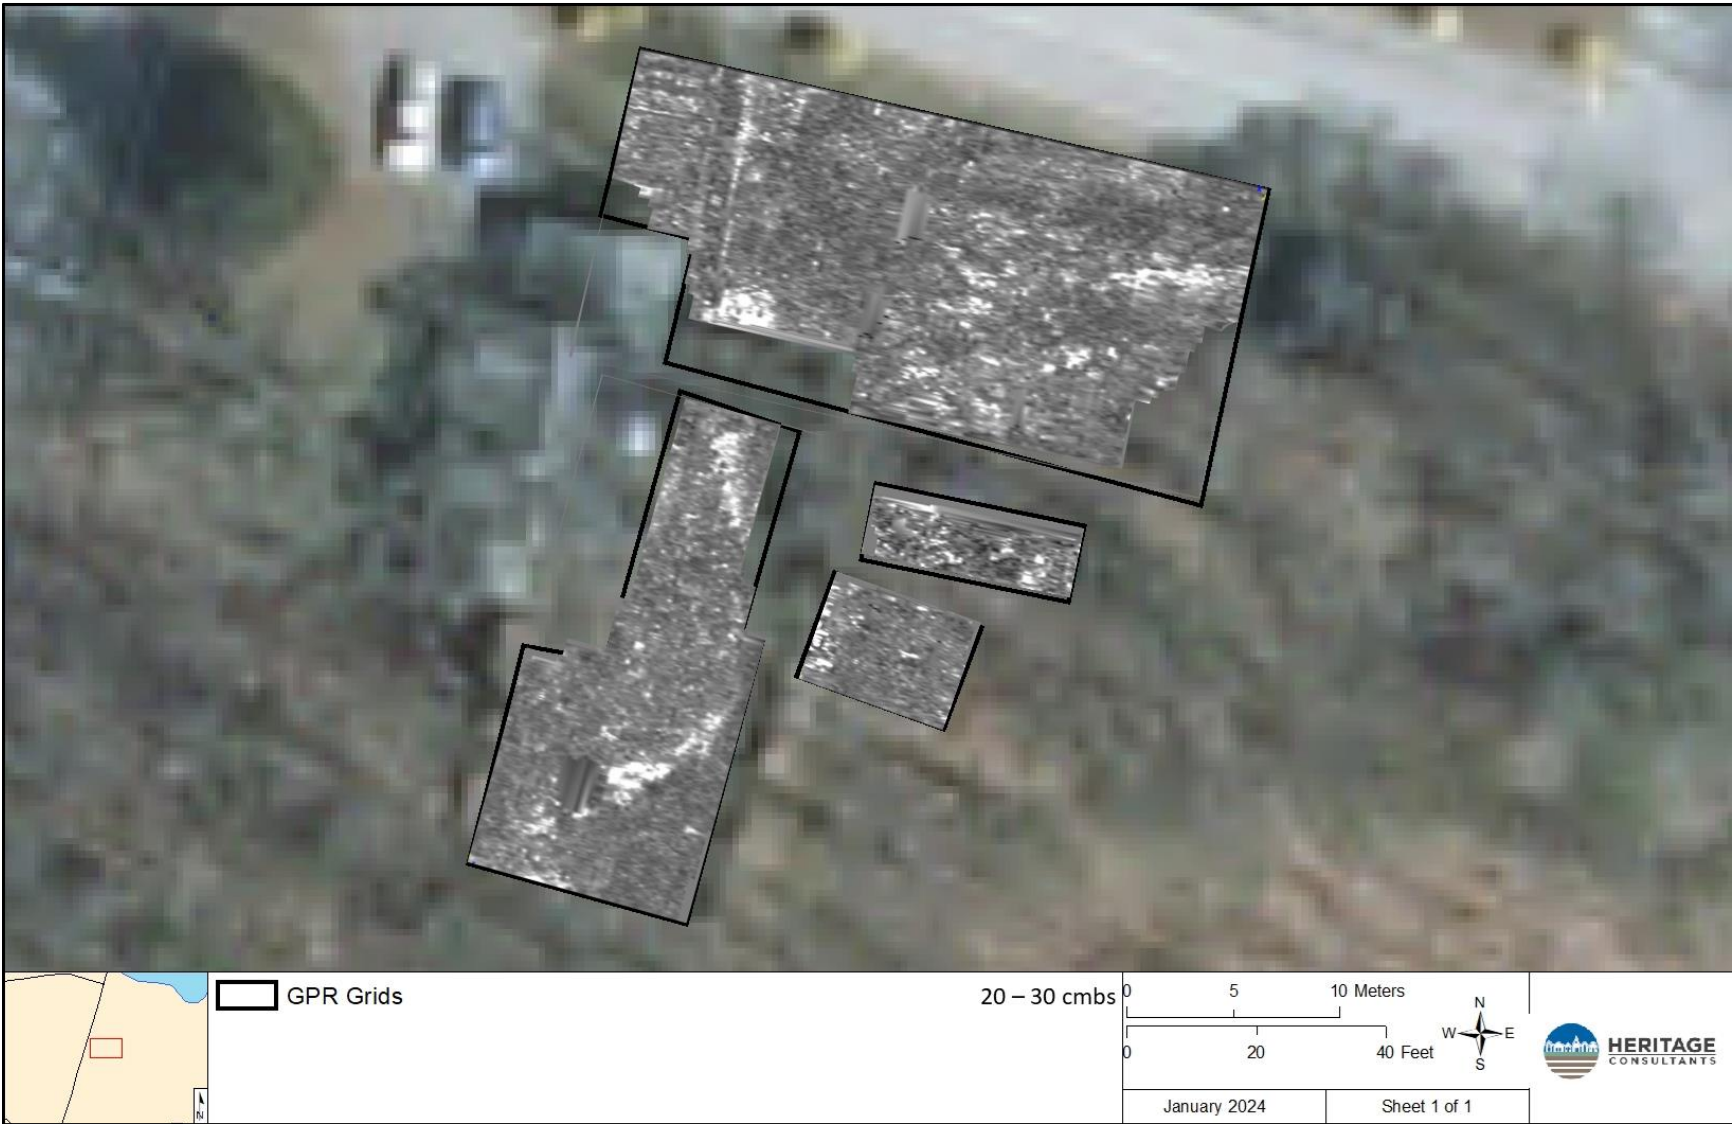
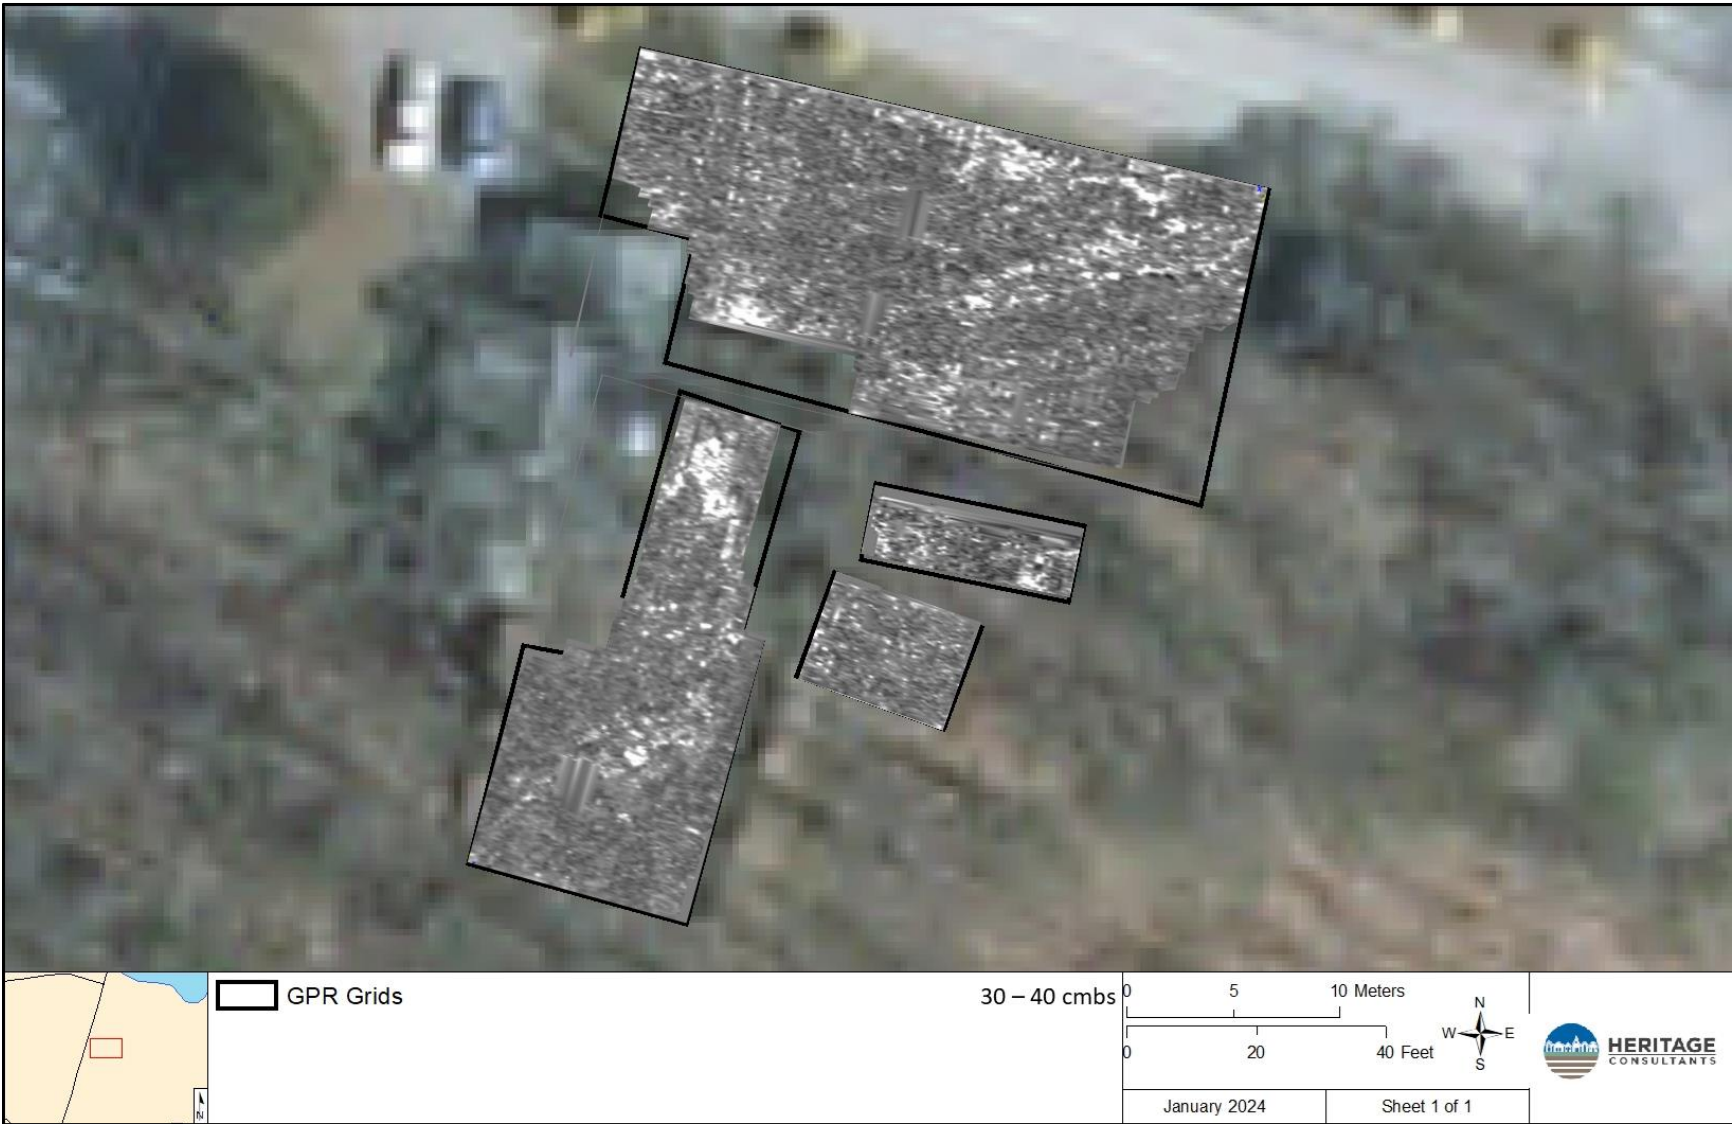
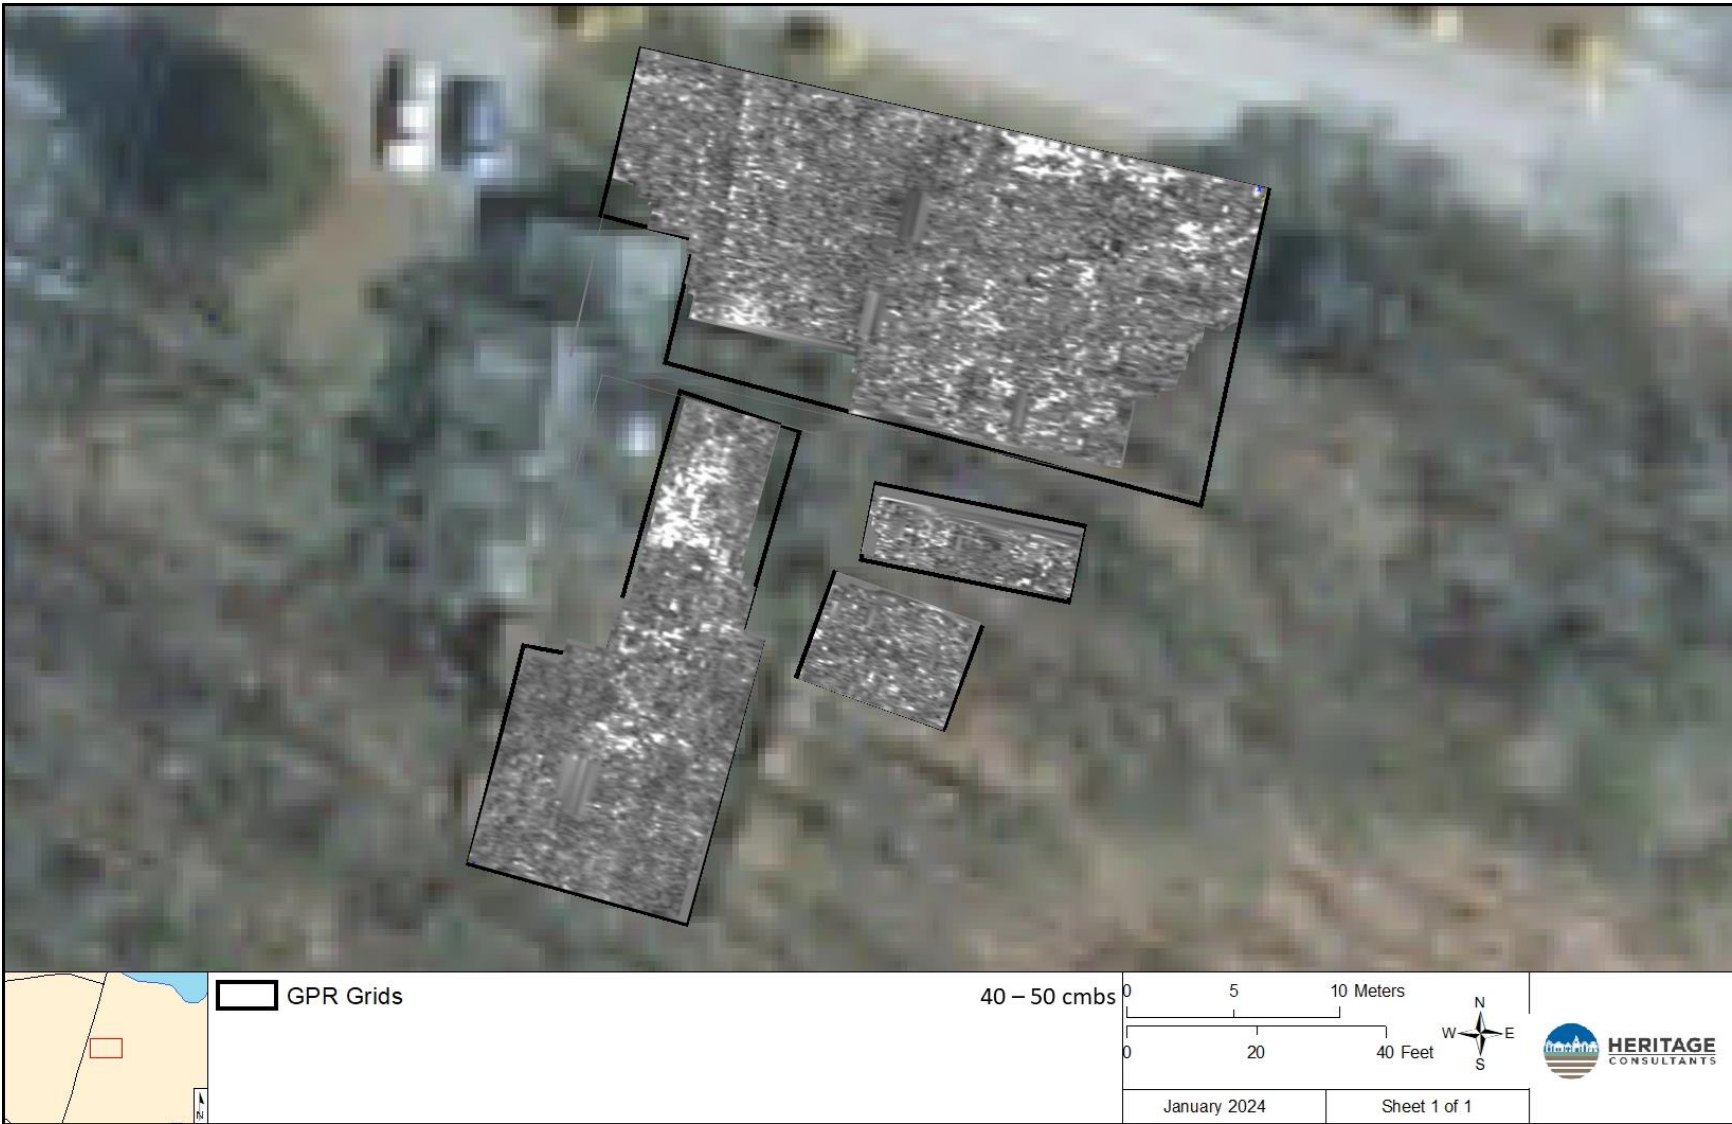
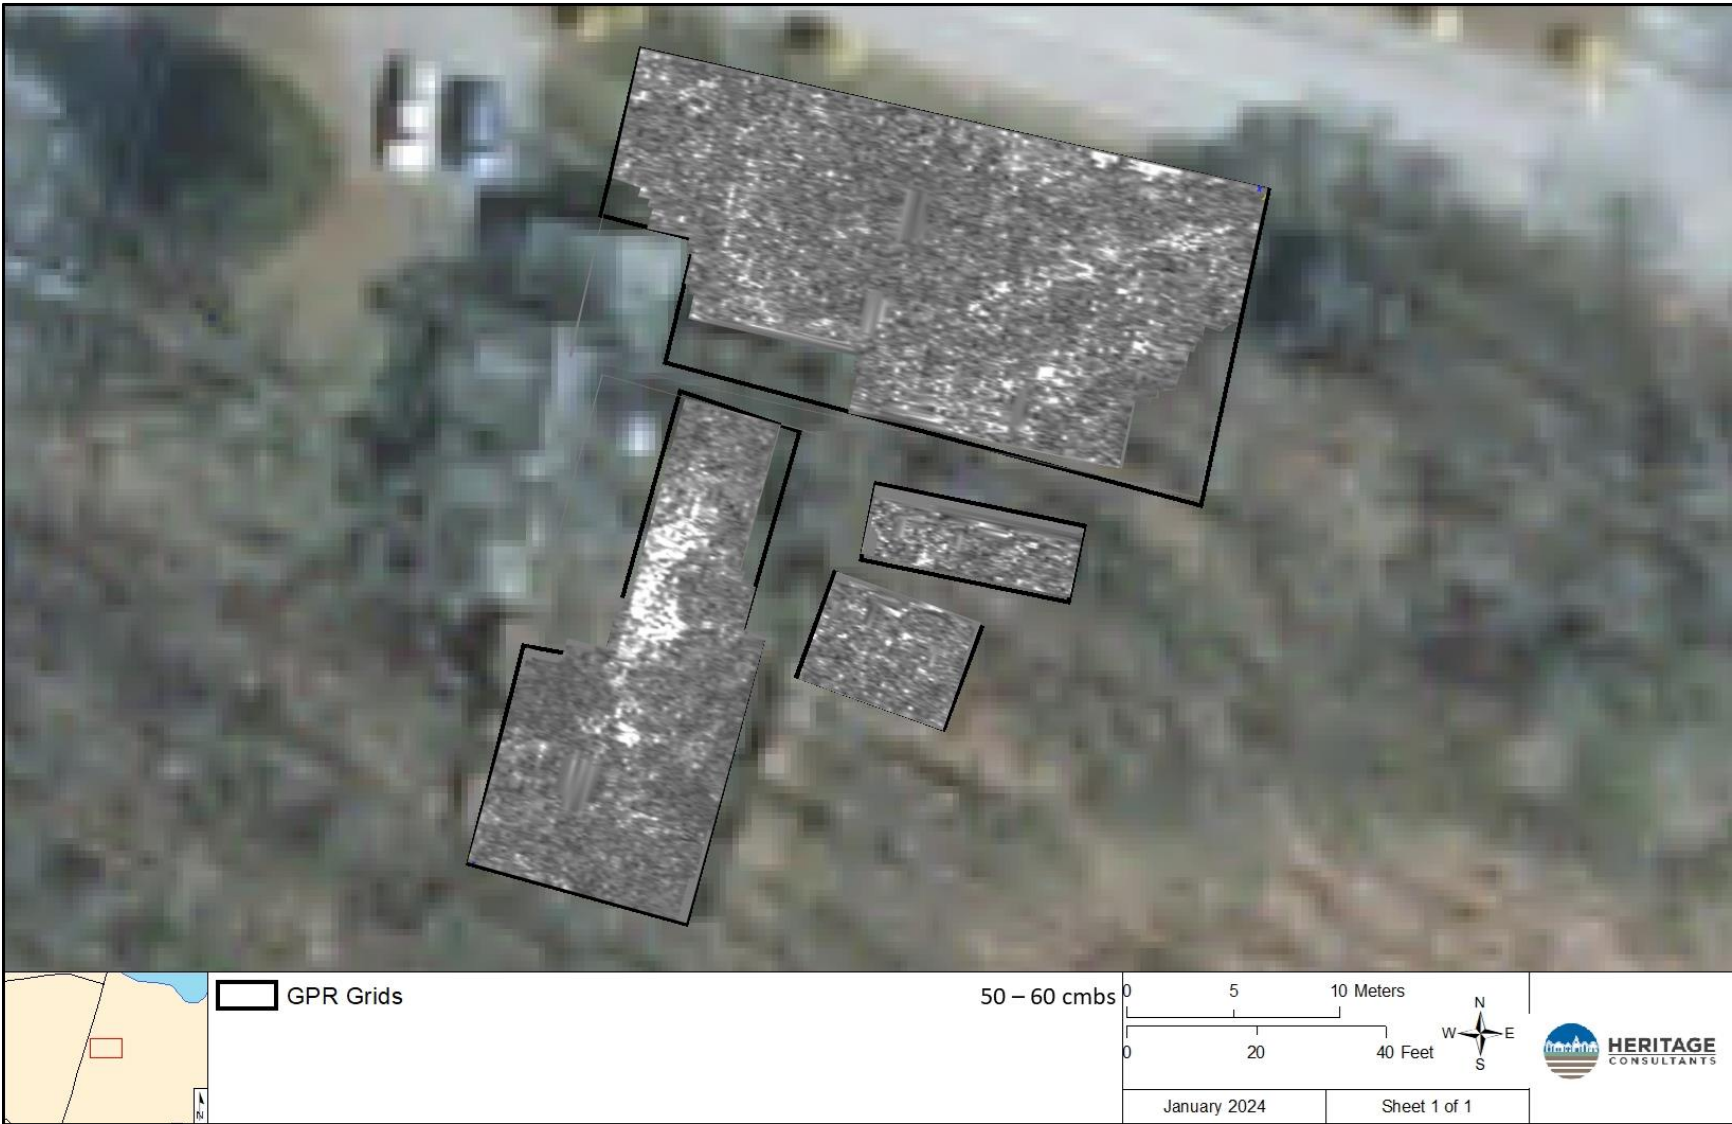
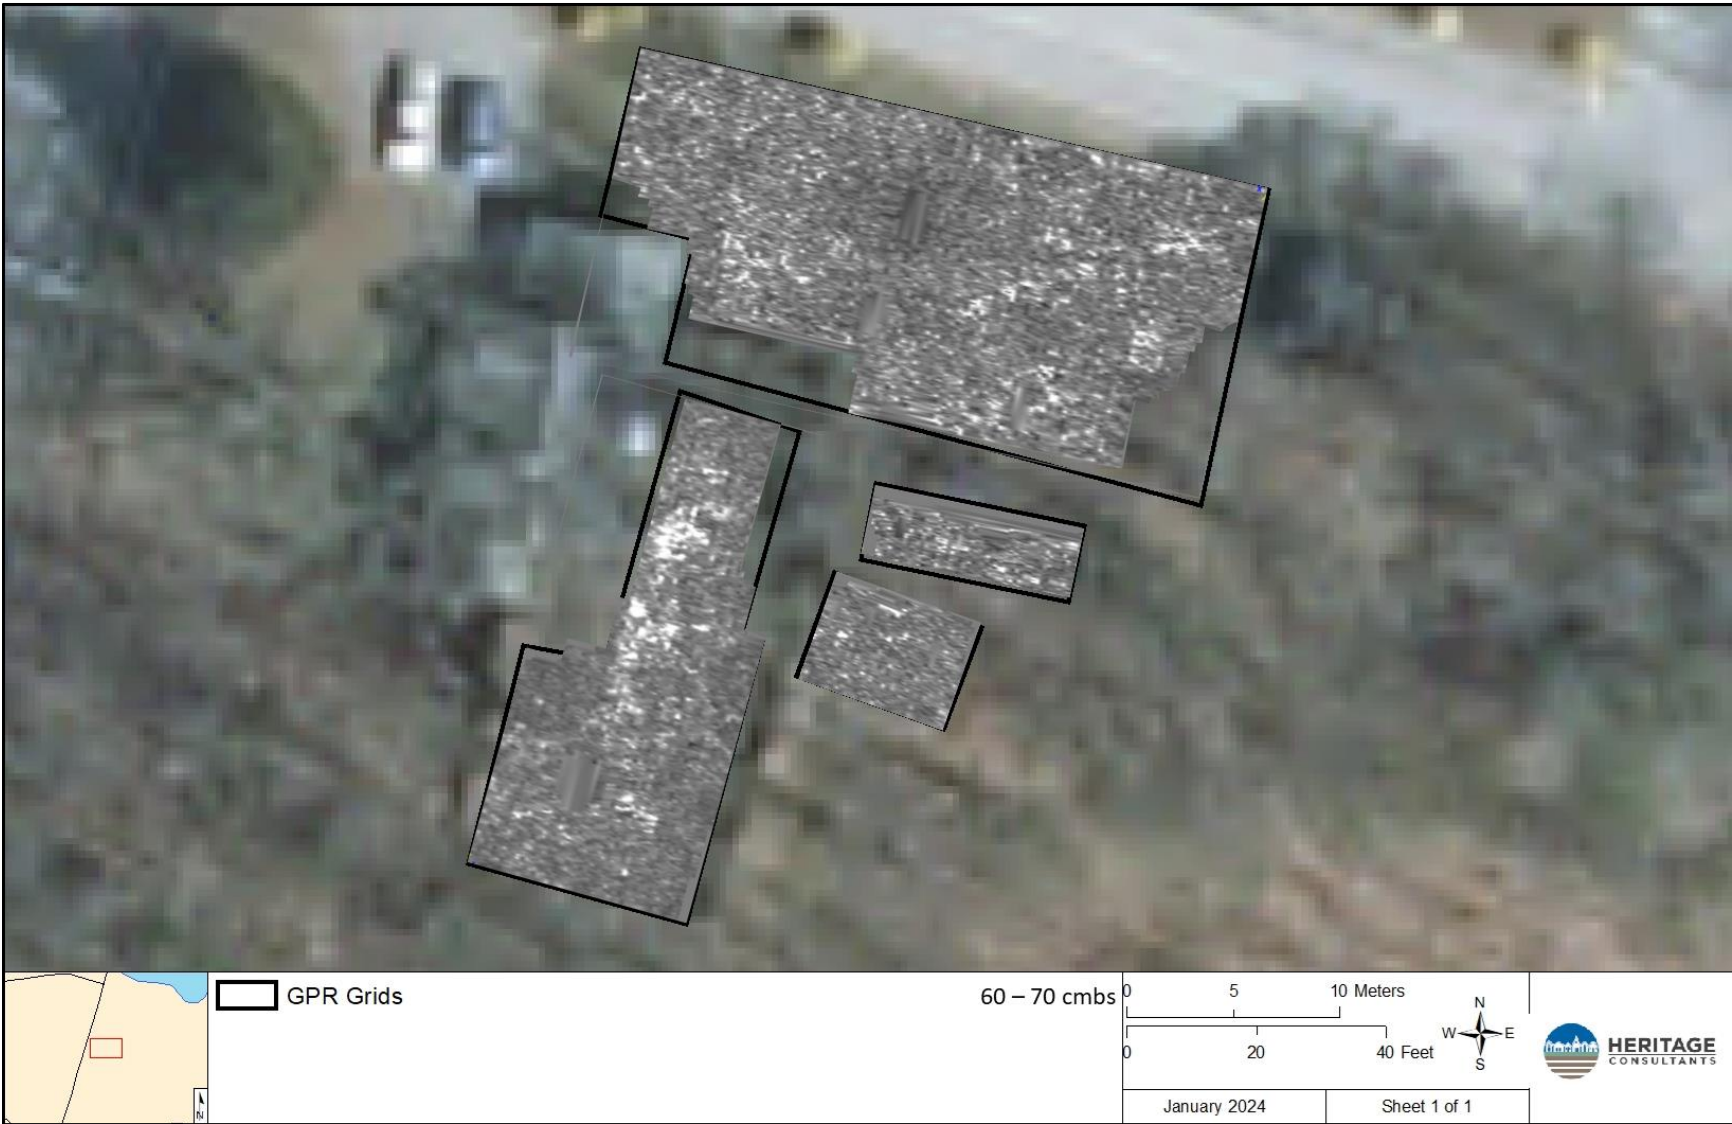
Figure 13: GPR amplitude map of Survey Grids 1-4, with approximate depth indicated.

Figure 14: GPR amplitude map of Survey Grids 1-4, with approximate depth indicated.

Figure 15: GPR amplitude map of Survey Grids 1-4, with approximate depth indicated.

Figure 16: GPR amplitude map of Survey Grids 1-4, with approximate depth indicated.

Figure 17: GPR amplitude map of Survey Grids 1-4, with approximate depth indicated.

Figure 18: GPR amplitude map of Survey Grids 1-4, with approximate depth indicated.
