Preservation Plan

African Burying Ground at Langdon Farm Portsmouth, NH

PRESERVATION
COMPANY

June 2024

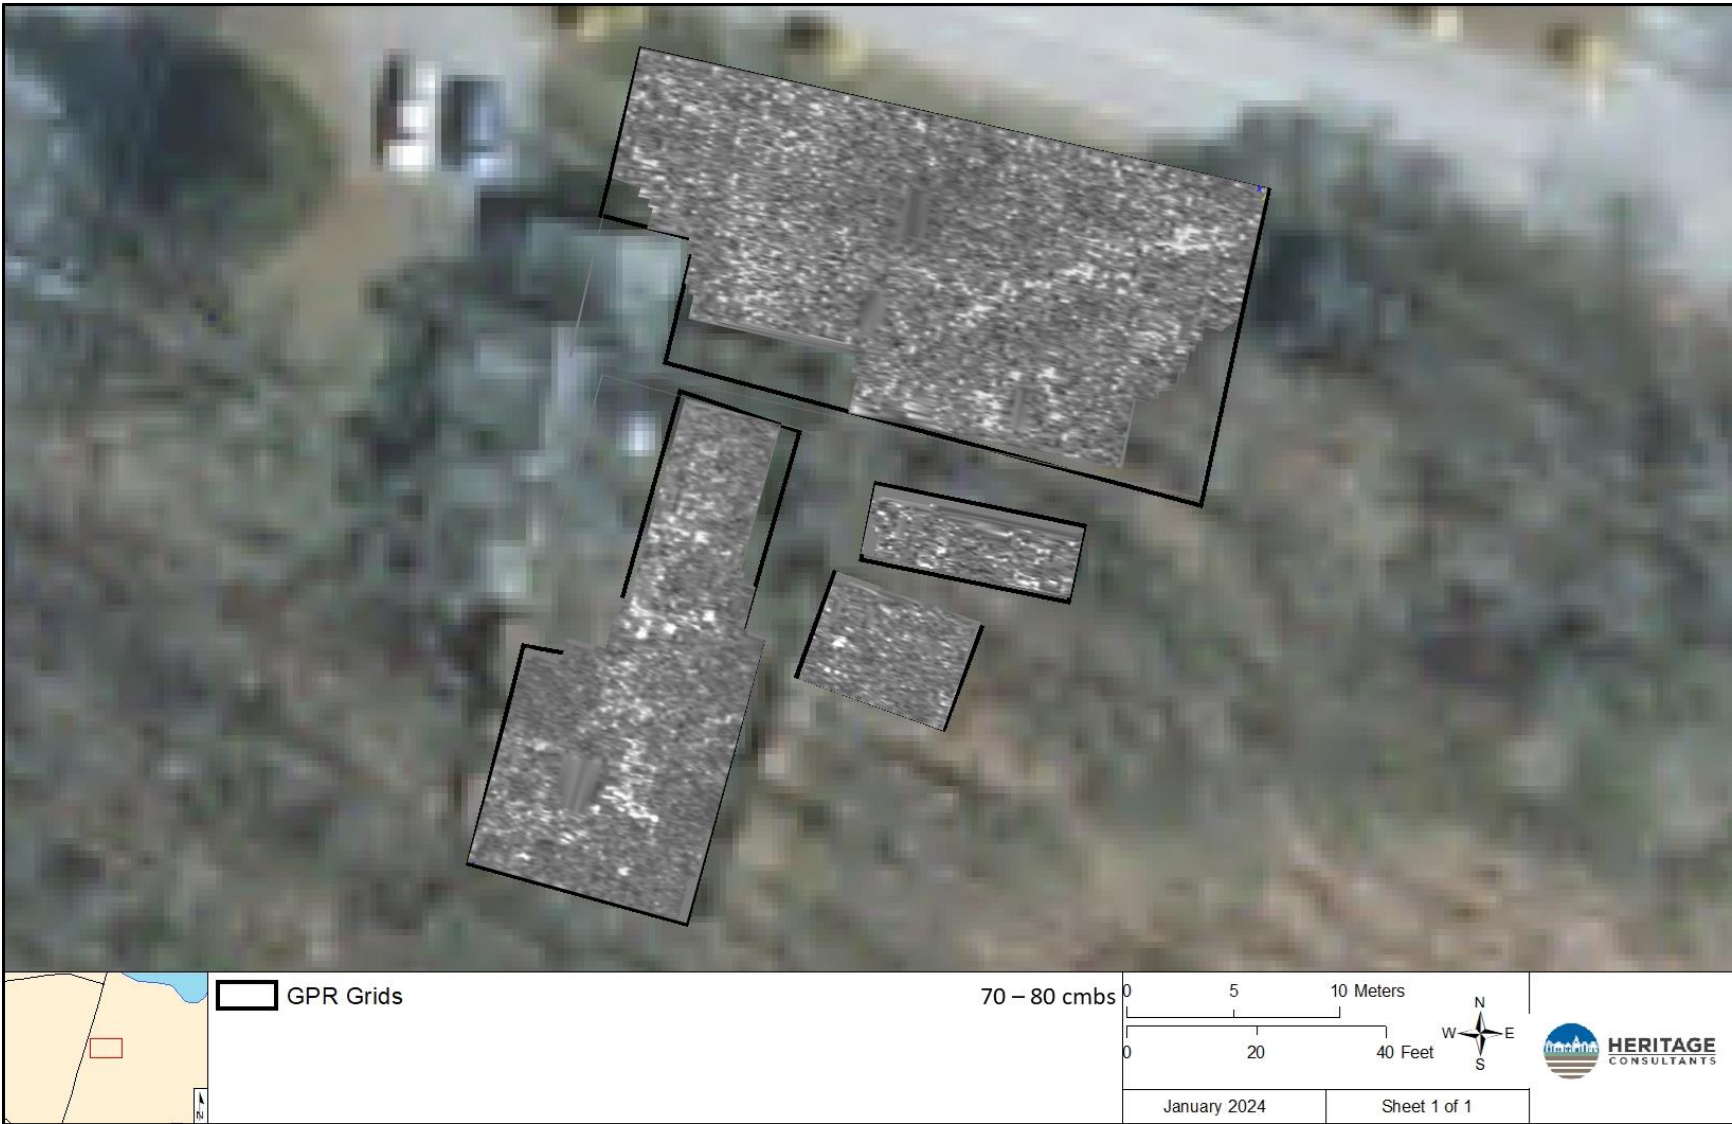
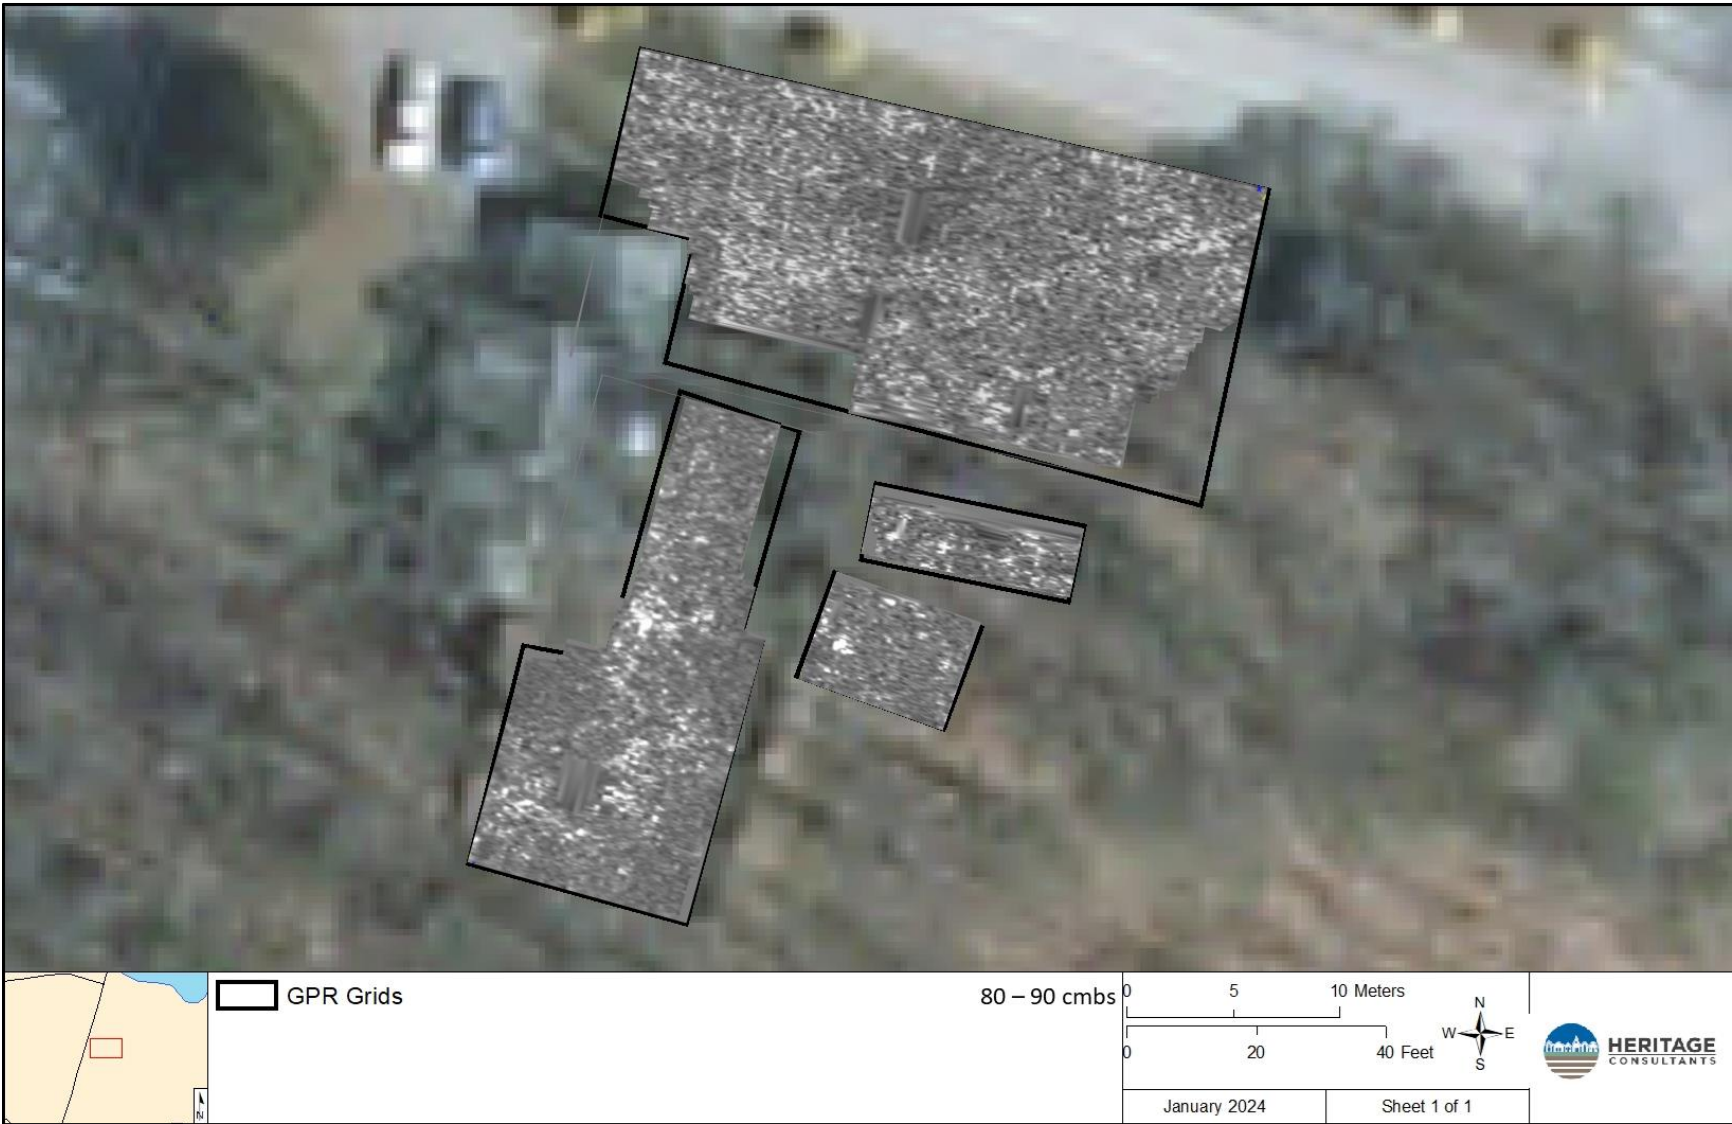
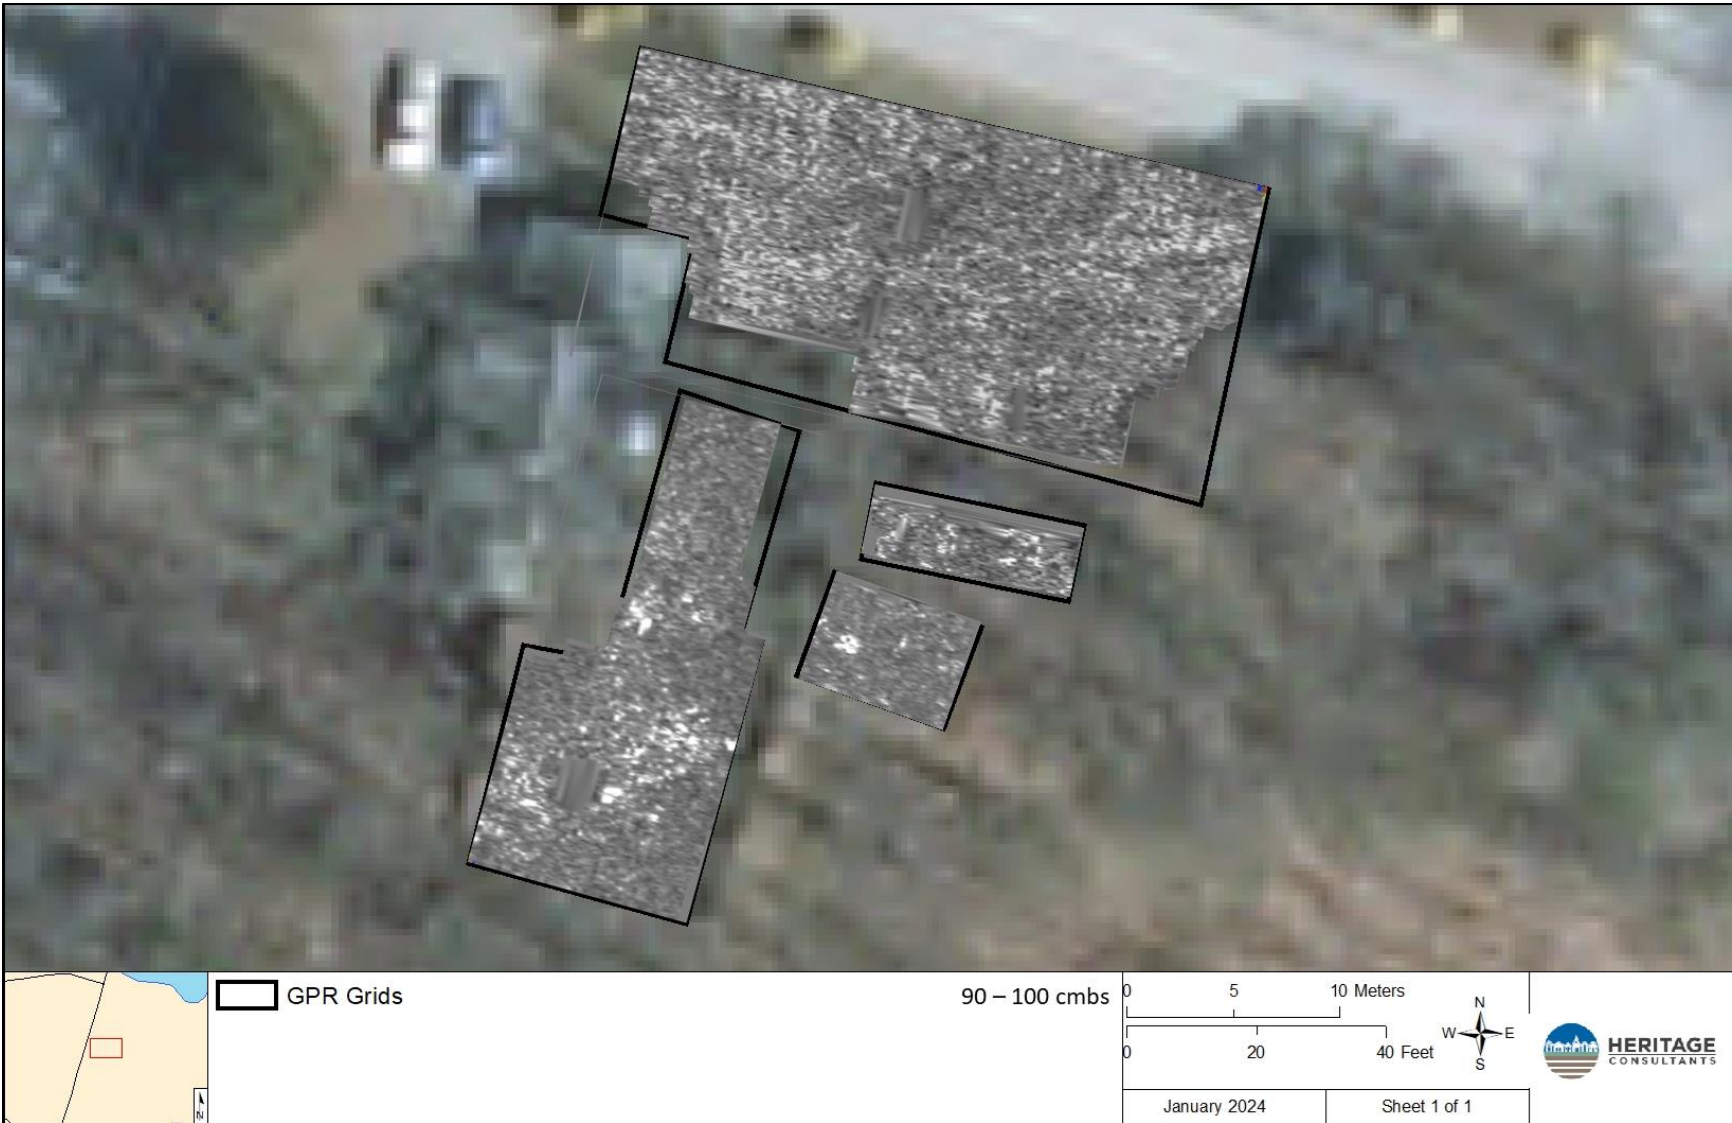
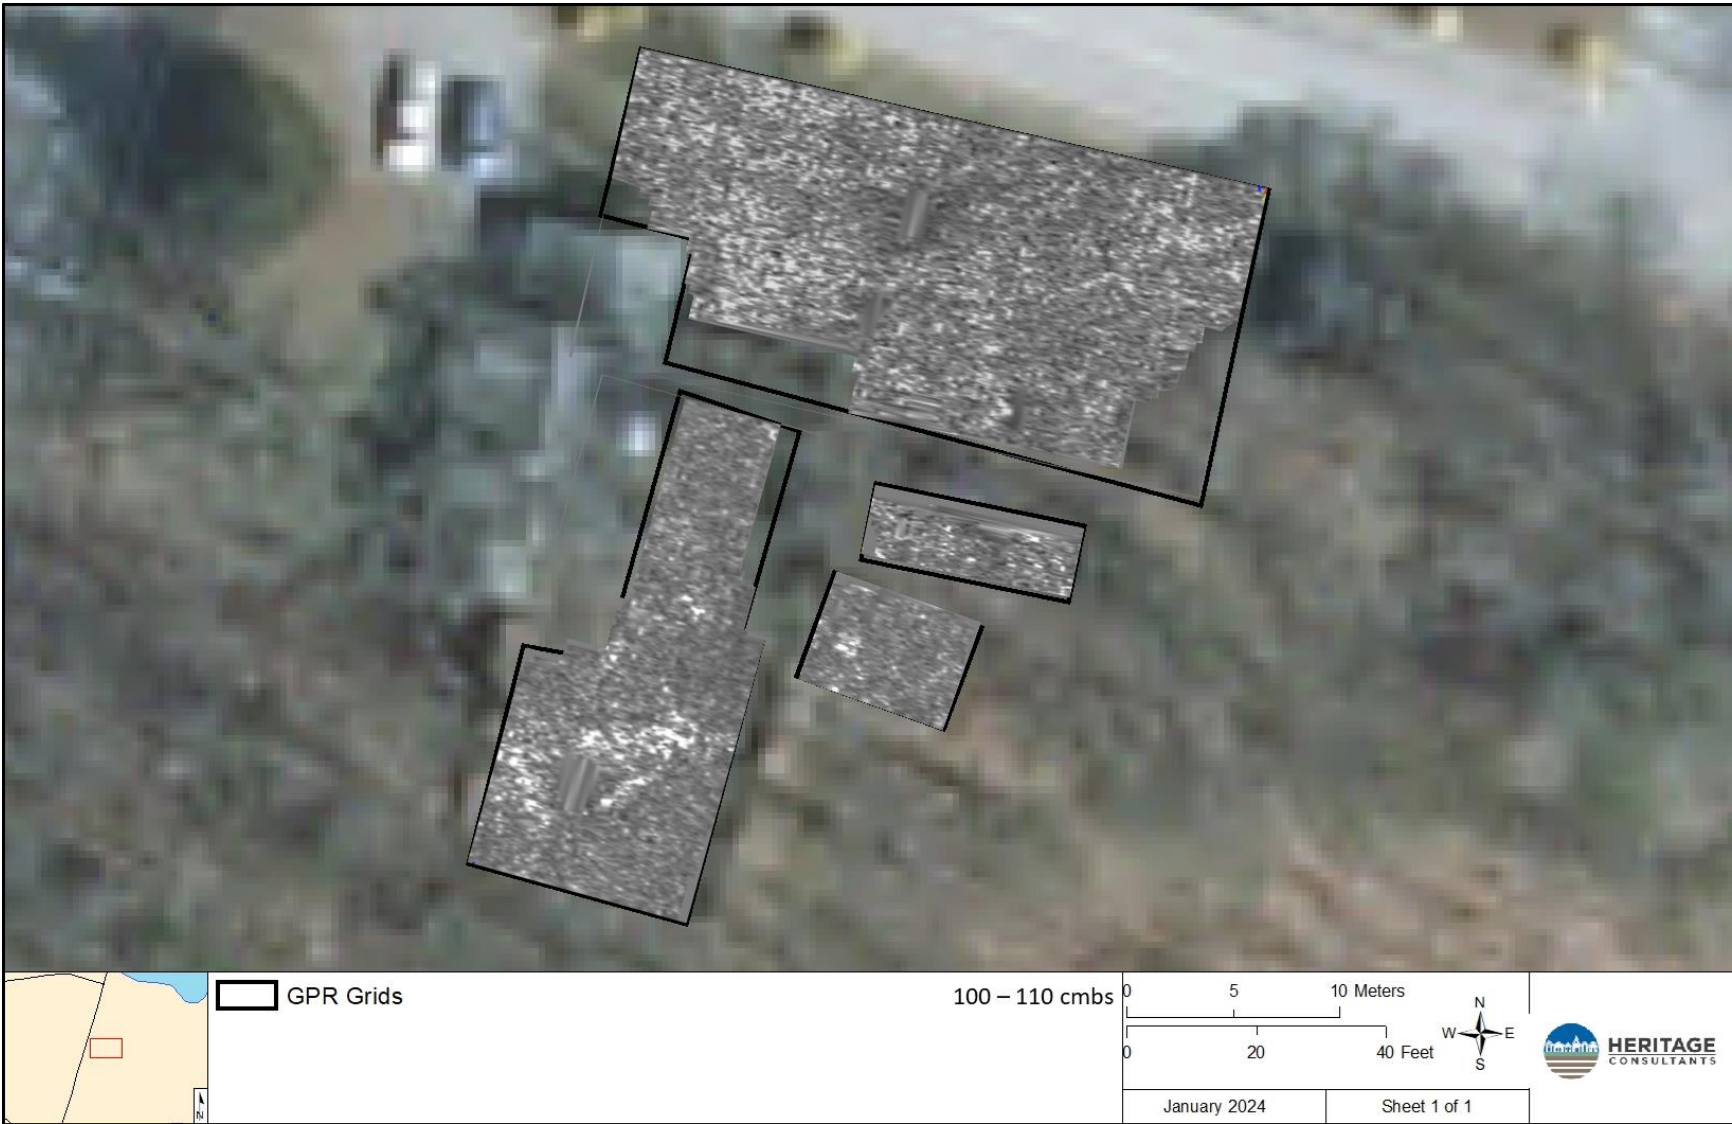
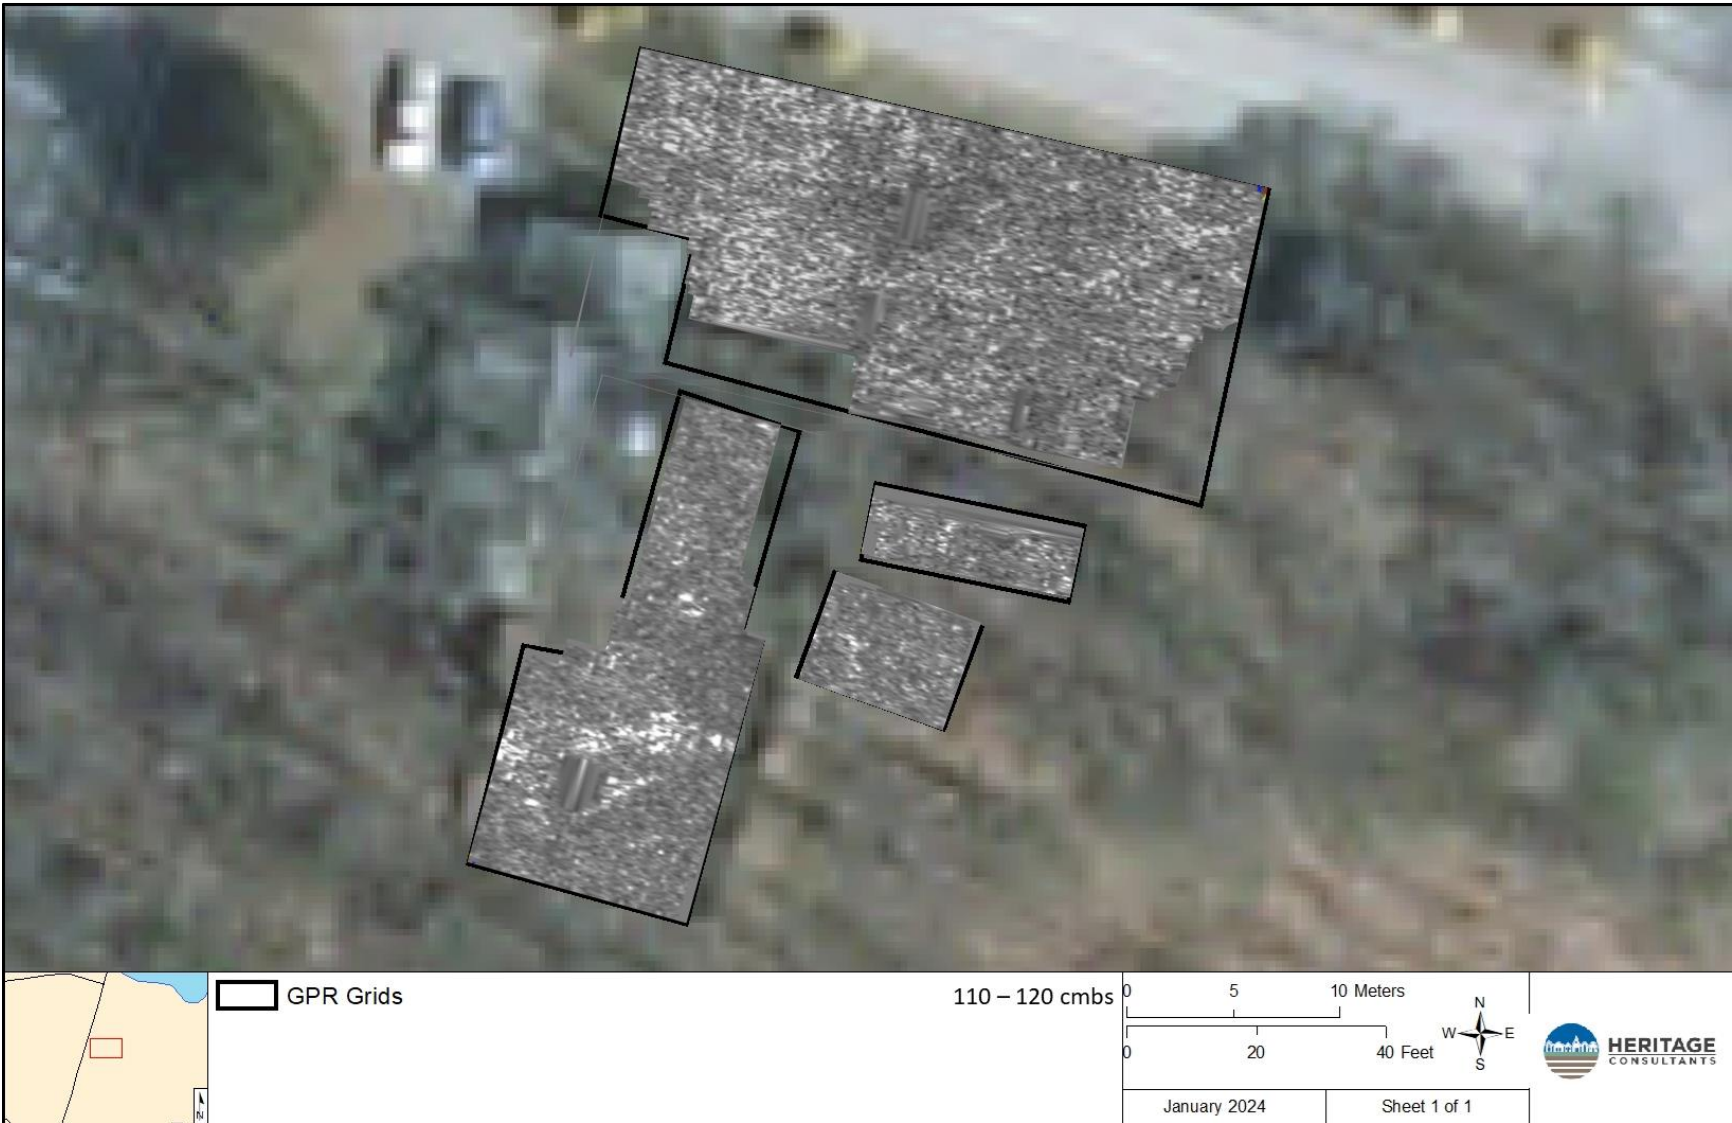
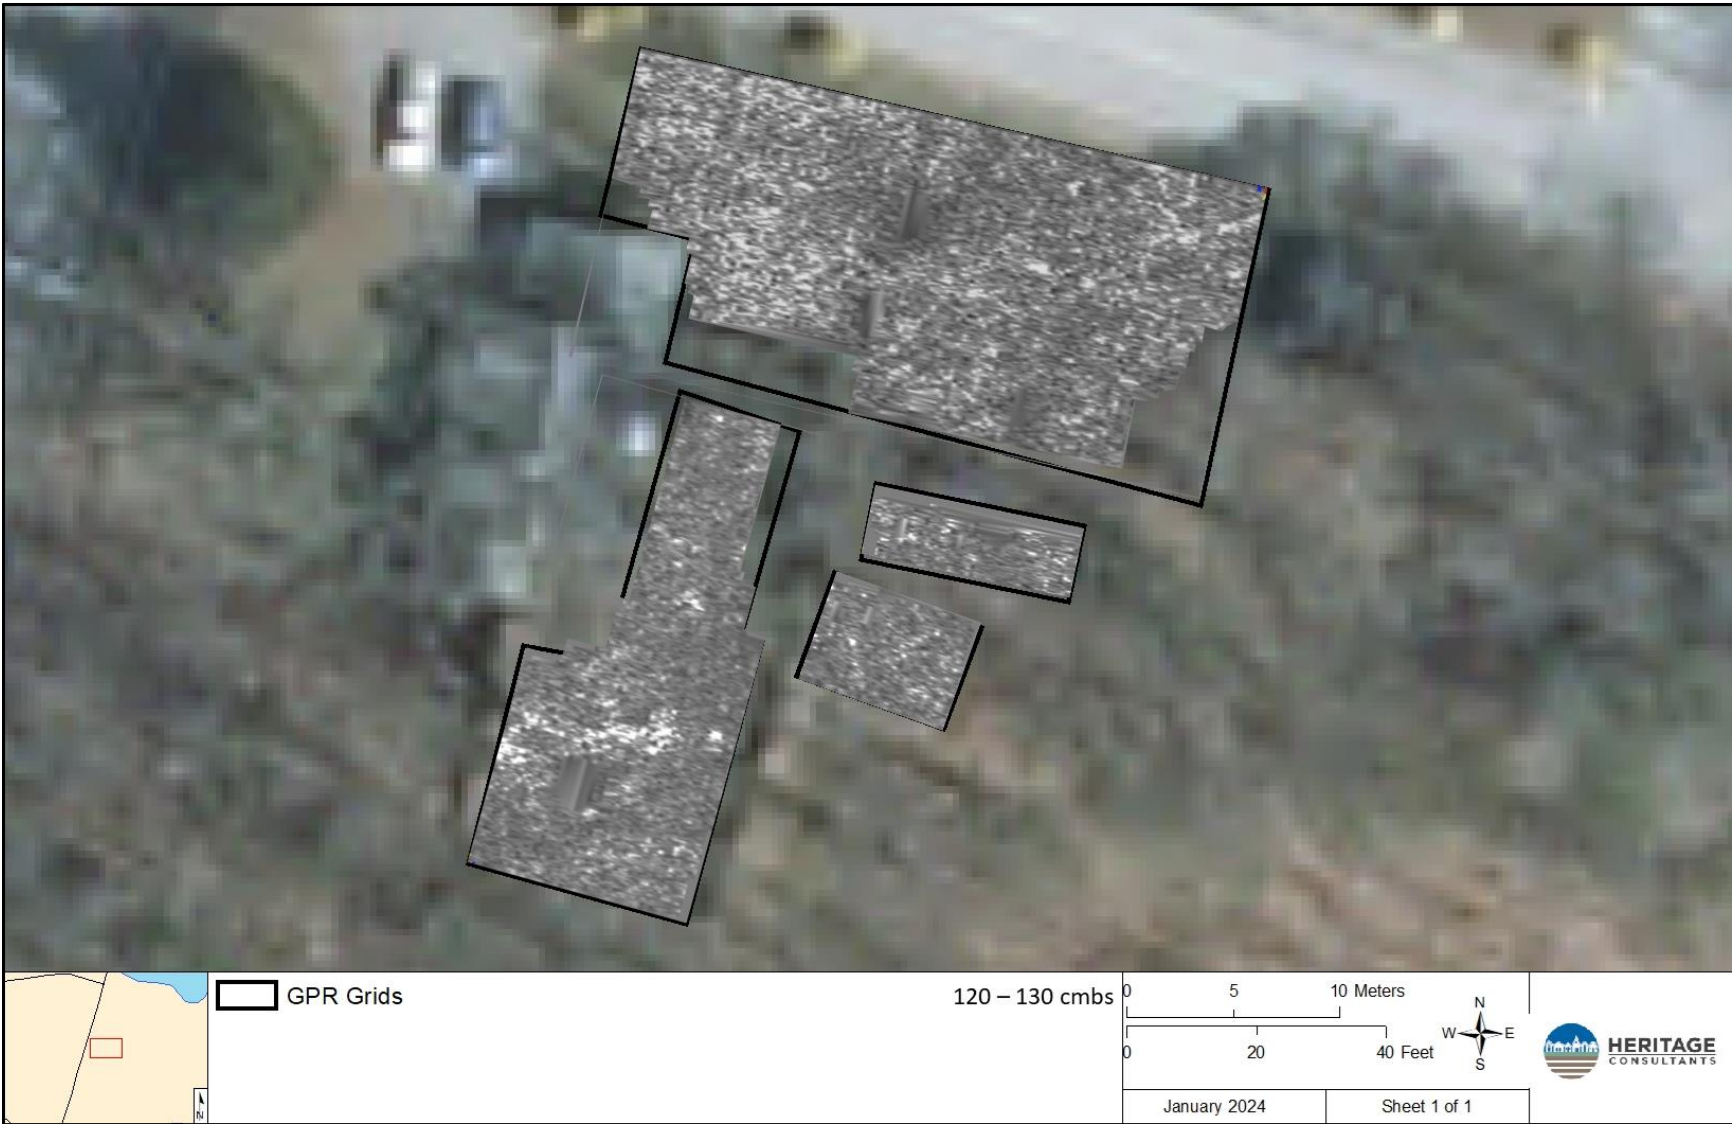
Figure 19: GPR amplitude map of Survey Grids 1-4, with approximate depth indicated.

Figure 20: GPR amplitude map of Survey Grids 1-4, with approximate depth indicated.

Figure 21: GPR amplitude map of Survey Grids 1-4, with approximate depth indicated.

Figure 22: GPR amplitude map of Survey Grids 1-4, with approximate depth indicated.

Figure 23: GPR amplitude map of Survey Grids 1-4, with approximate depth indicated.

Figure 24: GPR amplitude map of Survey Grids 1-4, with approximate depth indicated.

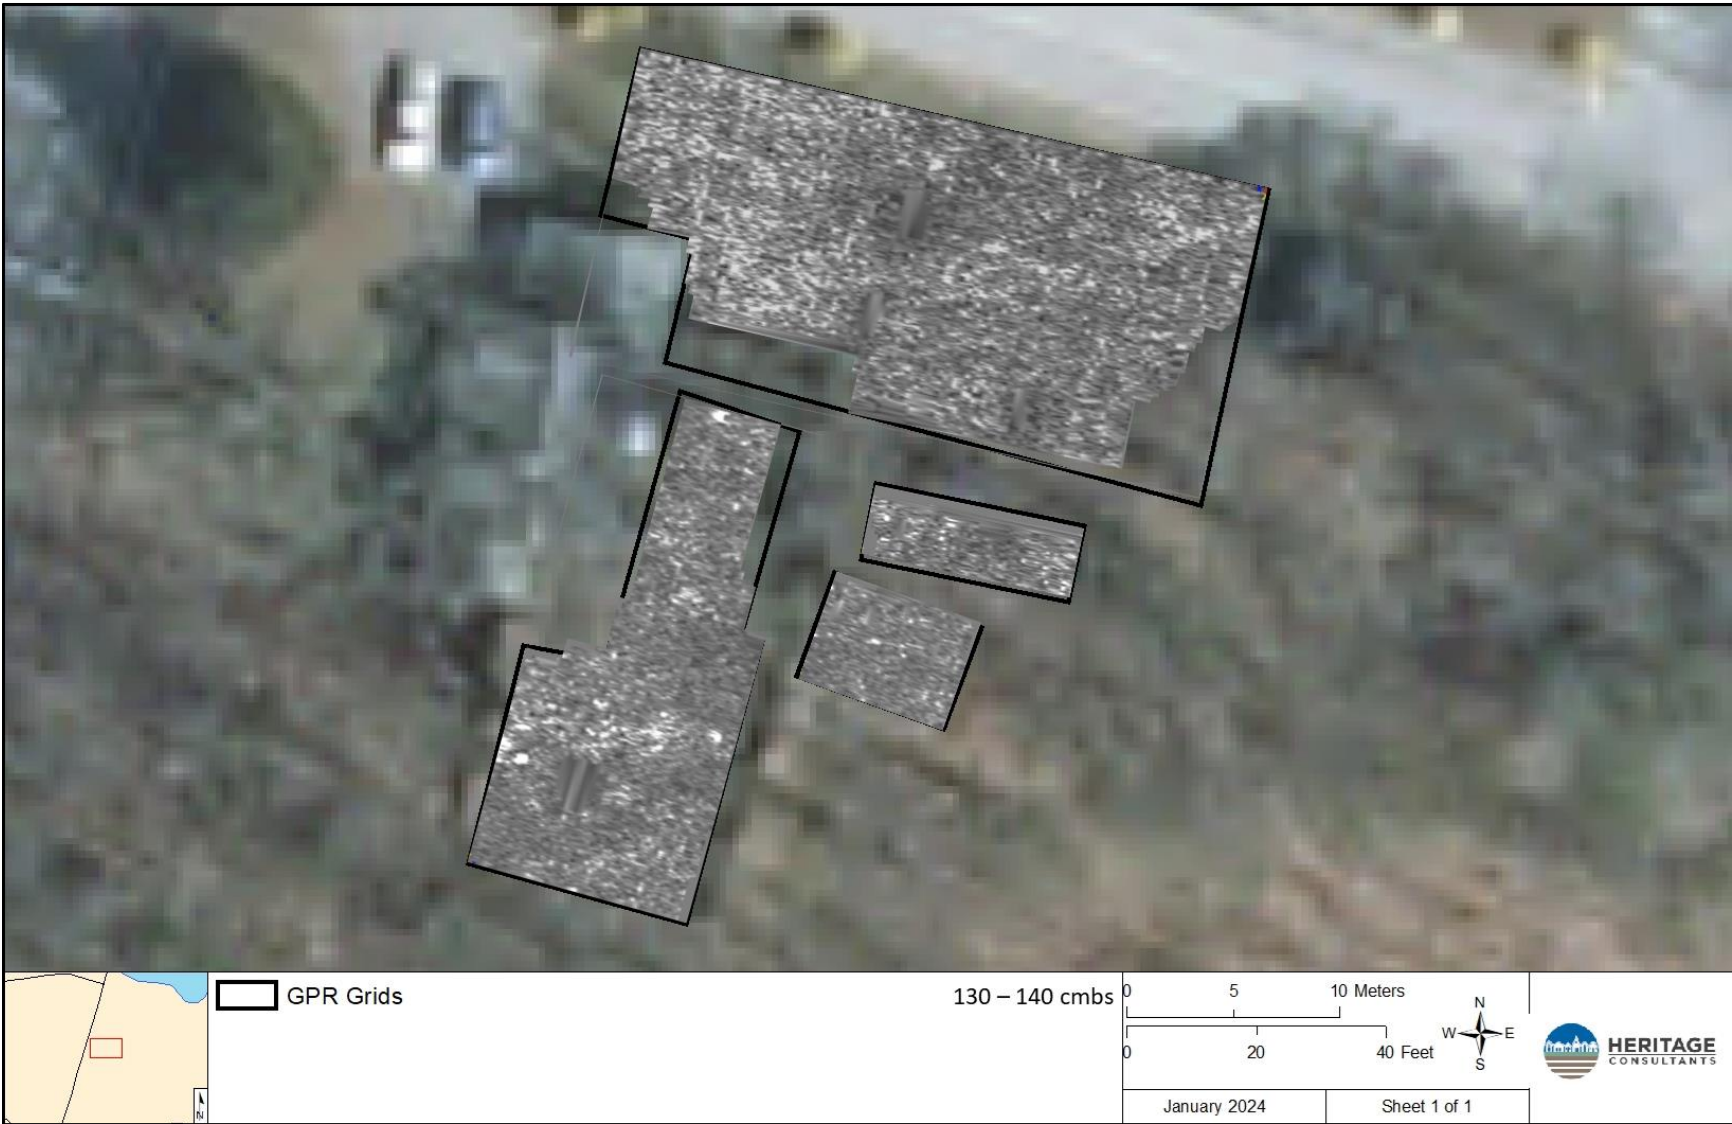
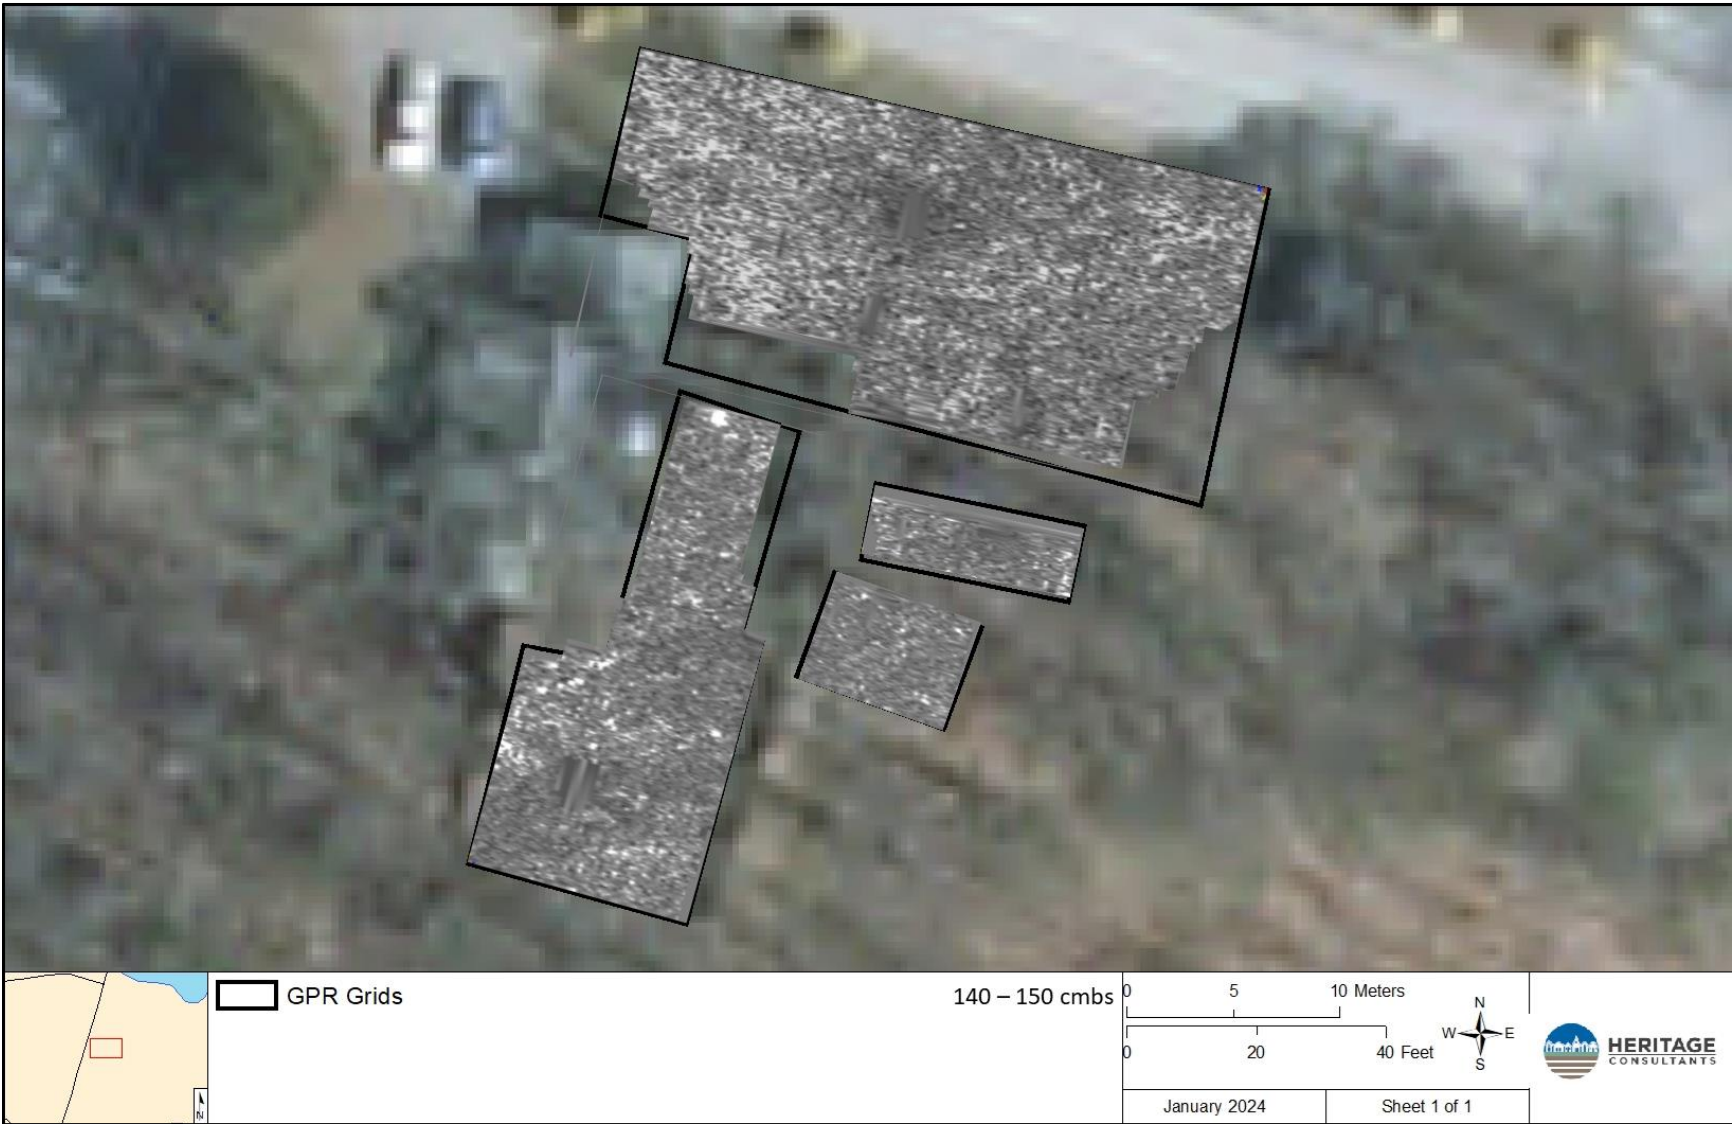
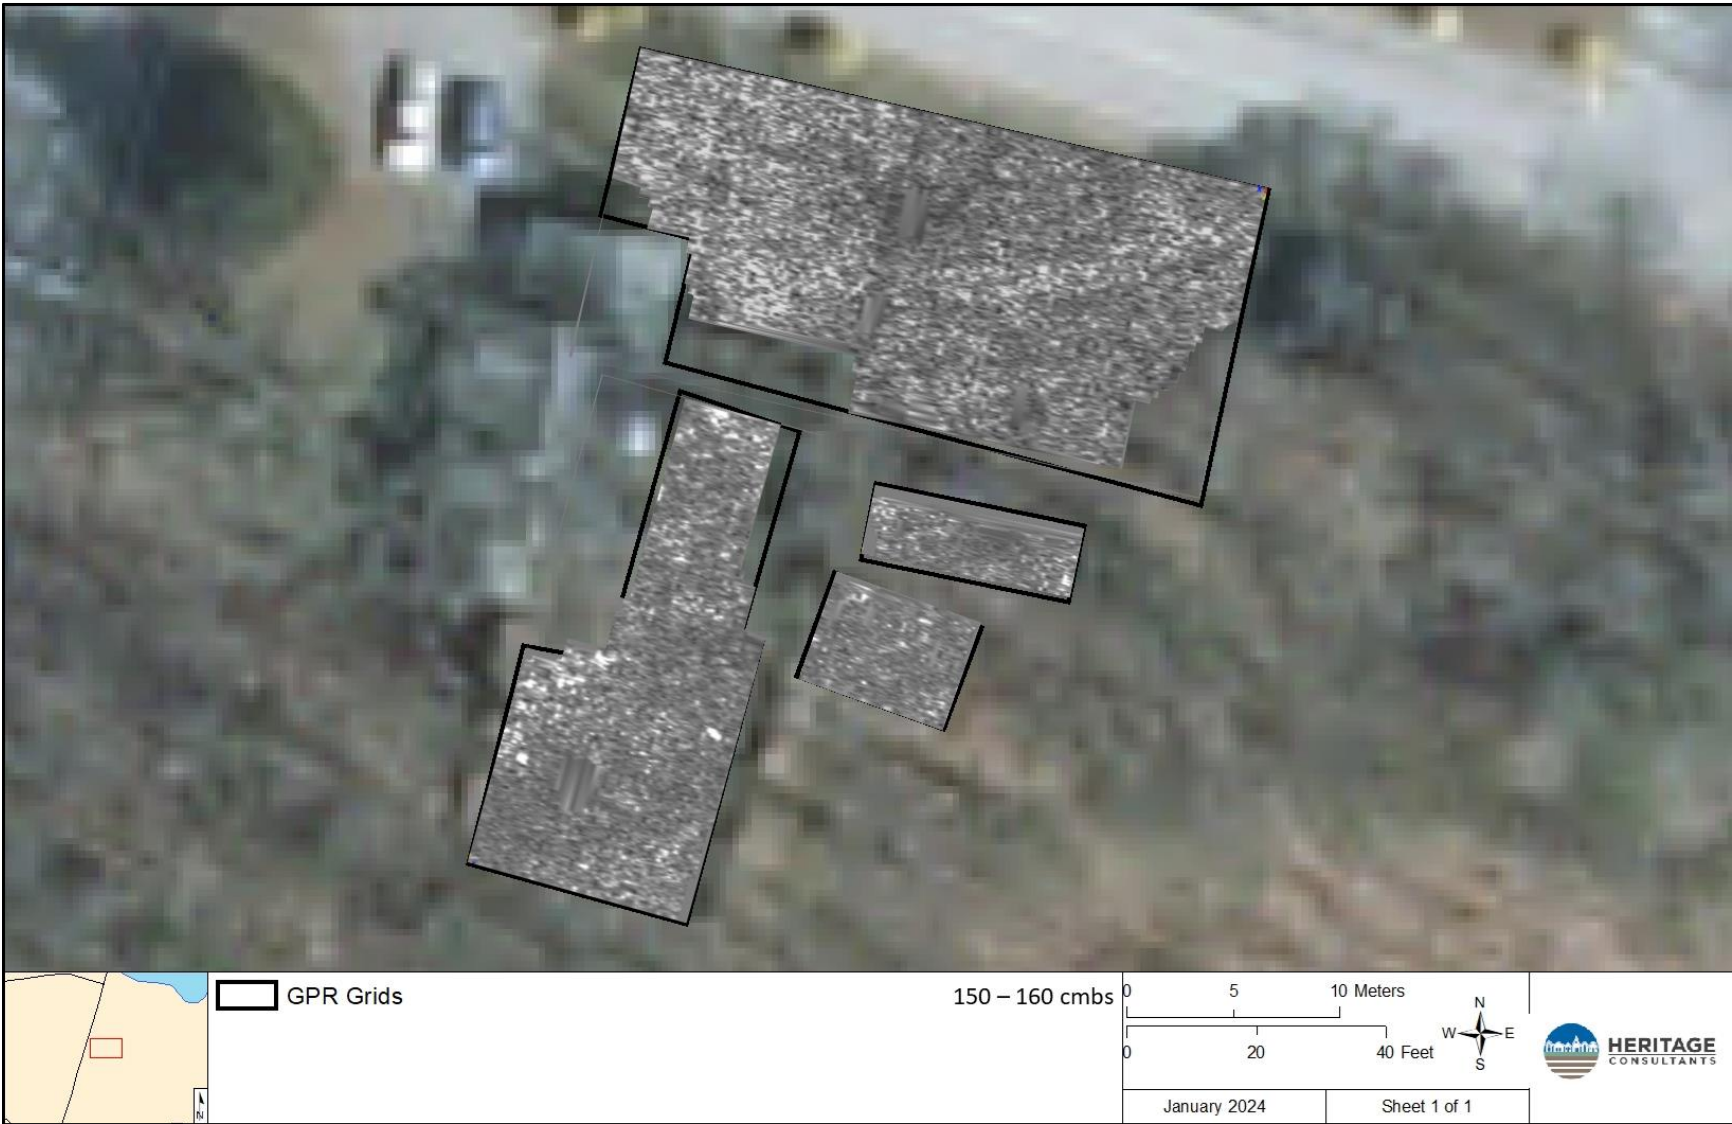
Figure 25: GPR amplitude map of Survey Grids 1-4, with approximate depth indicated.

Figure 26: GPR amplitude map of Survey Grids 1-4, with approximate depth indicated.

Figure 27: GPR amplitude map of Survey Grids 1-4, with approximate depth indicated.

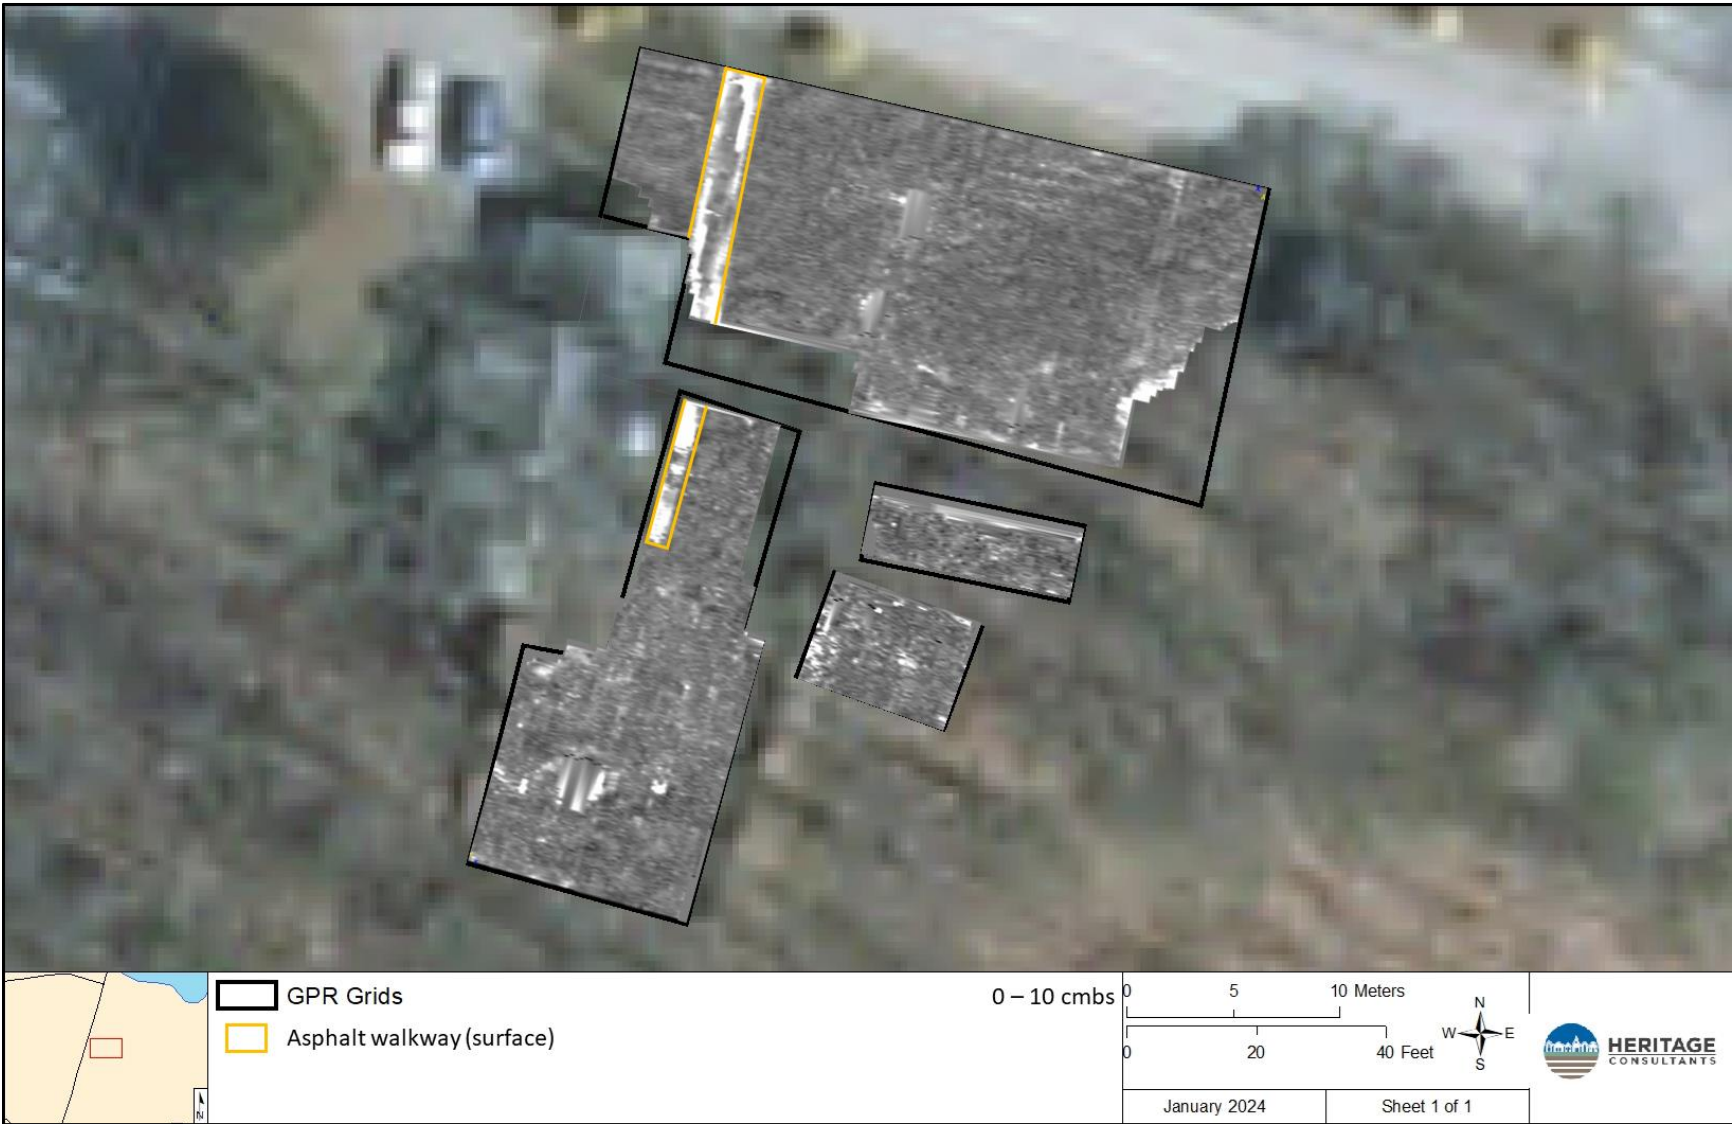
While relatively few burials were clear, reflective rectangles in plan view, a portion of the burials displayed several of the qualities associated with coffin burials. Select burials have been annotated to illustrate some of these characteristics. To begin, most potential burials were highly reflective, suggestive of significant soil differences in areas that contained probable coffins from areas of normal subsoil. This intense reflectivity may be a result of air voids contained within portions of semi-decayed coffins, as well as the presence of buried metal coffin hardware that GPR energy cannot penetrate. The high amplitude of these reflectors was generally a unique feature of the anomalies identified as probable burials, as shallower targets interpreted as tree roots tended to display more muted reflections, were dendritically shaped within plan view amplitude maps, and were generally reflective at different depths in successive profiles. Coffins, on the other hand, display as rectangular in plan view and are generally reflective at the same depth. A second characteristic of many of the anomalies interpreted as burials was a broad hyperbola in the radargram or profile view. Hyperbolas form in GPR data as a result of the conical spread of GPR energy through the ground, with the central peak of the hyperbola marking the top of a given target. If the target has a flat top (like many coffins), then it will remain at a constant distance from the antenna, producing a flat band across the top of the target. In practice, since most coffins face some amount of decomposition or collapse, these bands rarely present as being perfectly flat. However, even a semi-decomposed coffin can produce a broader top than targets like tree roots that tend not to have large horizontal expanses.

Figure 32: Annotated GPR amplitude map of Survey Grids 1-4, with approximate depth indicated.

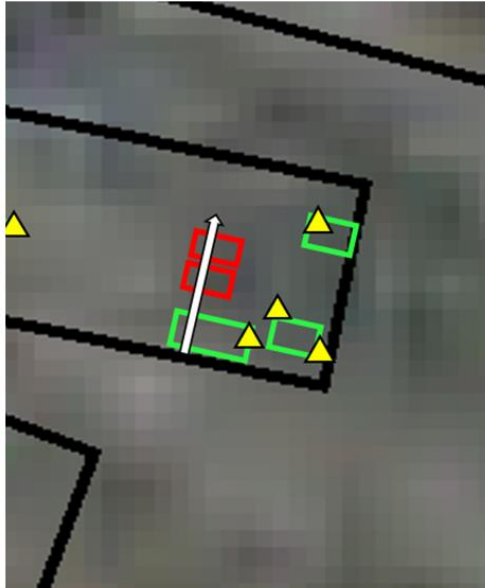
Transect Location Map

GPR Transect Profile Grid 1 Line 44

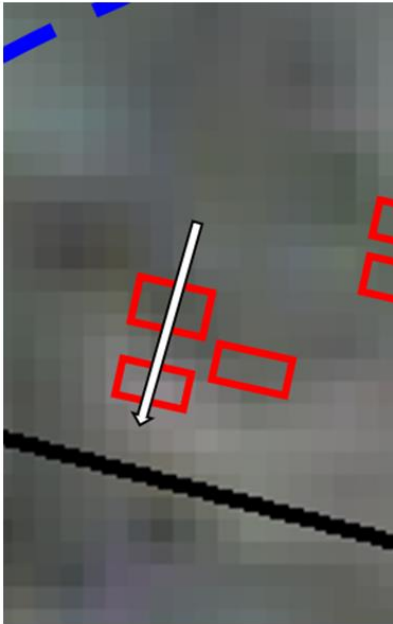
Transect Location Map

Figure 47: Selected GPR profile of probable unmarked burials located in Grid 2. The position of radar profile is indicated by the white arrow in the left plan view map, and the burials are indicated by the red arrows in the radargram to the right.

GPR Transect Profile Grid 2 Line 46

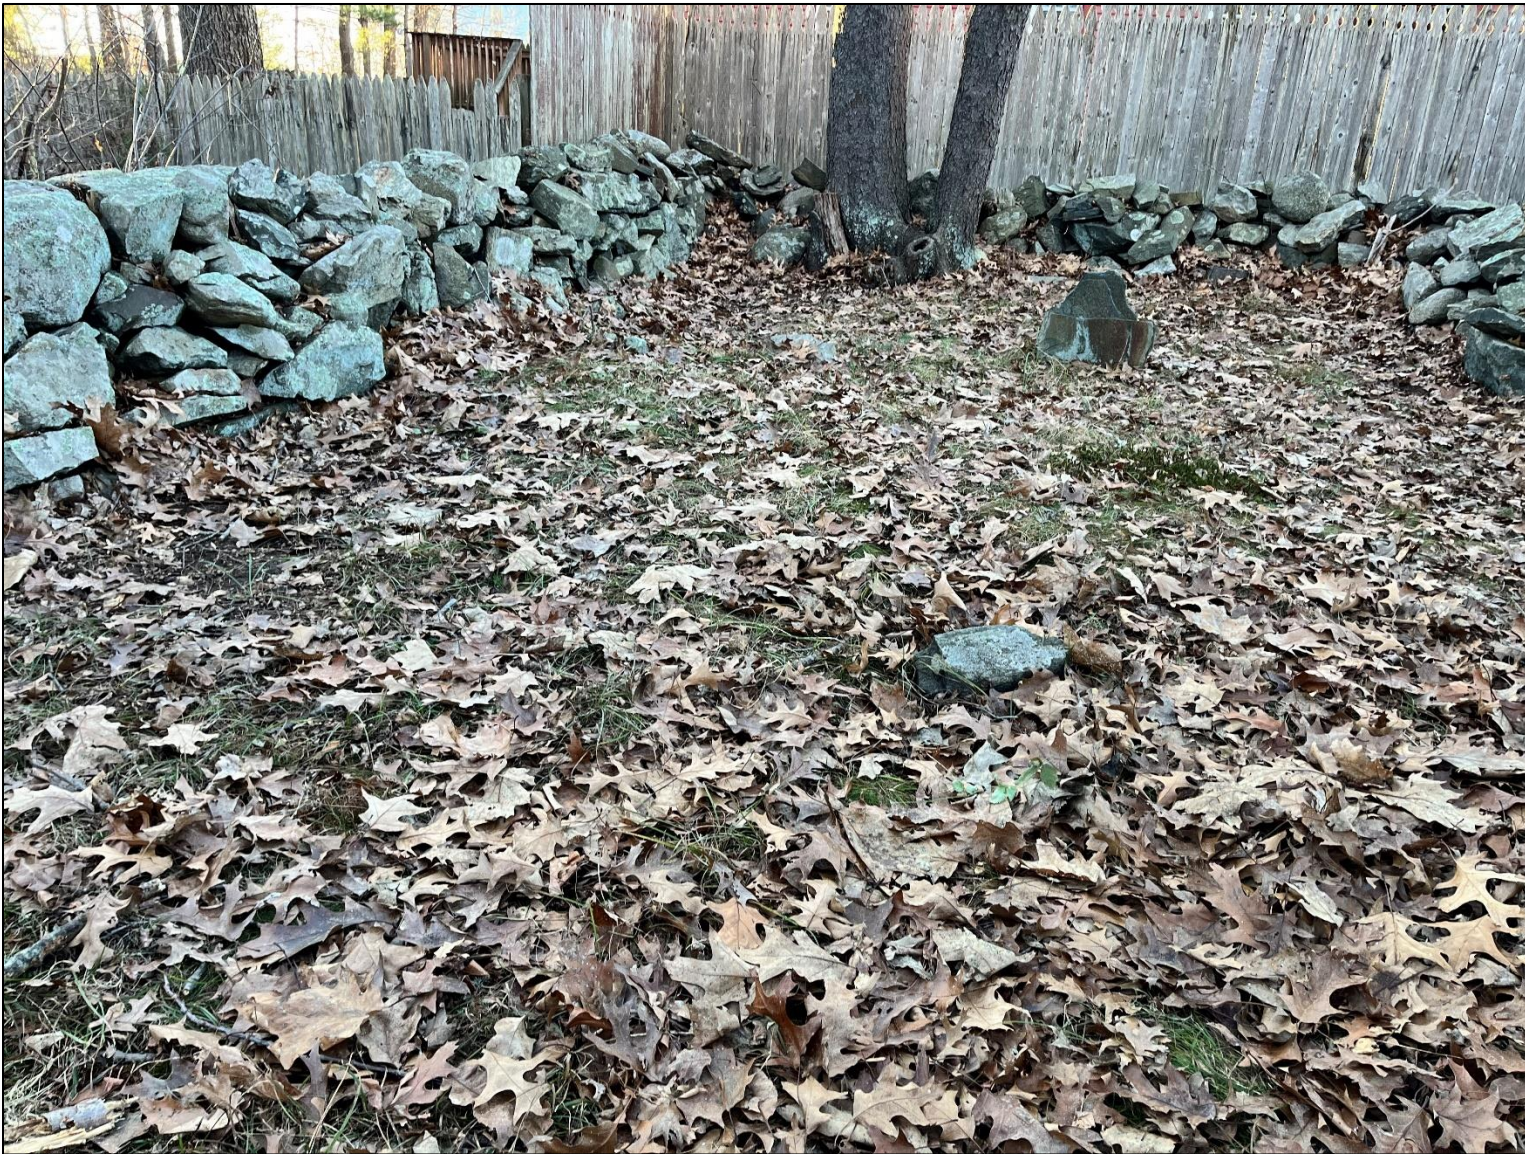
Photo 2: Close-up photograph of the potential burial markers on the western side of Survey Grid 1, facing west.
