Preservation Plan

African Burying Ground at Langdon Farm Portsmouth, NH

PRESERVATION
COMPANY

June 2024

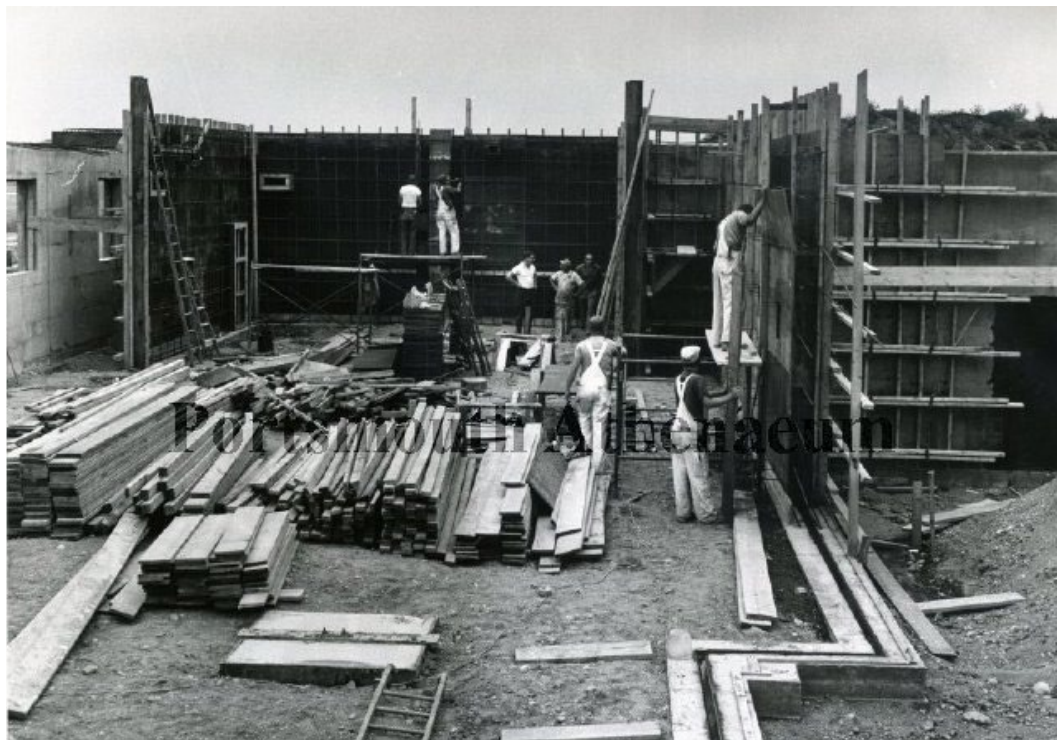
Figure 9: Foundation under construction 1965 (Portsmouth Athenaeum)

The ground breaking for the new church was in the spring of 1965. The foundation was built during the summer. In the spring of 1966, the steeple was placed on the roof.

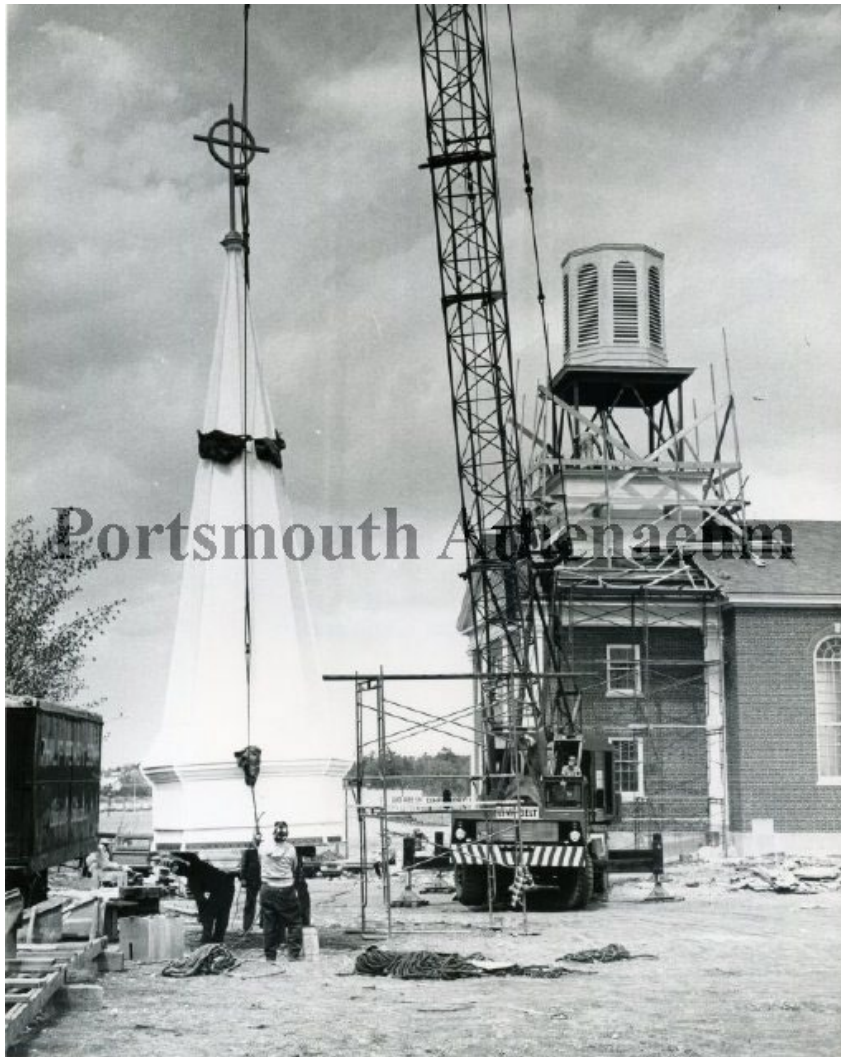
Figure 10: Steeple assembly, probably spring 1966 (Portsmouth Athenaeum)

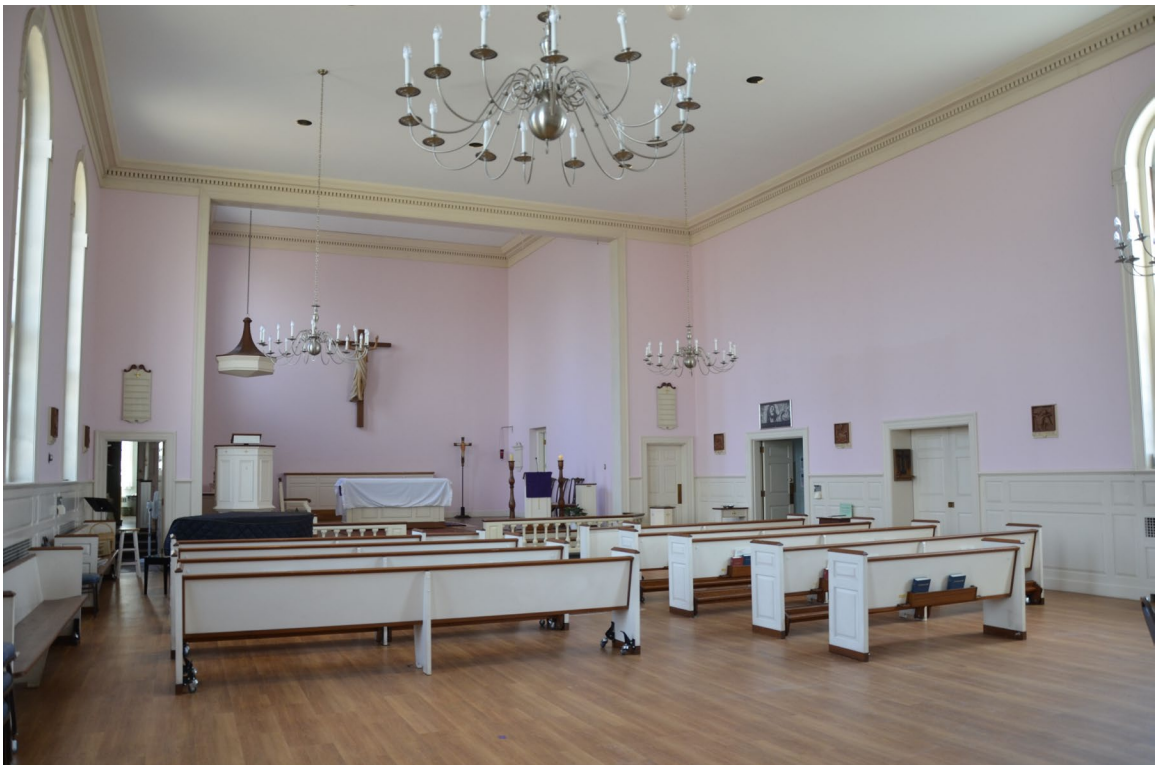
Photo 11) Interior sanctuary, facing southeast

The church interior has had few changes since construction was complete. The sanctuary walls have paneled wainscotting and molded cornice with dentils (Photos 11, 12). The doors and windows have molded casings (Photo 14). The doors are three- and six-panel, painted wooden doors. The slip pews are original. They were placed on casters for flexibility ca. 2015. Vinyl plank flooring was installed at that time. The rear pews were removed. The ceiling was repaired around the same time and the interior painted. The chandelier light fixtures are original with new LED lights (Dozier 2024). The chancel rail has turned balusters. The altar, pulpit with suspended sounding board, and the lectern are original. The balcony choir loft has a railing of turned balusters. The organ is older than the church, purchased used (Photo 13).

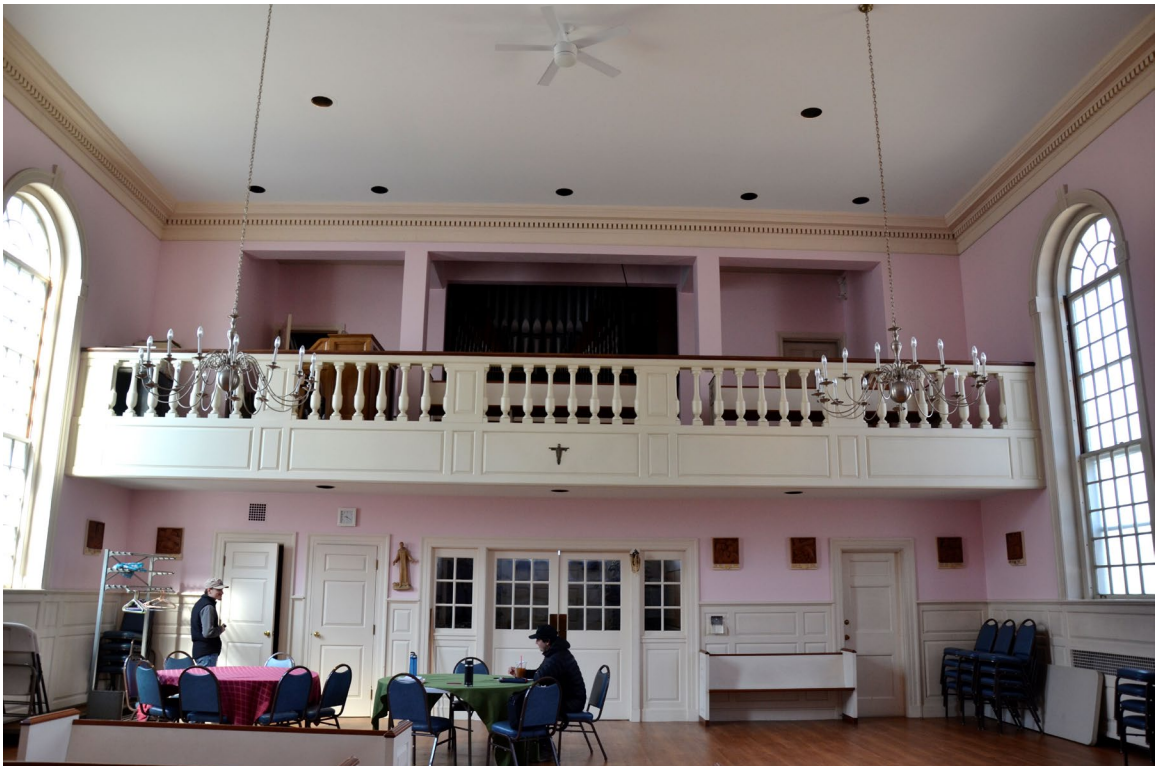
Photo 12) Interior balcony, facing west-northwest

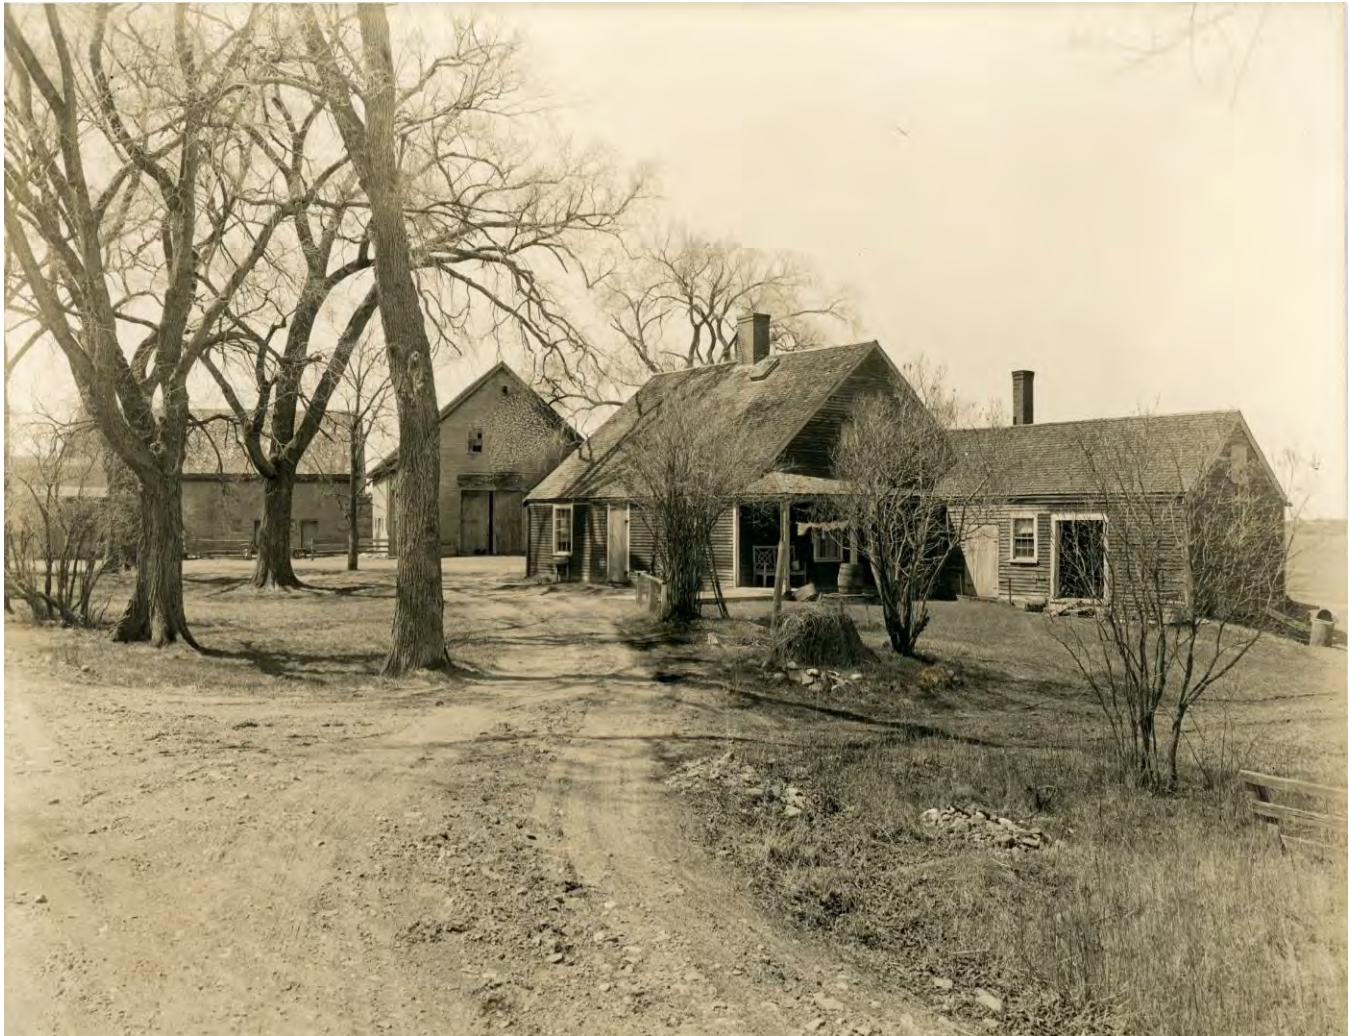
Figure 14. Cape and barns, facing northwest, early twentieth century (Courtesy of Alexander B. Warwick, Portsmouth Athenaeum)

Historically, a semi-circular dirt driveway passed in front of the house and connected to the dooryard in front of the barns. The front yard had several large shade trees (Figure 14). The back yard was formerly open field with scattered fruit trees (Figure 17). Brick paths and gardens now fill the area behind the cape and connect to the parking lot and other buildings.

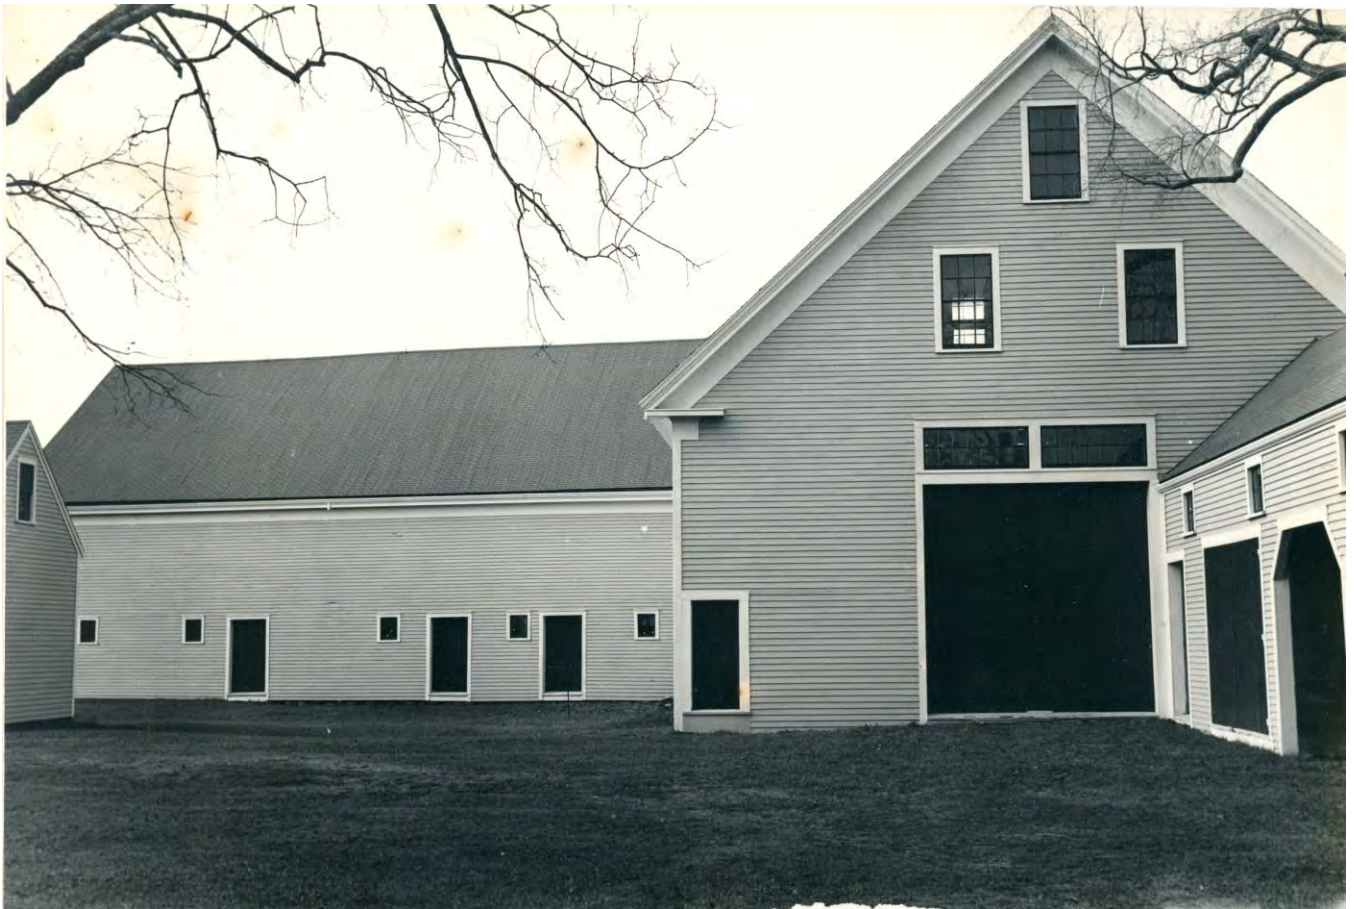
Figure 16. Outbuildings viewed from the back yard, facing west. Barn on site of John Elwyn Stone Forestry Learning Center at right, barn on site of maintenance barn at left (Courtesy of Alexander B. Warwick, Portsmouth Athenaeum)

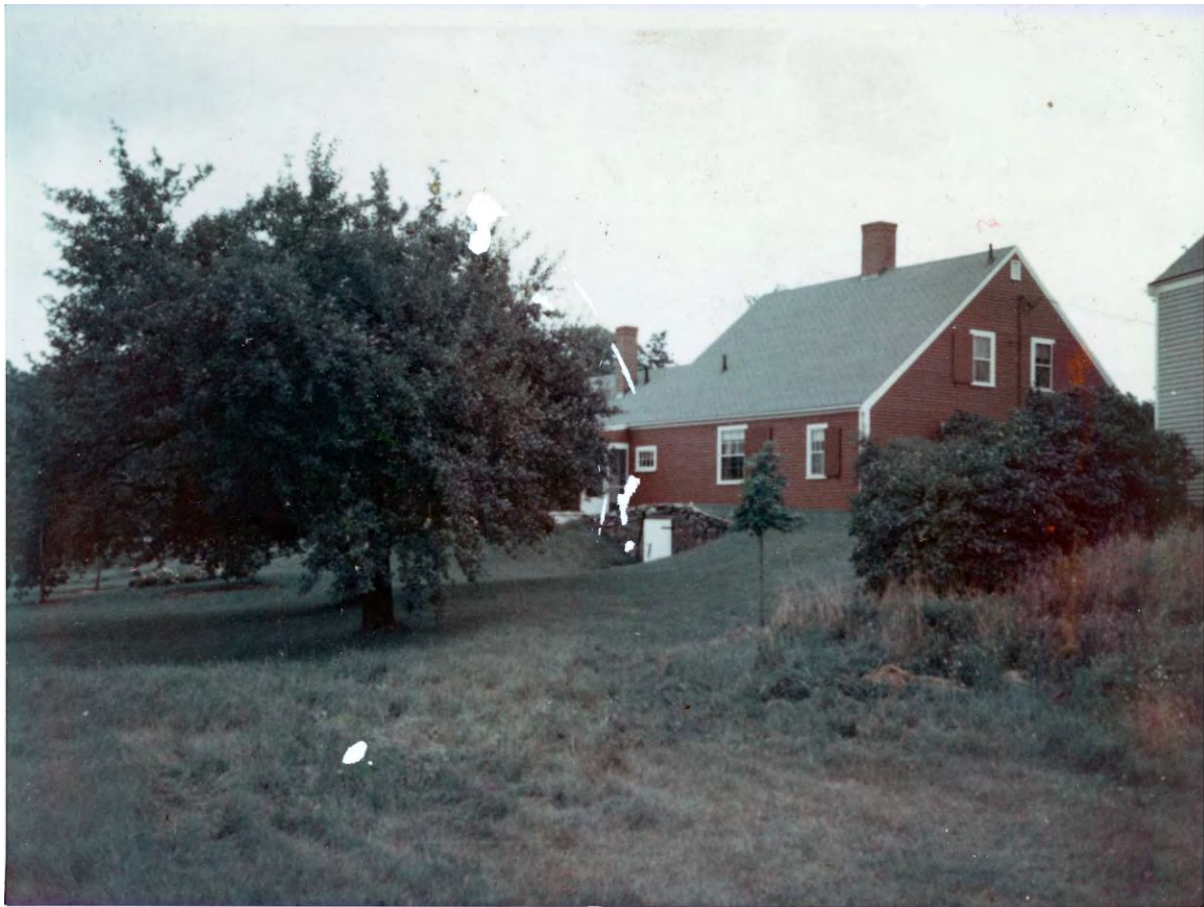
Figure 17. Rear of the cape, mid-twentieth century, facing southeast from the back yard (Courtesy of Alexander B. Warwick, Portsmouth Athenaeum)

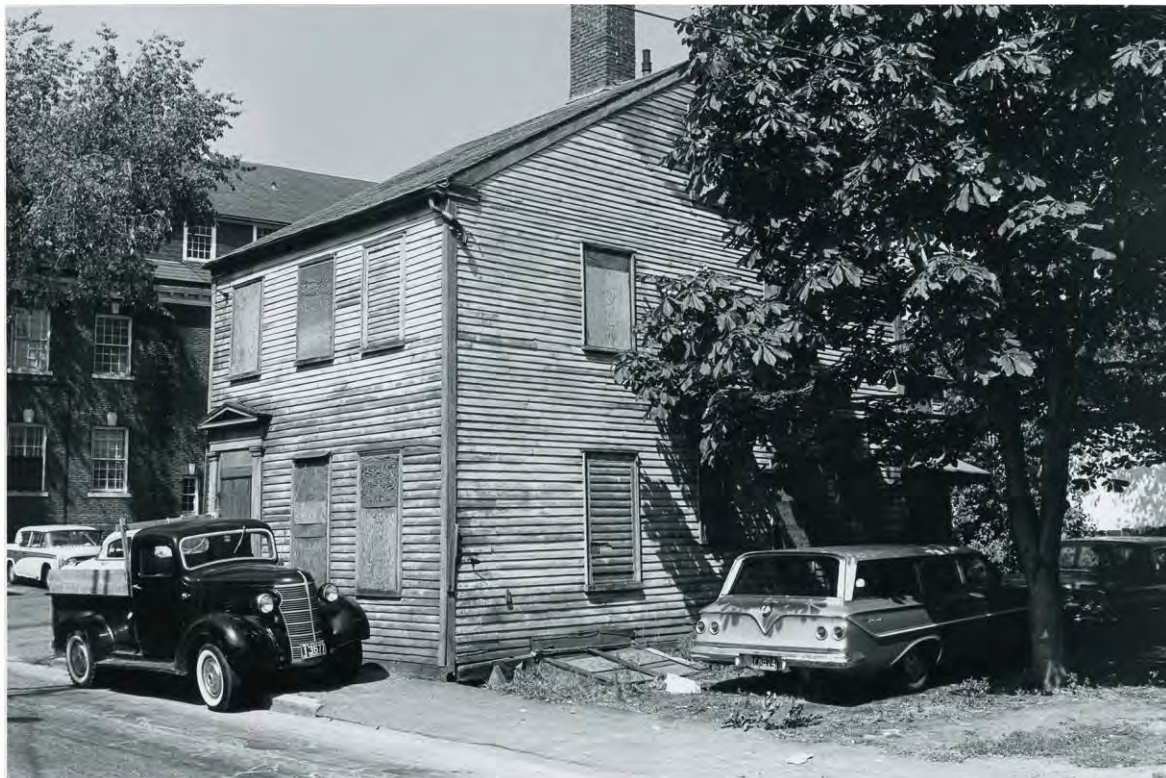
Figure 19. "Rosemary Cottage" on its original site on Chapel Street in downtown Portsmouth, before it was moved in ca. 1969 (Courtesy of the Portsmouth Athenaeum)

Rosemary Cottage (Photos 12-14) is a two-story building set back northeast of the other buildings. It was vacant at the time of survey and is slated for removal. The structure was moved from Chapel Street in downtown Portsmouth ca. 1969 and reconstructed. As originally built in the early 1800s, it was a 2½-story, 3 x 2 bay, "half house" with a fireplace chimney and pedimented front entry (Figure 19). On the new site, the walls were sided with half logs that remain on three elevations. In the 1970s, there was a stockade fence around the building. In the 1980s-90s, the building was used as classroom space. The west elevation has newer wood shingles and 1/1 windows. Other windows are boarded up. Two filled-in bays on the front (south) side of the building opened into attached greenhouses installed in the late 1970s and recently removed.

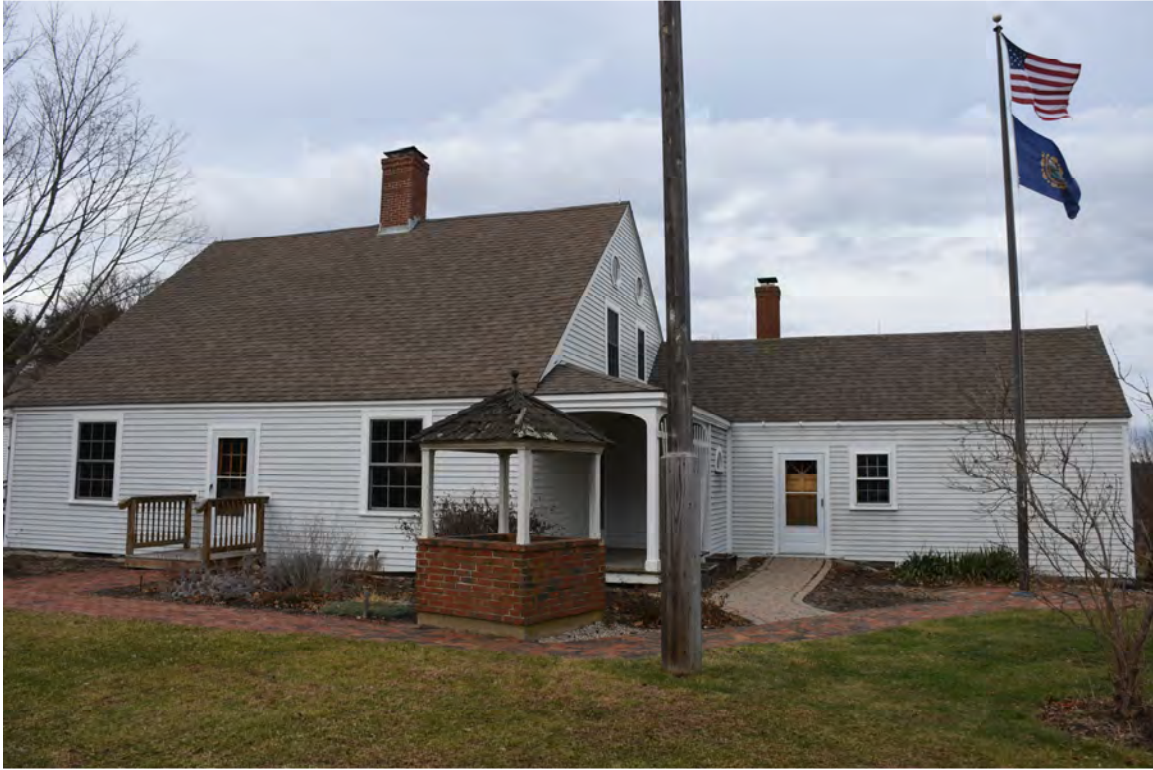
Photo 2) Historic cape or Elwyn House, façade
Reference (file name): PIC_9331

Direction: NNW
Date taken: December 2020

The *Historic Cape*, also known as the Elwyn House, is 1½ stories with a side gable roof, center chimney and center entry on the three-bay façade (Photos 2-5). The house faces south-southeast nearly parallel to the road. The building has its original form and fenestration, with all new windows and doors installed ca. 2013. The wooden front steps are new. The historic side porch on the east elevation was rebuilt in the 1960s. A historic wing on a mortared stone foundation projects from the northeast corner of the cape. The ells on the north elevation were added in the 1960s and remodeled ca. 1979. The walls are clad in clapboards with flat trim. The windows have 6/6 sash. The east gable ends have octagonal and lunette windows installed ca. 2013 in place of similar 1960s windows. There are three brick chimneys, with others removed above the roofline. The central brick chimney is original. An exterior fireplace chimney was added to the west elevation of the ell in the 1960s. A stove chimney rises from the wing. A series of additions on the back of the house date to the twentieth century. The back of the house was remodeled with the enclosure of decks and porches in the late 1970s (Dupere 2022). There is basement access on the back of the house where there was historically a stone bulkhead. The buildings were painted a reddish brown in the 1960s and then a dark maroon red, before the grey and white color scheme was adopted more recently (Dupere 2022).

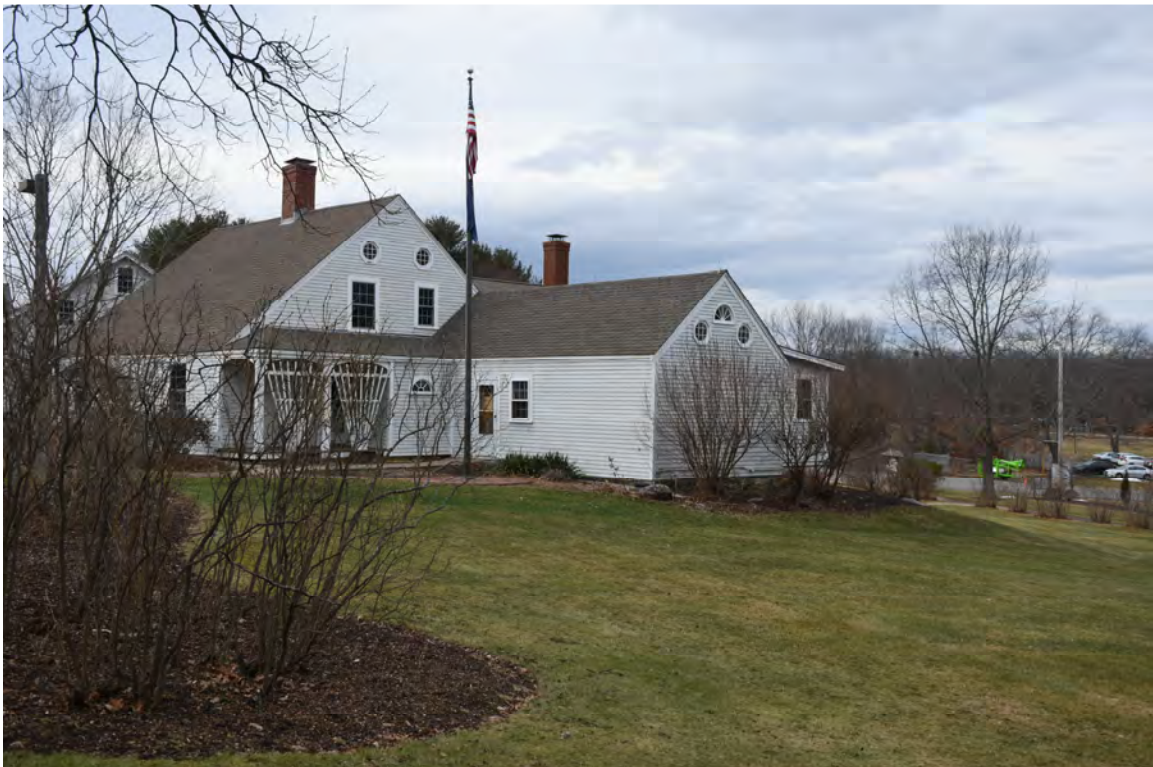
Photo 3) Cape east elevation and wing
Reference (file name): PIC_9337

Direction: NW
Date taken: December 2020

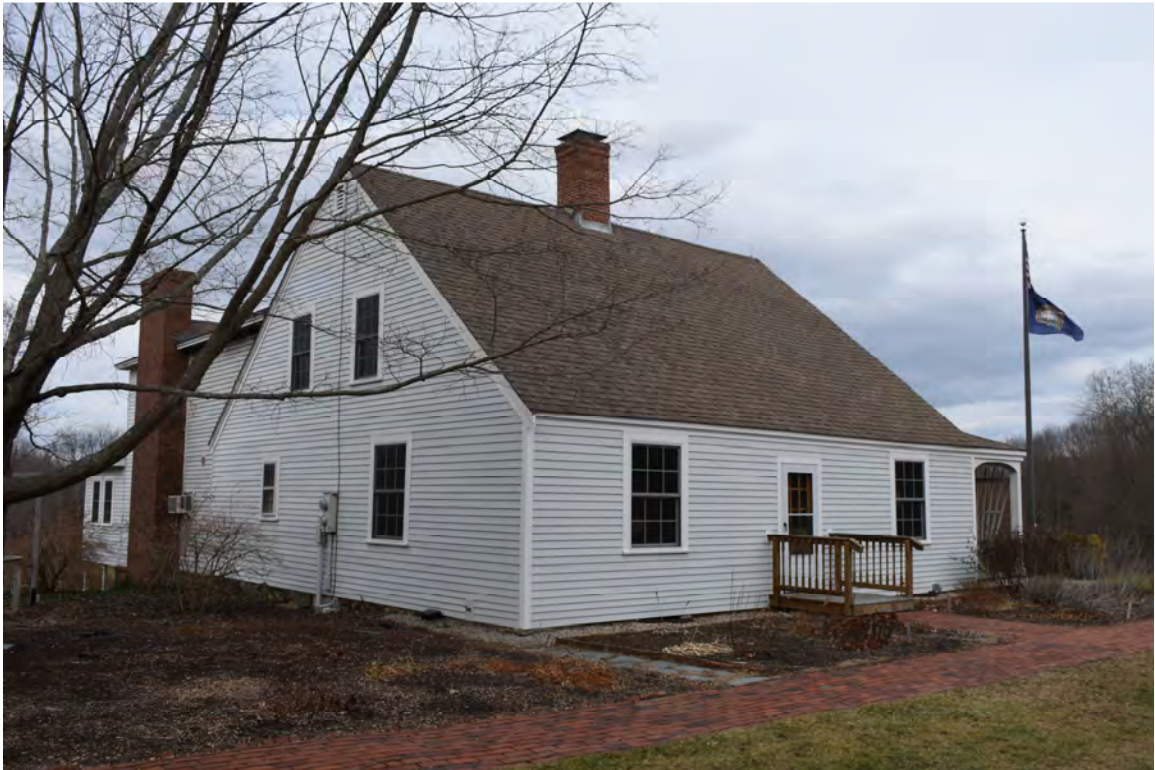
Photo 4) Cape west elevation and façade
Reference (file name): PIC_9330

Direction: NE
Date taken: December 2020

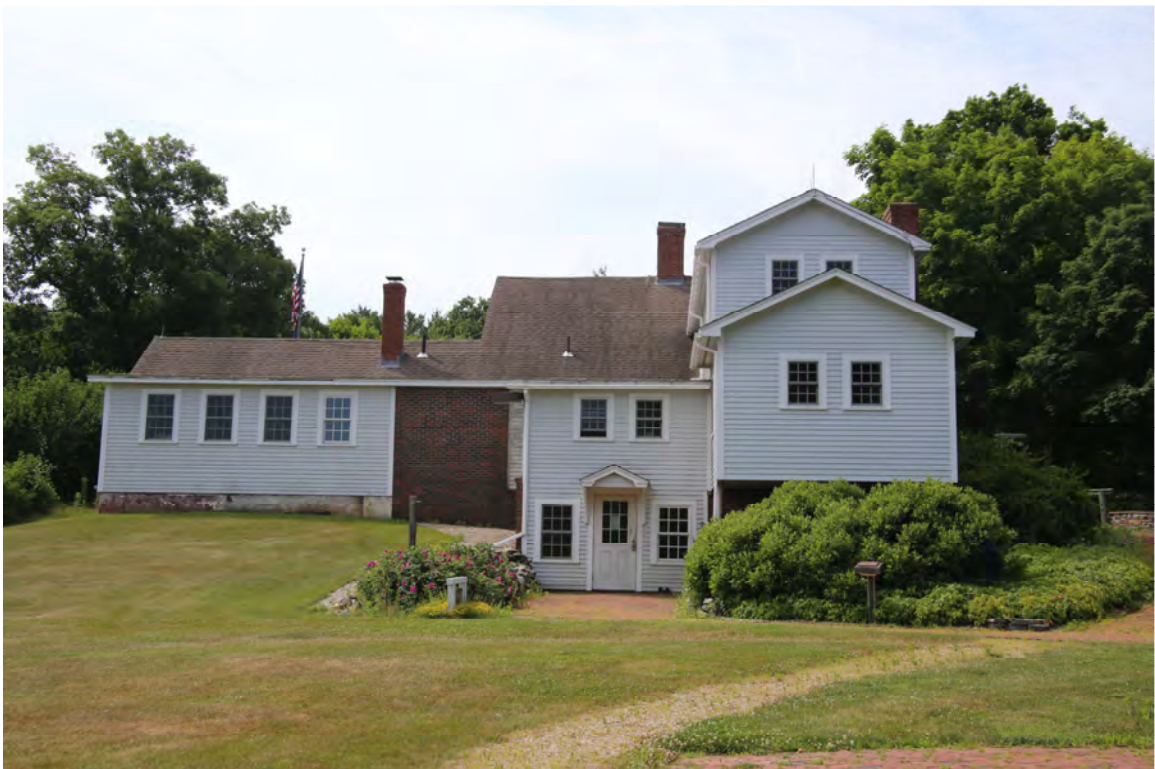
Photo 5) Cape rear (north) elevation
Reference (file name): IMG_9301

Direction: SSE
Date taken: July 2022

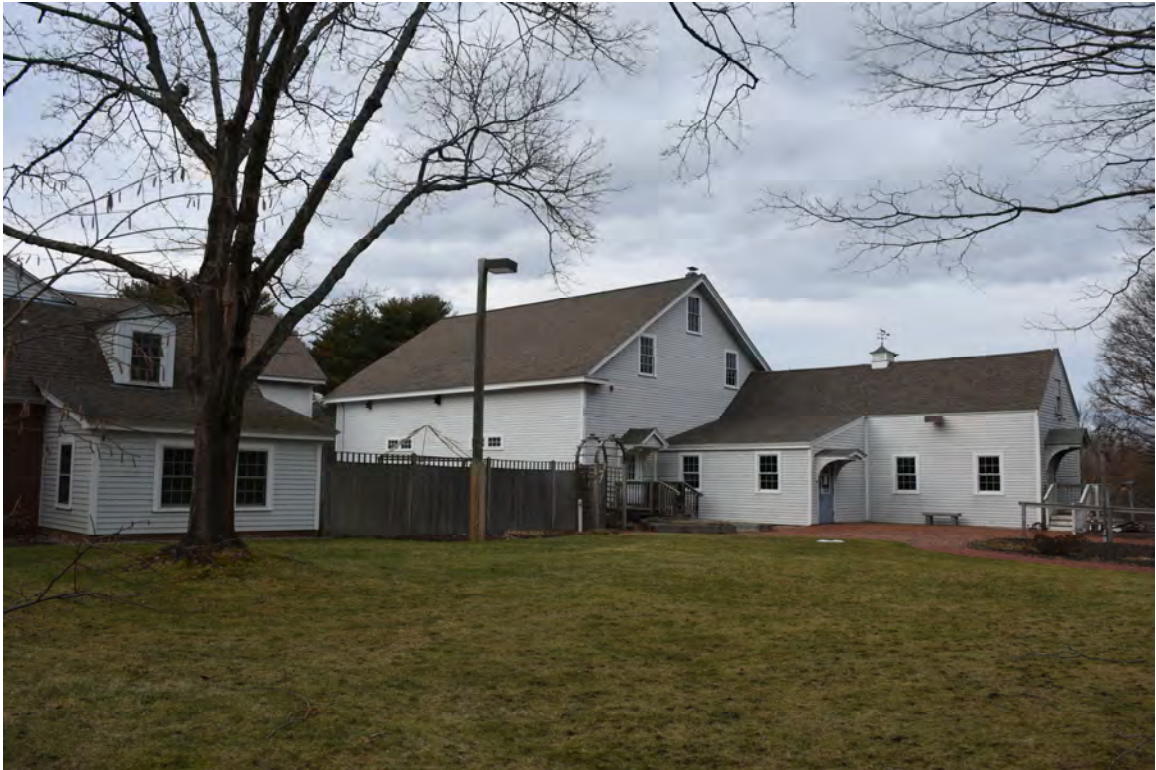
Photo 6) Barn, now John Elwyn Stone Forestry Education Center
Reference (file name): PIC_9343

Direction: NW
Date taken: December 2020

The main Urban Forestry Center building is the *John Elwyn Stone Forestry Learning Center*, which has meeting hall and classrooms in a remodeled barn (Photos 6, 7). The foundation dates to the nineteenth century, but most of the walls and the roof were rebuilt after a fire in 1969 (Dupere 2022). The stone foundation is visible on the north side where the ground slopes down. There is basement access with modern doors. In the late 1970s, the rebuilt barn was remodeled into meeting rooms. The building is roughly parallel to the road. The pre-1969 historic barn was a typical New England barn with gable end barn doors topped by transom lights, 6/6 windows in the gable ends and small stall windows on the side elevations (Figures 15, 16). The long, one-story extension off the northeast corner of the barn was once a vehicle shed with a row of doors and knee wall windows above. There are entrances on the eastern gable end of the barn, the end of the shed and in a small shed-roofed extension. The entries are sheltered by gable door hoods on curved wooden brackets. The modern doors are metal with nine lights above. The same treatment is used throughout the complex. The back door on the west elevation is sheltered by a modern door hood with gable roof and has modern wooden steps. Like all buildings, the roof is sheathed in tan asphalt shingles.

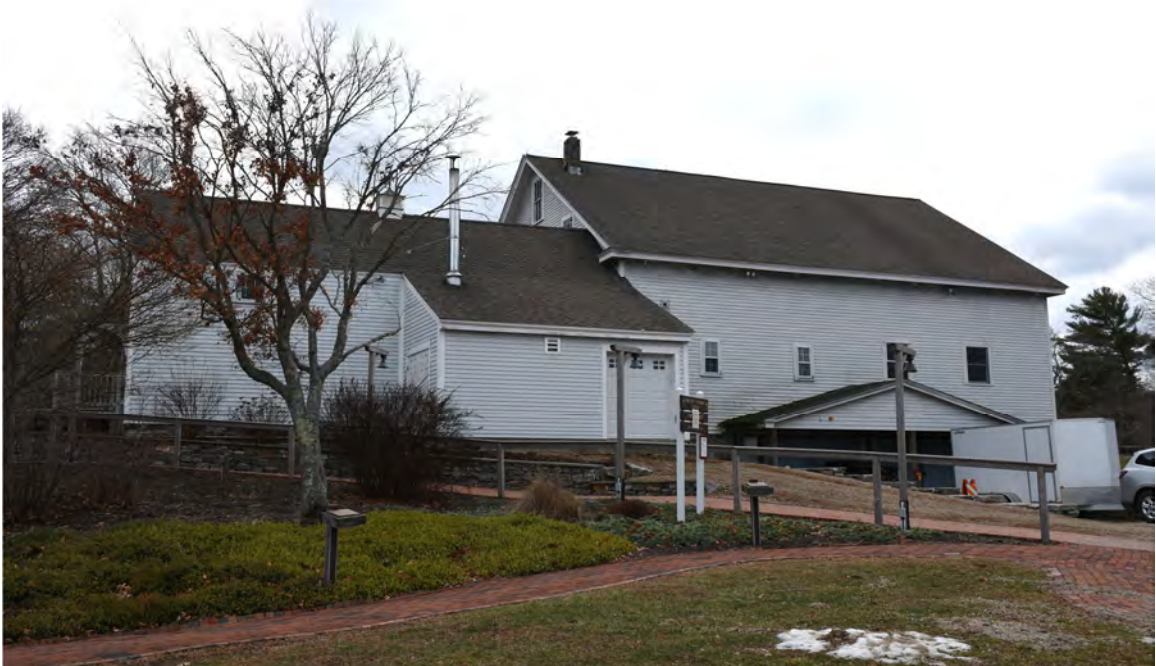
Photo 7) Barn north elevation from garden paths
Reference (file name): PIC_9328

Direction: SW
Date taken: December 2020

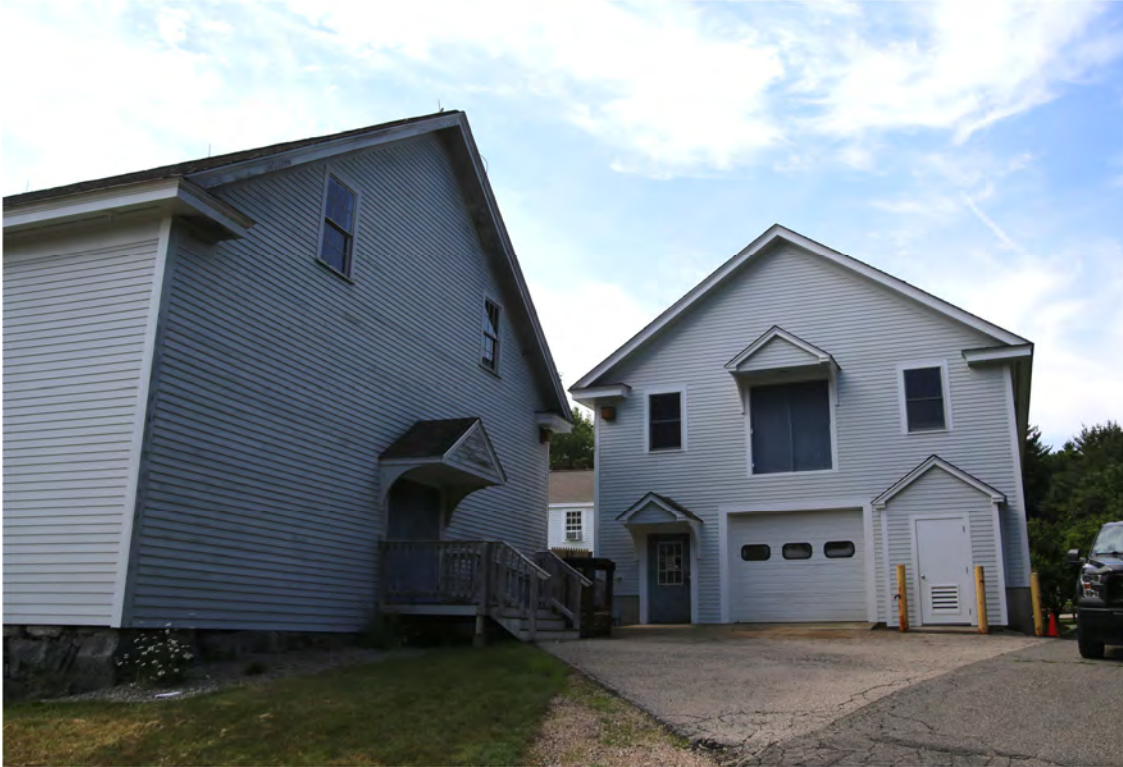
Photo 8) Barn and maintenance barn west and north elevations
Reference (file name): IMG_9320

Direction: S
Date taken: July 2022

The *maintenance barn* (Photos 8, 11) dates to 2003 (Dupere 2022). The 2+ story, gable front barn with its gable end toward the road is on the site of a historic building. It replaced a barn built in 1969 that was erected in place of a nineteenth century barn. The footprint is the same, but the roofline is slightly higher. The clapboard siding with flat trim and the projecting eaves and gable end returns reflect the original building. The foundation is poured concrete. Windows have 1/1 sash. The two garage bays on the front end have overhead doors. The north gable end has a central garage bay with a loft door above and doors to the ground floor and basement, sheltered by gable-roofed hoods.

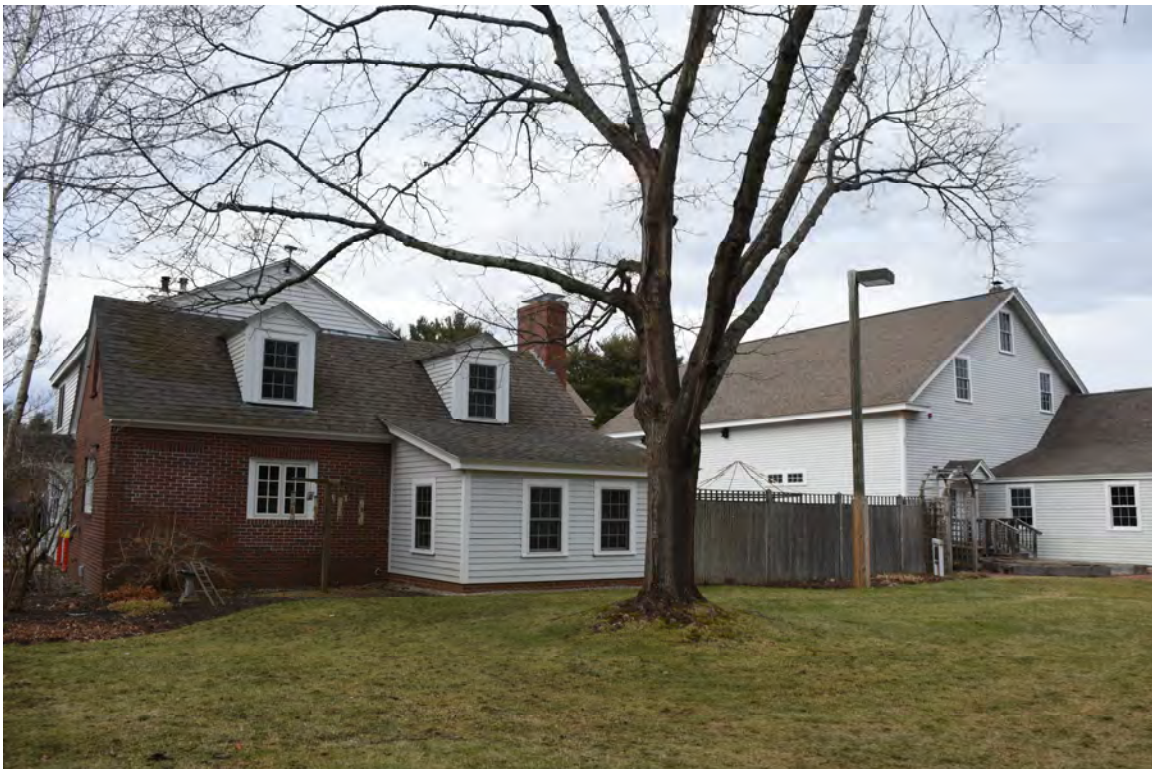
Photo 9) Caretaker's house and barn east elevations from front yard
Reference (file name): PIC_9345

Direction: NW
Date taken: December 2020

The *caretaker's house* (Photos 9-11) is a small residence in the yard west of the old cape, south of the barns. It was built around an old brick outbuilding, reportedly once used as a butcher shop. It was enlarged in the mid-twentieth century for residential use, remodeled ca. 1977, and again ca. 2003 following fire and water damage (Dupere 2022). The front door faces Elwyn Road with access from the driveway in front of the maintenance barn. The brick portion of the building near the road has a gable roof. The windows have brick trim and 6/6 and 6 x 6 casement sash. Openings on the east wall are bricked in. A two story extension on a brick foundation project to the west and a smaller addition with dormers to the north. The walls are clapboarded, and the windows have modern 1/1 sash. The yard north of the house is enclosed by privacy fencing connecting to the corners of the barns.

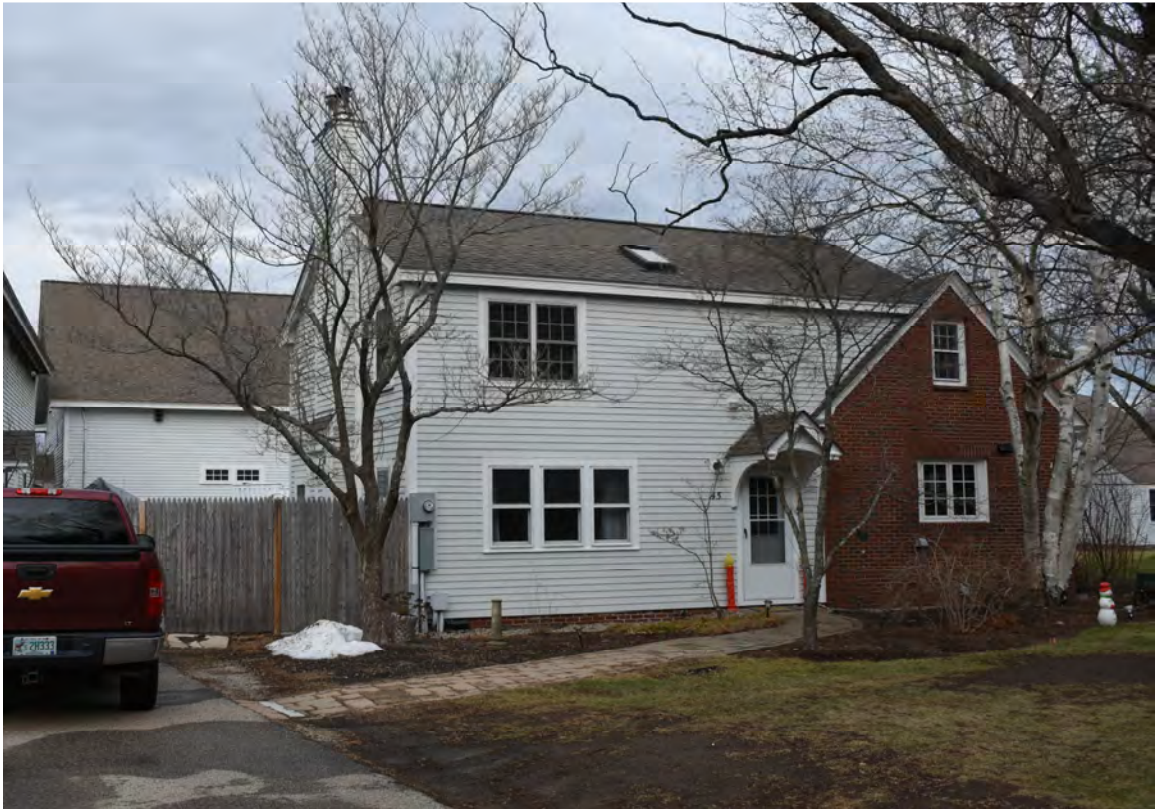
Photo 10) Caretaker's house south elevation from driveway
Reference (file name): PIC_9348

Direction: NNE
Date taken: December 2020

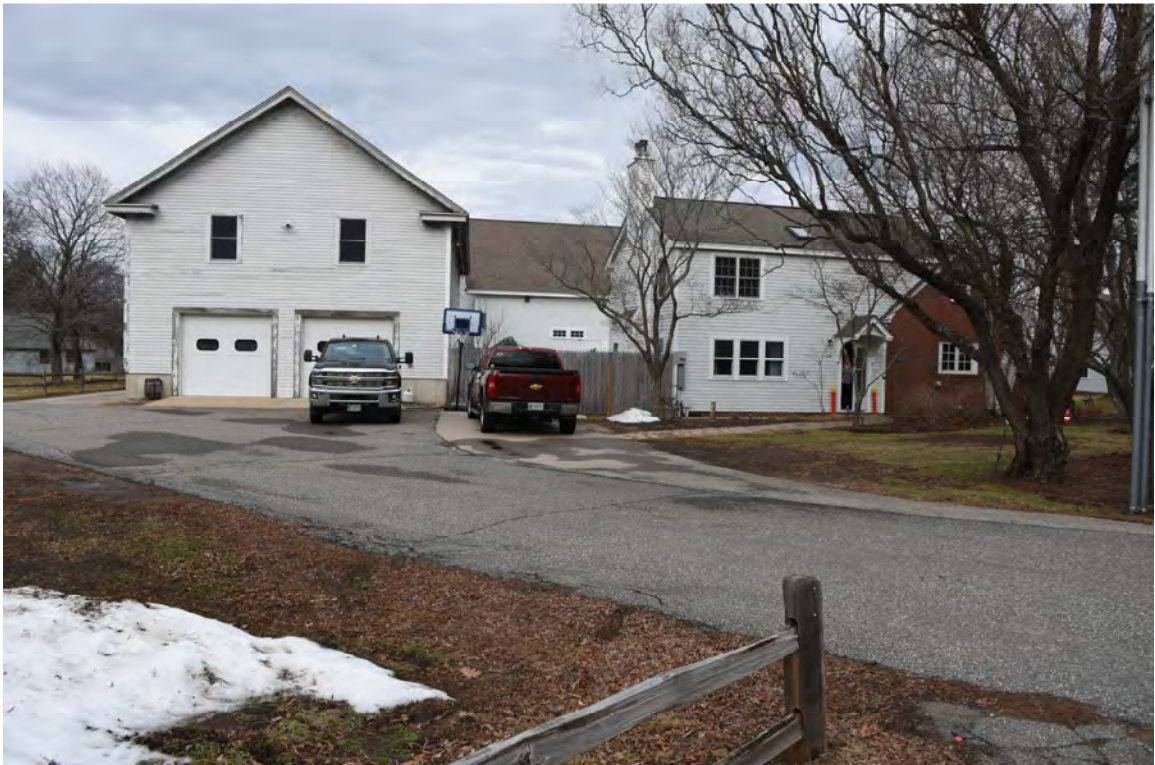
Photo 11) Maintenance barn and caretaker's house from driveway
Reference (file name): PIC_9350

Direction: NNE
Date taken: December 2020

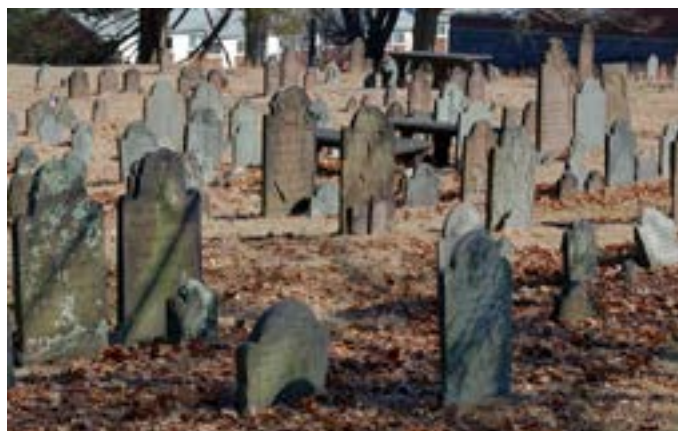
Figure 1. Sandstone and slate grave markers in the Ancient Burying Ground in New London, CT, display a variety of weathering conditions. Markers in the cemetery date from the mid-17th to the early 19th centuries. Photo: Jason Church.

While cemeteries are often considered to be perpetual, their most prominent feature—the grave markers—are not. They weather, naturally decay, often are poorly maintained and repaired and, on occasion, are vandalized (Fig. 1). Grave markers are usually noteworthy not only for their inscriptions but also for their craftsmanship. Exceptional markers are considered works of art.

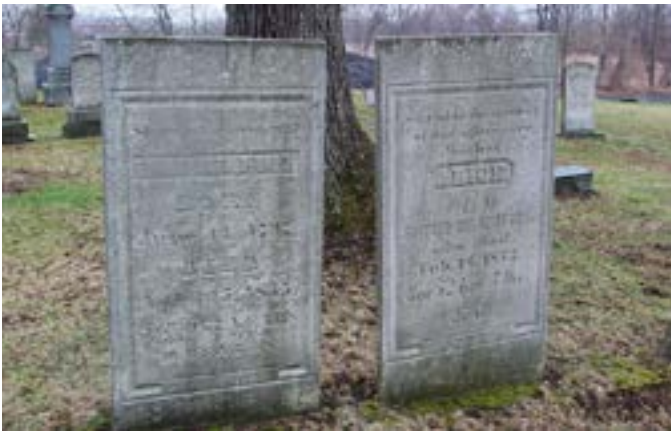
Figure 2. These mid-19th century, single-element stone grave markers in the Grove Cemetery in Bath, NY, are set in a vertical position. Photo: Jason Church.

The great variety in the types of grave markers is a fascinating aspect of the study and appreciation of historic cemeteries. Three broad categories can be used to describe grave markers—(1) single-element, (2) multiple-element, and (3) structures. Single-element grave markers are stone, cast iron, or wood elements that are set in a vertical position or placed as a horizontal slab on the ground (Fig. 2). Early examples of this simplest type of grave markers are field stone and basic wooden or wrought iron crosses, with the name of the deceased person scratched into or engraved on the marker. Often, these rudimentary grave markers are overlooked, significantly deteriorated, or lost. Vertical stone slabs and large stone ledgers laid horizontally over the gravesite are more sophisticated examples of this type.

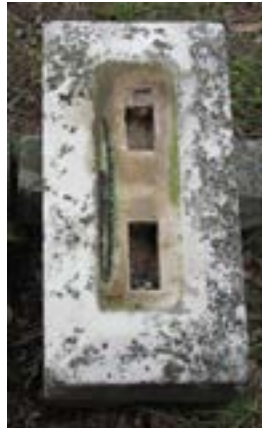
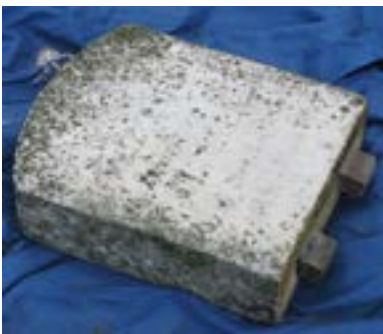
Figure 3. A multi-element grave marker from the early 19th century in the St. Michael’s Cemetery, Pensacola, FL, consists of a vertical element with tabs (left image) into a slotted base (right image). Photo: Fran Gale.

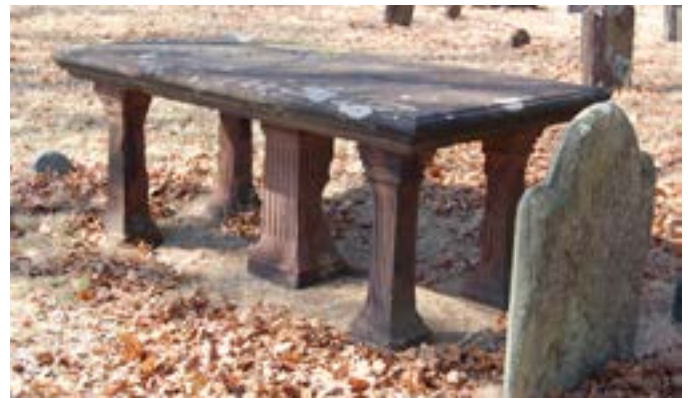
Figure 4. This sandstone table tomb, located in Cedar Grove Cemetery, New London, CT, is an engineered grave marker structure consisting of a horizontal stone tablet supported by four vertical table “legs” with and a central column,. Photo: Jason Church.

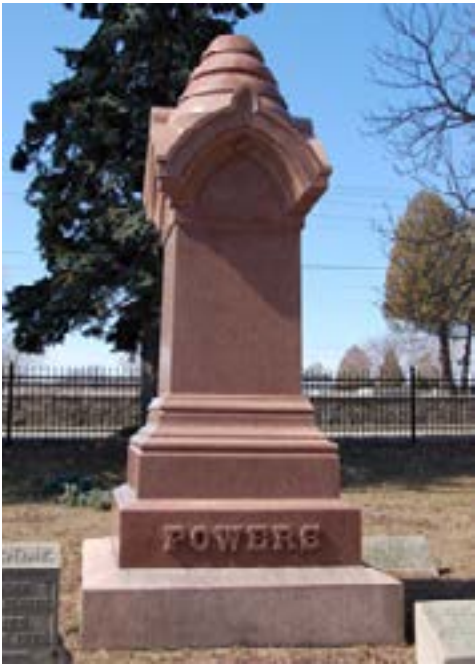
Figure 5. A variety of colors of natural stone are found in historic cemeteries, such as this pink granite marker in the Cedar Grove Cemetery, New London, CT. Photo: Jason Church.

Stone is a naturally occurring material with a wide range of properties and is available in a variety of colors (Fig. 5). Geologists classify stone according to the way in which it was formed with the three categories being igneous, sedimentary and metamorphic rock. Stone found in cemeteries is predominantly quarried, though the use of field stones is not uncommon. The mineralogy and chemical composition of stones vary. Some are composed primarily of silicate minerals; granites, sandstones, slate, and schist are examples. Other stones contain calcium carbonate with marble and limestone in this group. Mineralogy, chemical composition, and

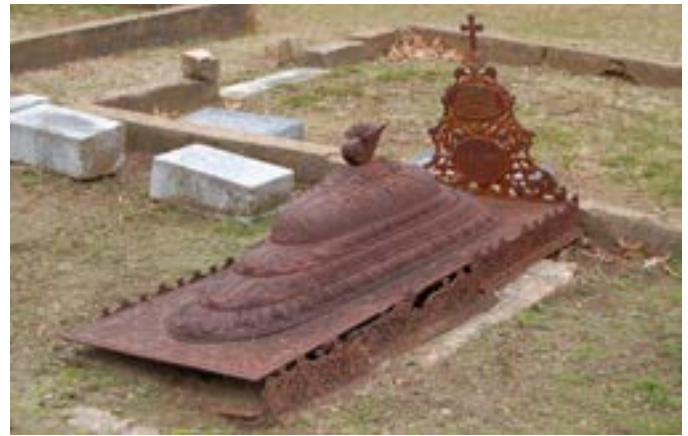
Figure 6. Decorative cast-iron grave markers like this late-19th century one in Oakland Cemetery in Shreveport, LA, are produced by heating the iron alloy and casting the liquid metal into a mold. Photo: Jason Church.

Metals are solid materials that are typically hard, malleable, fusible, ductile, and often shiny when new (Fig. 6). A metal alloy is a mixture or solid solution of two or more metals. Metals are easily worked and can be melted or fused, hammered into thin sheets, or

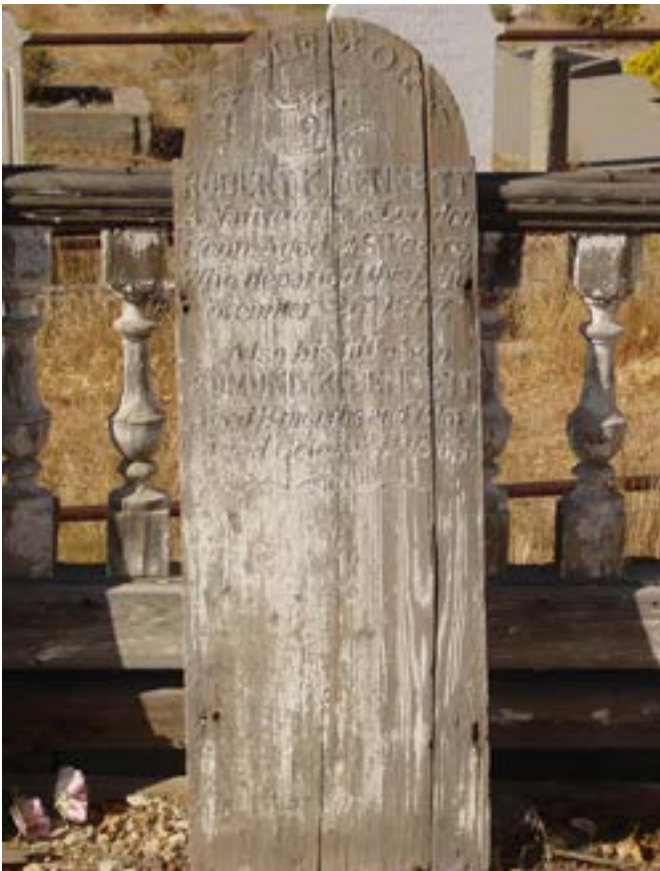
Figure 7. As shown by this 1877 marker in Silver Terrace Cemetery, Virginia City, NV, exposure to sunlight can damage wood grave markers, making the wood more susceptible to water damage and cracking. Photo: Jason Church.

and characteristics of these cells determine the wood's appearance and influence wood properties. Wood-cell walls and cavities contain moisture. Oven drying reduces the moisture content of wood. After the drying process, the wood continues to expand and contract with changes in moisture content. The loss of water from cell walls causes wood to shrink, sometimes distorting its original shape (Fig. 7).
