Preservation Plan

African Burying Ground at Langdon Farm Portsmouth, NH

PRESERVATION
COMPANY

June 2024

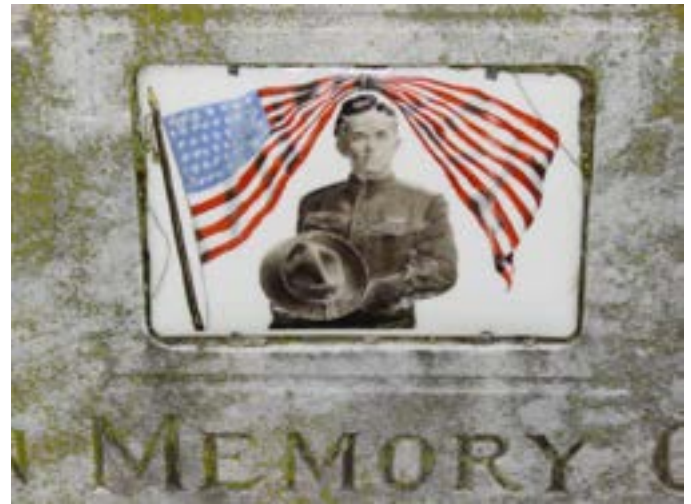
Figure 8. A fired ceramic, this cameo is set in a marble grave marker, located in Elmwood Cemetery, Memphis, TN. Different materials may require different conservation approaches. Photo: Mary Striegel.

Old cemeteries often include a wide variety of other materials not normally associated with contemporary grave markers, such as ceramics, stained glass, shells, and plastics (Fig. 8). As with masonry, metals, and wood, each has its own chemical and physical properties

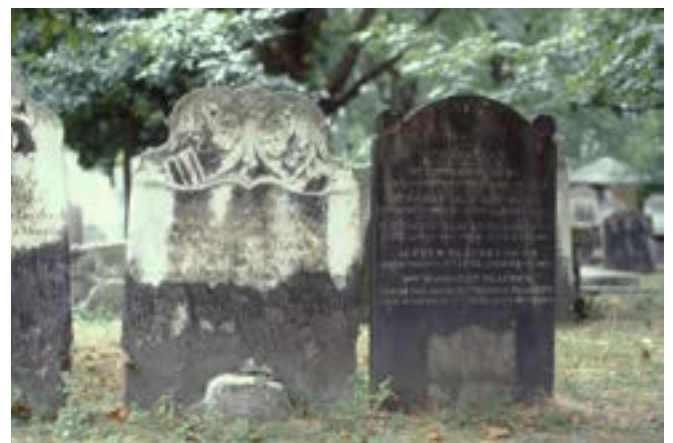
Figure 9. The limestone and sandstone grave markers in this historic cemetery have different weathering processes. On the left, the limestone shows surface loss in areas exposed to rainwater and gypsum crust formation below. The sandstone marker on the right displays uniform soiling, but surface hardening may be occurring. Photo: Fran Gale.

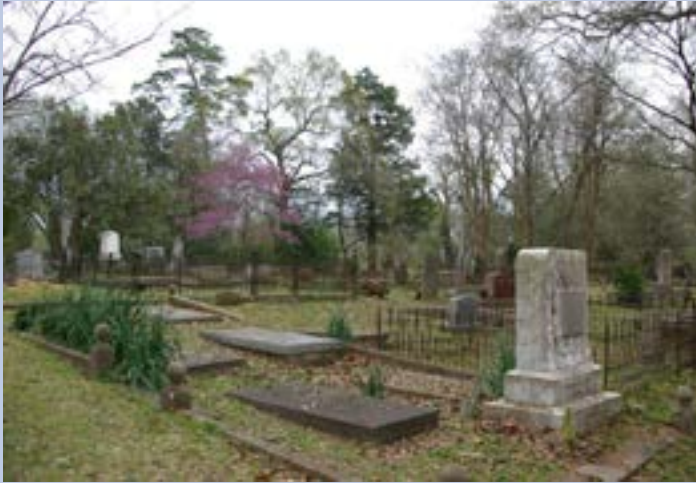
Figure A. Cemeteries are cultural landscapes made up of a variety of features. Grave markers are but one component of cemeteries that also include walkways, drives, fences, coping, trees, shrubs, and other vegetation. Each component adds to the understanding of the cemetery landscape. Photo: Debbie Dietrich Smith.

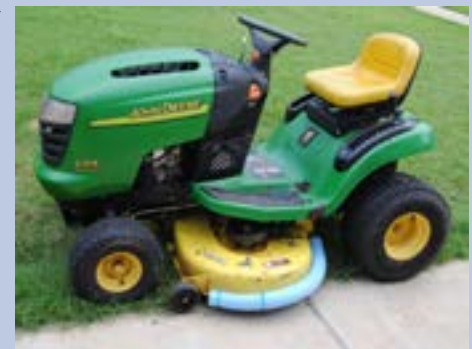
Figure B. A pool ‘noodle’ can be fitted to the deck of a lawnmower to prevent damage to grave markers. Photo: Debbie Dietrich Smith.

Regarding lawn care, historic cemeteries were not designed for today’s large riding lawnmowers, yet this is the mower of choice for many cemeteries, as mowing is one of the most time-consuming and costly maintenance tasks generally undertaken. Mowing between tight spots with a large riding mower deck is destined to cause damage. Best practices include using a smaller, push mower between particularly sensitive features, and outfitting riding mower decks with protective bumpers. Low-cost options include using fire hose padding or a foam swimming ‘noodle’ (Fig. B). Additional damage is caused by riding over low stones or coping, especially when the blade height is set low. If rolling over these features is unavoidable,

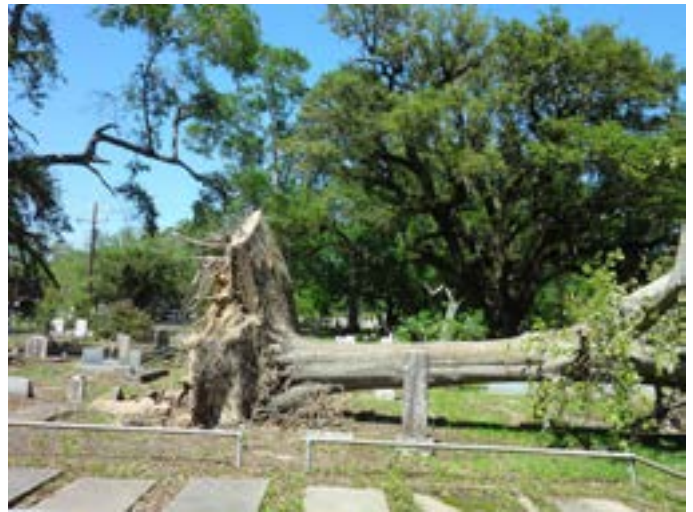
Figure 11. Woody vegetation can damage grave markers and pose a risk to visitors unless well managed and maintained. Photo: Jason Church.

Woody vegetation can damage grave markers in a variety of ways (Fig. 11). Trees, bushes, and vines can shade grave markers, extending the time that the markers are exposed to moisture. Tendrils and roots may burrow into mortar joints and openings, causing mechanical damage and large plants may lift up or shift markers. Even leaves and twigs, when allowed to collect on the ground near grave markers, can affect water drainage and evaporation (Fig. 12).

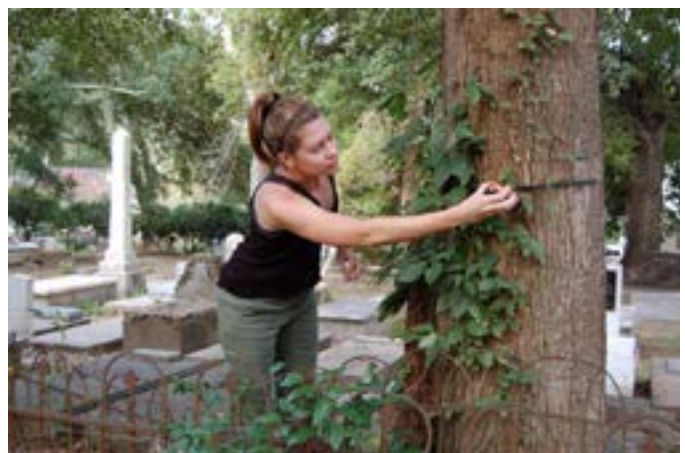
Figure 12. A cemetery professional undertakes a tree inventory in American Cemetery, Natchitoches, LA, to determine the health of trees in the cemetery. Management decisions for trimming or removal are based on the inventory. Photo: Debbie Dietrich Smith.

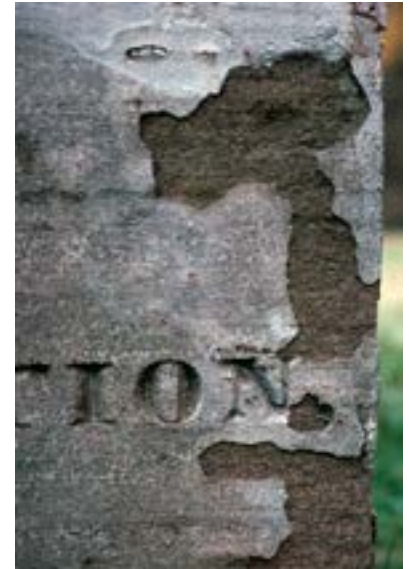
Figure 14. High-pressure water washing can damage grave markers. The photograph shows "wand marks" on the headstones produced by inappropriate pressure washing. Photo: Jason Church.

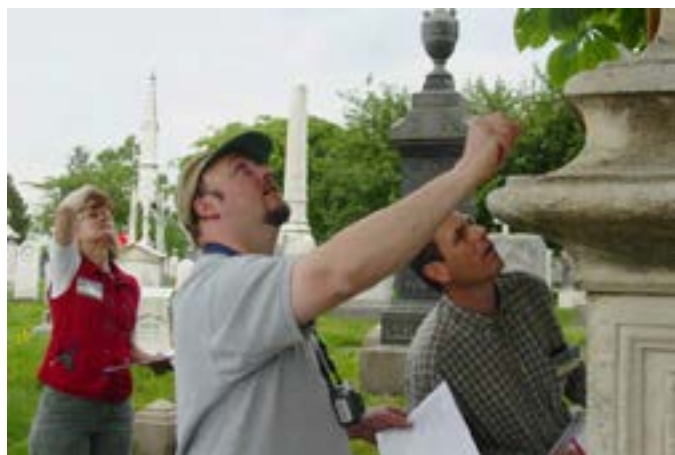
Figure 15a. Condition surveys are undertaken to document current conditions, determine safety issues, and plan both emergency stabilization and future treatment plans. There are a variety of survey forms available that can be tailored to the specific cemetery. Photo: Mary Striegel.

Depending upon the size of the cemetery and funding available, the initial assessment may be carried out by a team consisting of cemetery staff, a materials conservator, and, where necessary, an architect or structural engineer for cases involving large monuments and mausoleums (Figs. 15a and 15b). For smaller cemeteries without large monuments and mausoleums, and where funding is problematic, volunteers can be trained to prepare a condition assessment under the guidance of an experienced individual.

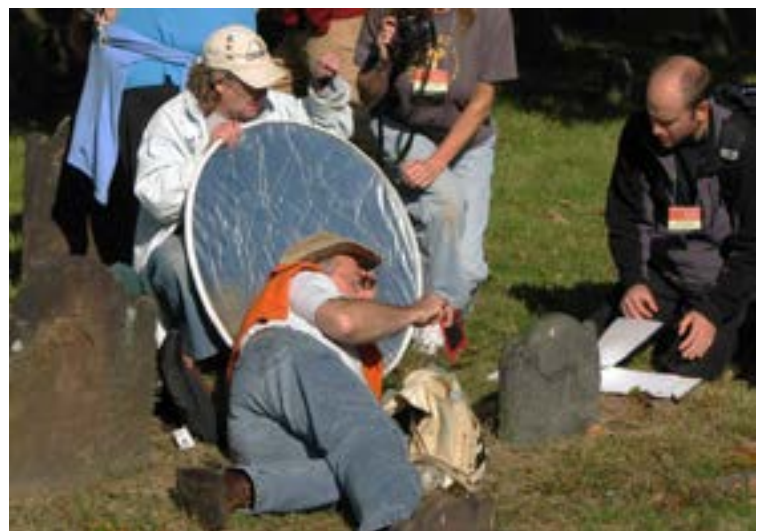
Figure 15b. Photographs are used to document the condition of the grave marker as part of a condition assessment. Photo: Fran Gale.

A tool kit for the condition assessment may include binoculars, digital camera, magnifying glass, measuring tape, clipboard, carpenter's rule, level, magnet, and flashlight. For large monuments, a ladder or aerial lift may be required. Photographs of each marker, including overall shots and close-up details, are an essential part of the documentation process. Photo logs are helpful for

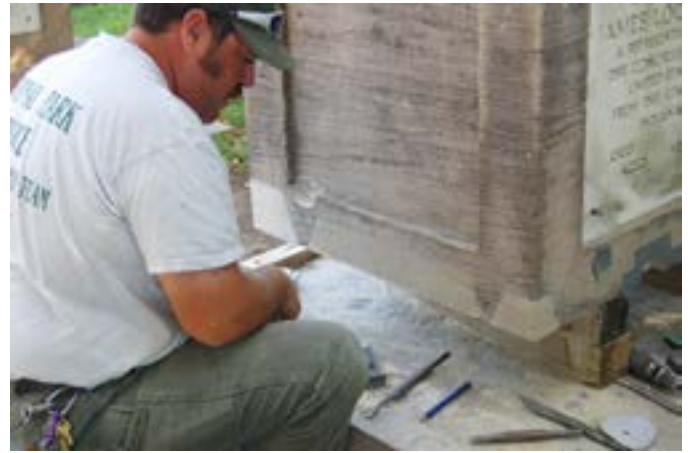
Figure 16. A professional mason works to insert a new piece of stone. Often referred to as a “dutchman”, this repair technique requires replacing the deteriorated stone section with a new finished piece of the same size and material. Photo: Jason Church.

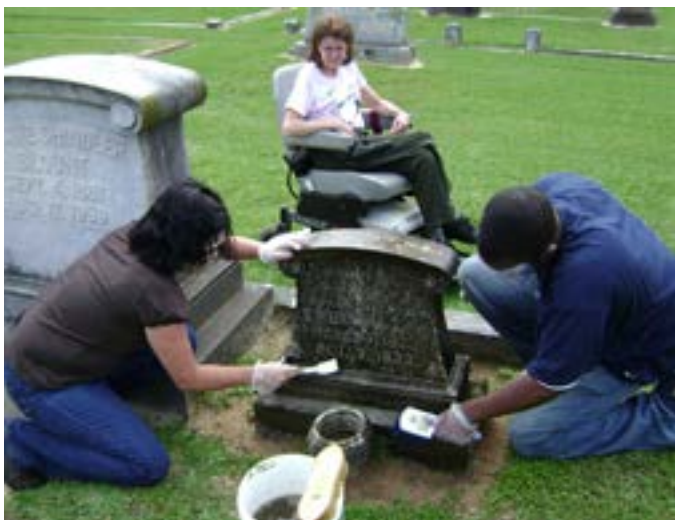
Figure 17. Volunteers can undertake cleaning of grave markers once they have received initial training. Cleaning methods may include wetting the stone, using a mild chemical cleaner, gently agitating the surface with a soft bristle brush, and thoroughly rinsing the marker with clean water. Photo: Jason Church.

Cleaning is carried out to remove soiling, staining, and contamination from grave markers (Fig. 17). Cleaning improves the visual appearance of the marker and sometimes reveals existing problems such as erosion and cracks. For various protective treatments, cleaning may be a necessary step in surface preparation. Although cleaning often is desirable and beneficial, the use of improper materials and techniques can cause great damage; when cleaning historic grave markers is undertaken, one should keep in mind the principle, “first do no harm.”

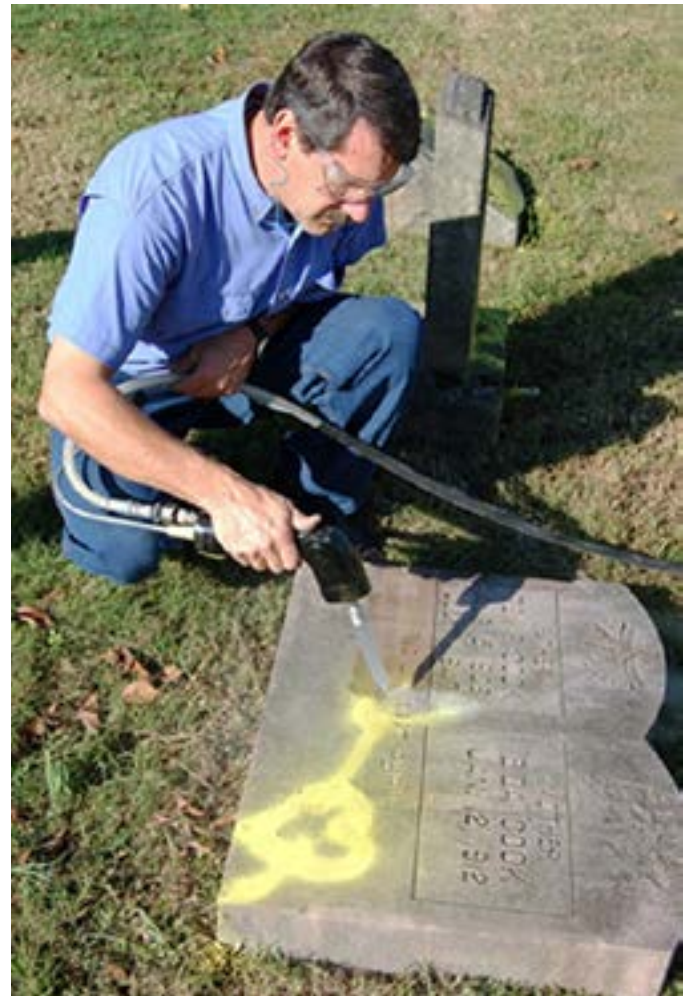
Figure 18. Graffiti is carefully removed using a low-pressure dry-ice misting instrument. Photo: Jason Church.

Markers with graffiti tend to be targets for further vandalism (Fig. 18). Timely removal helps deter future vandalism and improves the marker’s appearance.

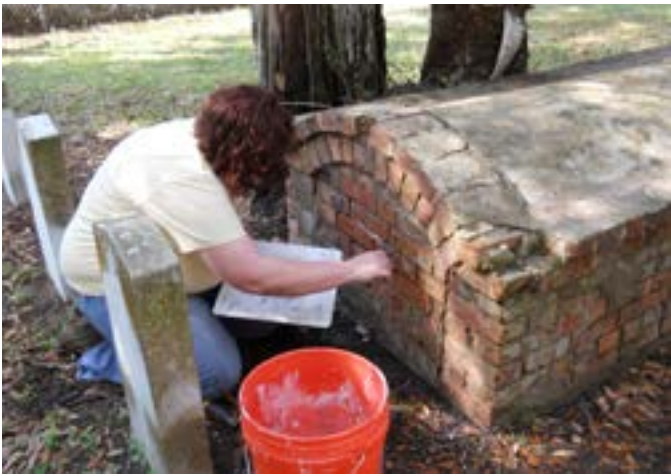
Figure 19. Masonry markers like this box tomb may require the repointing of mortar joints. It is important to use a mortar that is softer than the historic brick. In this case a conservator uses a lime putty-based mortar to repoint. Photo: Jason Church.

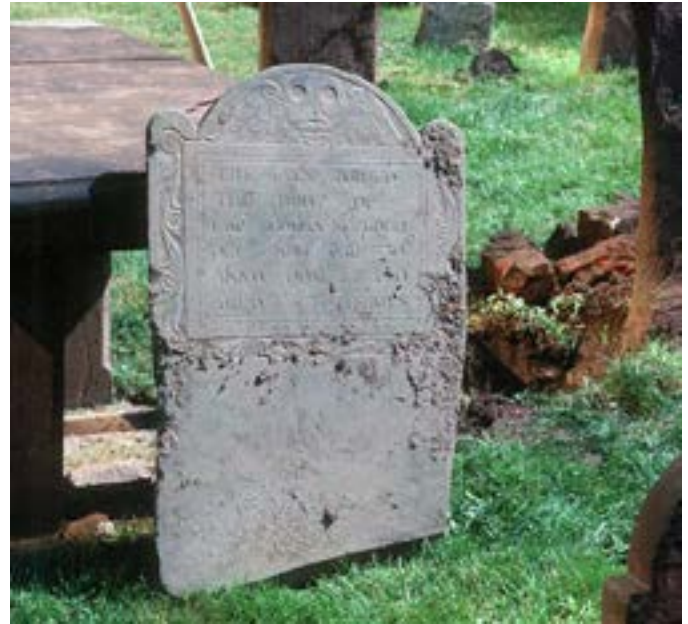
Figure 20a. This slate grave marker in the Ancient Burying Ground in Hartford, CT, is a ground-support stone. Resetting requires digging a hole that will hold the base of the stone and then compacting the soil at the bottom of the hole by hand. Photo: Fran Gale.

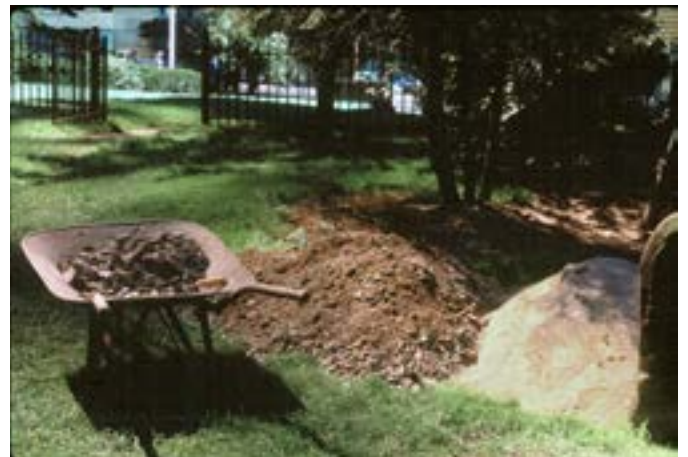
Figure 20b. To facilitate drainage, crushed stone, gravel, and sharp sand line the hole and are hand-tamped around the stone after placement. Photo: Fran Gale.

Resetting is recommended for grave markers when their foundations are unstable or out of plumb (Figs. 20a through 20c). This often complex activity involves lifting the grave marker, leveling its foundation, and returning the marker to its original upright position. Workers can be injured and the grave marker damaged if resetting is not carried out properly and safely.

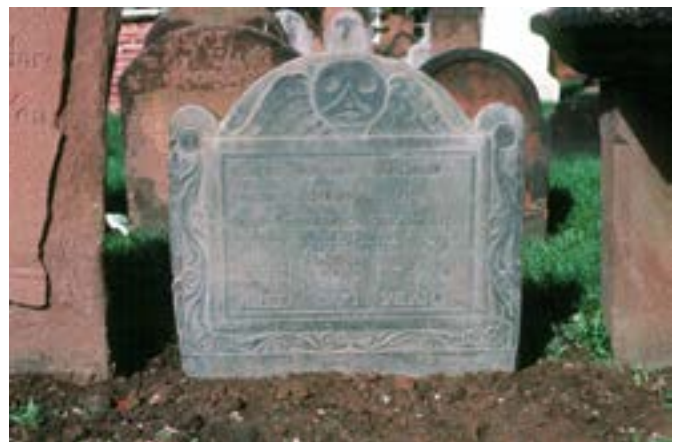
Figure 20c. The reset ground-supported grave marker should be level and plumb. Photo: Fran Gale.

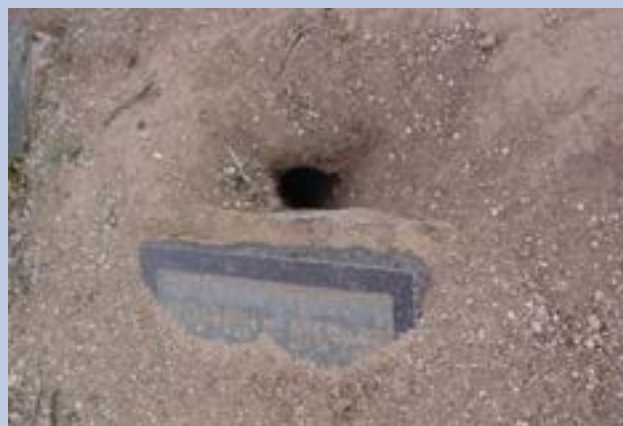
Figure C. Gophers and other burrowing animals produce uneven ground and holes that are trip and falling hazards to visitors and staff of historic cemeteries. Photo: Jason Church.

Trip and falling hazards include uneven ground, holes, open graves, toppled grave markers, fallen tree limbs, and other debris (Fig. C). Sitting, climbing, or standing on a grave marker should be avoided since the additional weight may cause

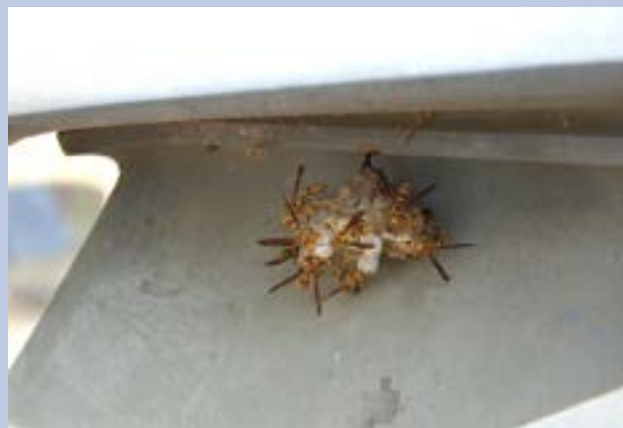
Figure D. Yellow jackets that are nesting below the projecting molding of this grave marker pose a hazard to visitors and staff because, if disturbed, they will vigorously defend their nest. Yellow jacket, paper wasp and hornet nests should be removed from grave markers by trained staff or specialists. Photo: Jason Church.

Snakes, wasps, and burrowing animals inhabit historic cemeteries (Fig. D). Snakes sun on warm stones and hide in holes and ledges, so it is important to be able to identify local venomous snakes. An appropriate venomous snake management plan should be in place, and

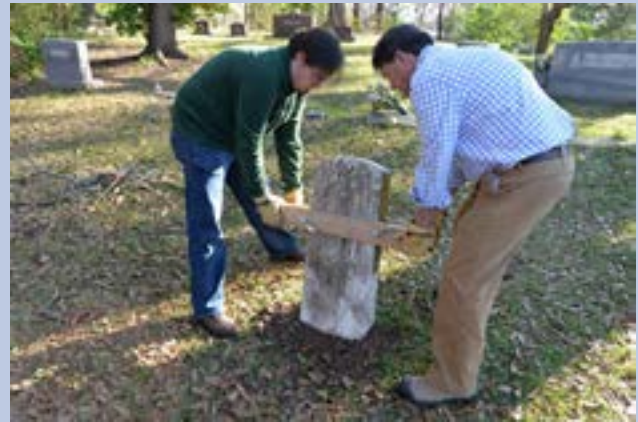
Figure E1. The simple wooden clamp system allows two people to safely lift a marble grave marker. Photo: Sarah Jackson.

lifting techniques. Lift equipment and ergonomically correct tools should be routinely used to lift heavy markers (for most people this includes markers that weight more than 50 pounds). For smaller grave markers, a simple wooden clamp system can be constructed for a two-person lift (Figs. E1 and E2).

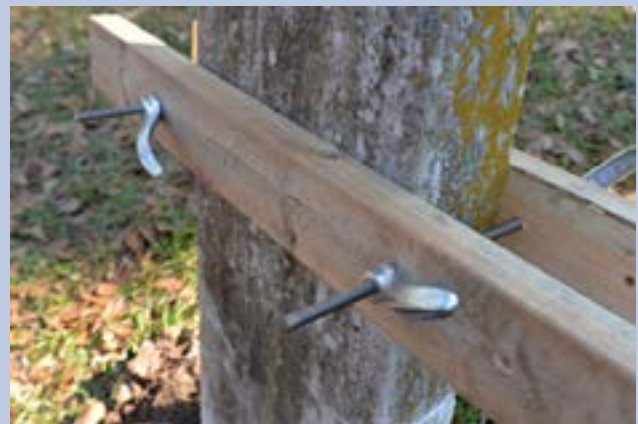
Figure E2. The clamp system is constructed from off-the-shelf wooden boards. Photo: Sarah Jackson.

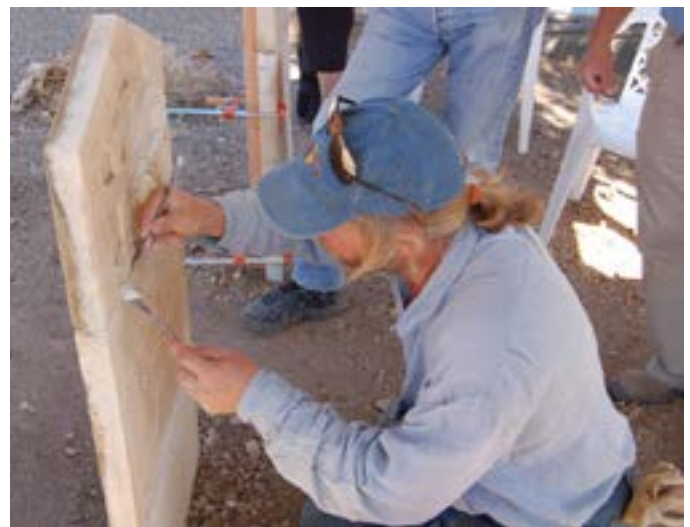
Figure 21. Cracks in a stone marker should be filled to keep water and debris out and prevent the crack from becoming larger. A patching mortar is designed to be used, in this case, with historic marble. Photo: Mary Striegel.

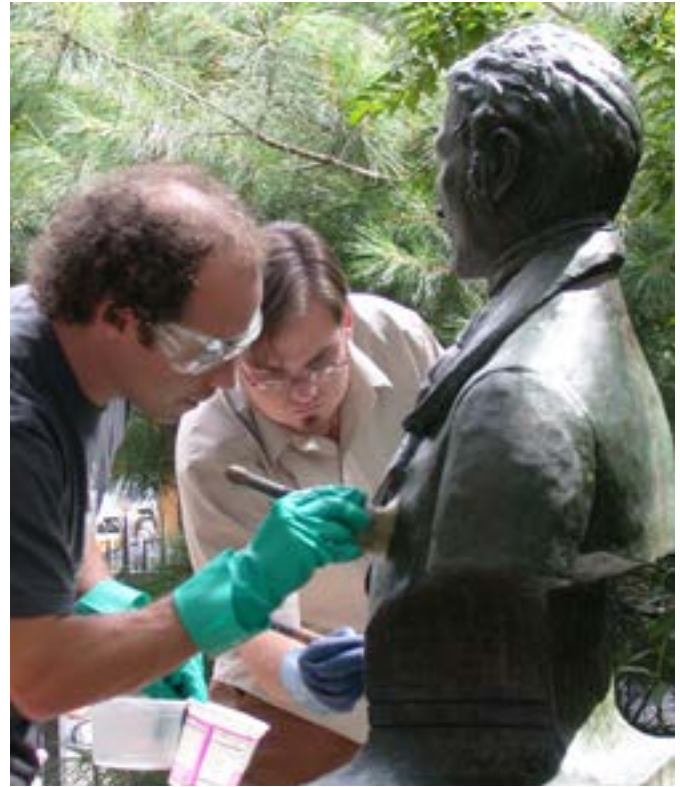
Figure 22. A protective coating must be maintained on metal elements. Wax or lacquer coatings help preserve the bronze patina and slow corrosion. Conservators apply a microcrystalline wax to this bust at St. Mark's Church in-the-Bowery, New York, NY. Photo: John Scott.

Wax coatings are often used for bronze markers (Fig. 22). Wax provides a protective barrier against moisture, soiling, and graffiti. There are several steps in the wax application process. Where there is little corrosion, gentle cleaning of the marker is undertaken prior to applying the wax coating. Apply a thin layer of wax to the marker using a stencil brush or chip brush.

Mineral spirits can be added to the wax to facilitate brush application. A soft, clean cloth is used to remove excess wax and buff the surface. A second coat of wax is sometimes needed.

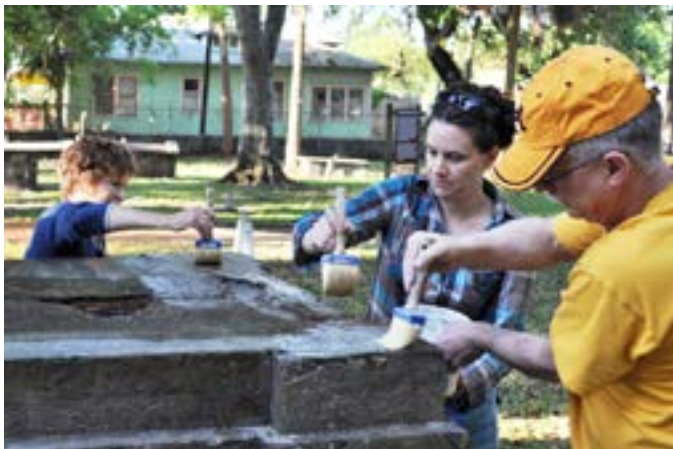
Figure 23. Limewash is a breathable coating sometimes used to protect the surface of the grave marker and provide a decorative finish. Limewash is applied by brush in five to eight thin coats (with each coat about the consistency of skim milk). The surface is allowed to slowly dry between coats. Sometimes the surface is covered by damp burlap to slow the drying process. Photo: Sarah Jackson.

Limewash is a traditional coating that brightens stucco-covered grave markers (Fig. 23). Like paint coatings, it needs to be periodically applied. Limewash is prepared with lime putty or hydrated lime and water. Curing begins following application. The lime putty or hydrated lime reacts with carbon dioxide in the air in a process called carbonation. This reaction eventually forms calcium carbonate, a stable hard coating. Limewash is a “green” coating with no volatile organic compound content and is “breathable,” i.e., it allows for water vapor transmission. Although commonly white, limewash can be colored or tinted with alkali-stable pigments such as iron oxide.

Before applying the limewash, the masonry surfaces should be inspected for coating residues that need to be removed and any required repair work undertaken. Stucco-covered surfaces should be repaired and allowed to fully cure before applying limewash. If the original color has been determined, the renewal coating can be formulated to match. In preparing the wash, enough water is added to lime putty or hydrated lime to produce slurry with the consistency of skim milk. A mixture of four parts water and one part lime usually works well. A Zahn or Ford cup can be found at a hardware store and used to measure the thickness of the limewash and ensure consistency with each batch. Although many traditional recipes include additives, a simple mixture of lime and water performs best. Using a power drill with a paddle attachment to stir the limewash will help ensure that the lime particles are fully suspended in the

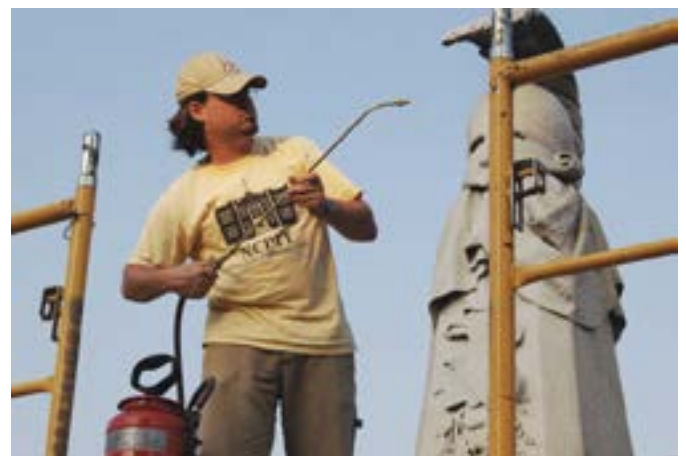
Figure 24. A severely deteriorating monument or grave marker can be treated with a stone consolidant. The treatment is usually applied using a spray system. The consolidant soaks into the stone and replaces mineral binders that hold the stone together. On-site and laboratory testing and evaluation are performed prior to using this non-reversible type of treatment. Photo: Lucas Flickinger.
